ORILLIA OPERA HOUSE | CONSERVATION PLAN UPDATE 2025

July 2nd, 2025 DRAFT

Orillia Opera House

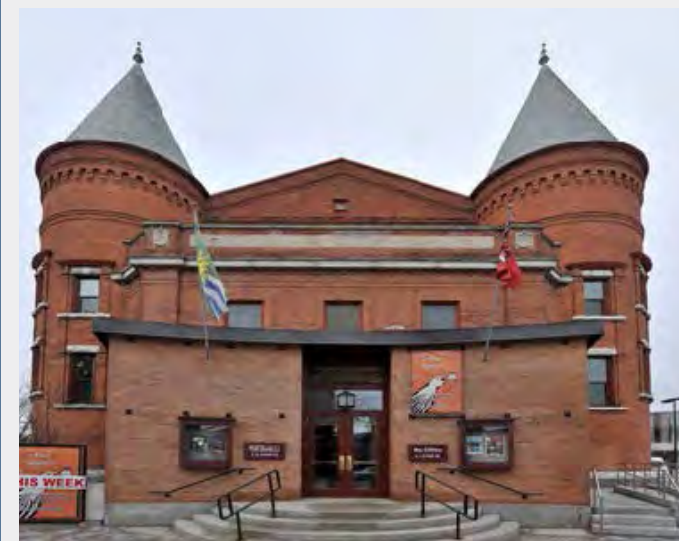
Current Conditions

Large wood-trussed canopies on the north and west entrances mark the former entrances for the Orillia market. Paint on the wood-trussed canopies is flaking and there is some wood deterioration.

The west canopy slate roof has been restored. The canopy over the north entrance is covered with asphalt shingles and appears to be in poor condition possibly due to accumulated debris fallen from above, rendering it inefficient. The new elevator tower at the NW corner has reduced the length of the north canopy. The existing eavestrough and downspouts are damaged, missing paint and poorly fastened to the wood fascia board and canopy rafters.

- Remove and replace the existing pre-painted metal flashings.
- Remove and replace the existing pre-painted aluminum eavestrough and downspouts.
- Remove paint on wood-trussed canopies back to bare wood. Cut back all deteriorated and damaged wood and apply epoxy consolidant. Prime and paint wood-trussed canopies to match heritage colour scheme.
- North canopy shingles to be reviewed and cleaned or replaced.

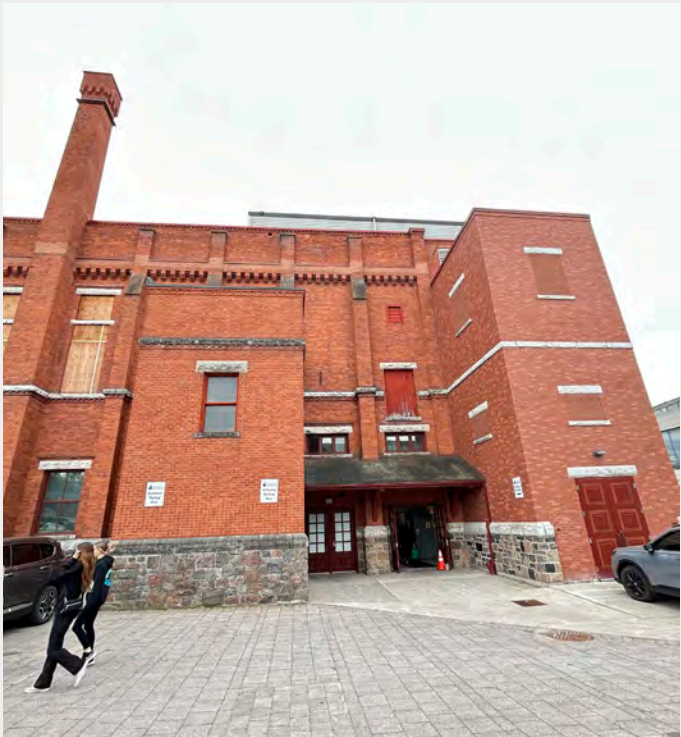
Rear market entrance canopy reduced size with elevator addition on the right corner.

Conditions noted in the BCA report are included in the table below				
Element Name	Level 1 Major Group	Level 2 Major Group Element	Vintage	Service Life
Entryway	B Shell	B20 Exterior Enclosure	1950	75
Description & Recommendation				
The entryway for the door into the bus driver space has an awning comprised of metal roofing on a wood structure. The roofing is beige painted metal panels over a wood structure. Both the materials have paint loss occurring, as well as localized damage of the wood. It is recommended that the structure be refinished with any damage repaired as part of building O&M.

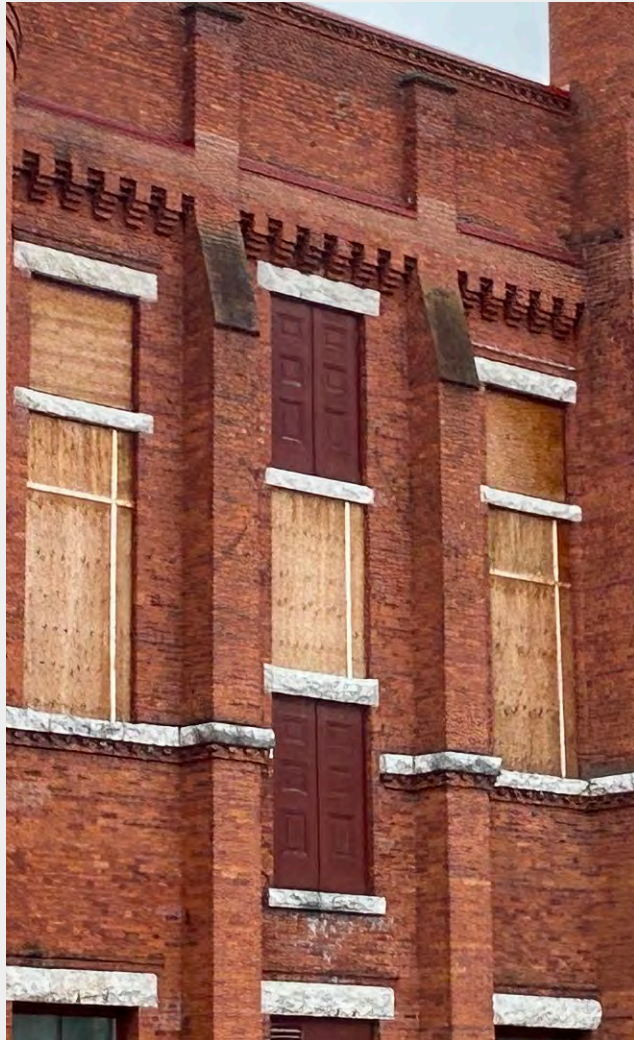
The exterior brick masonry has aged and weathered however the brick is generally ‘clean.’ There is atmospheric staining on the brick masonry piers, areas above the brick corbel banding, and on brick ledges and projections. There is also efflorescence on the west and north elevations below the mechanical louvers and in select areas around the exterior.

Efflorescence and staining on brick masonry

- Remove efflorescence and staining on west and north elevations.
- Remove atmospheric staining on brick masonry piers and brick above the corbel banding. Use low pressure wash to ensure the brick maintains an aged patina.

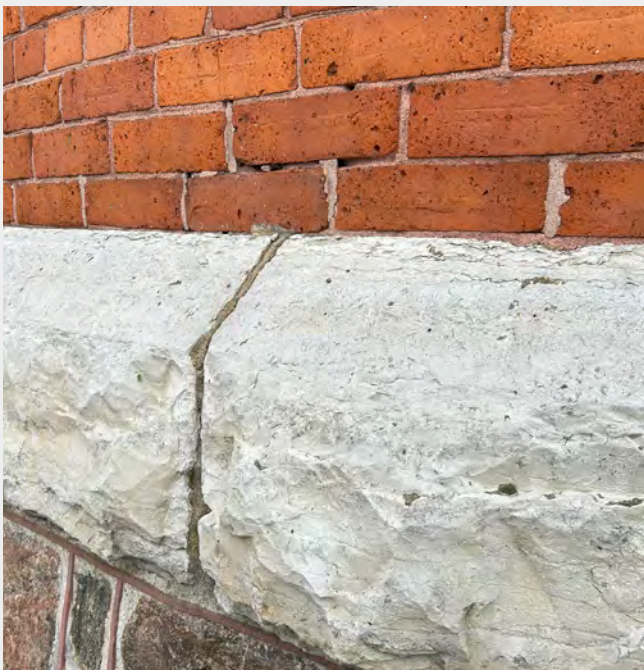
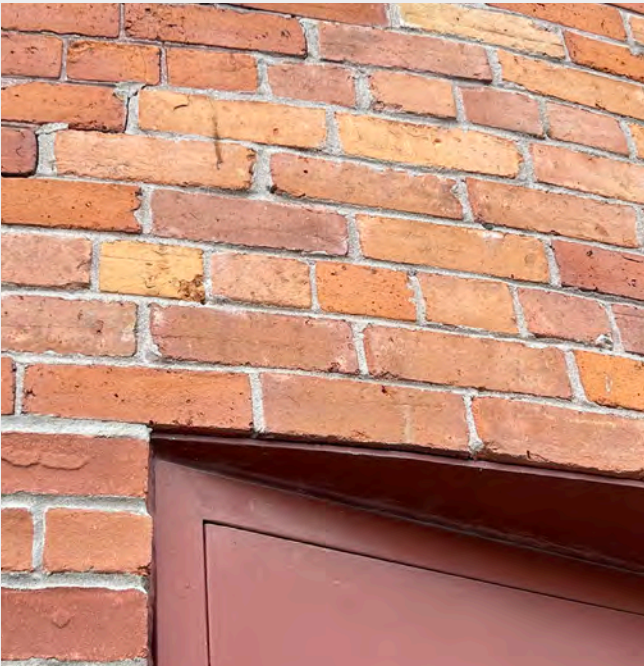
North elevation bricks showing holes, cracks and incompatible mortars.

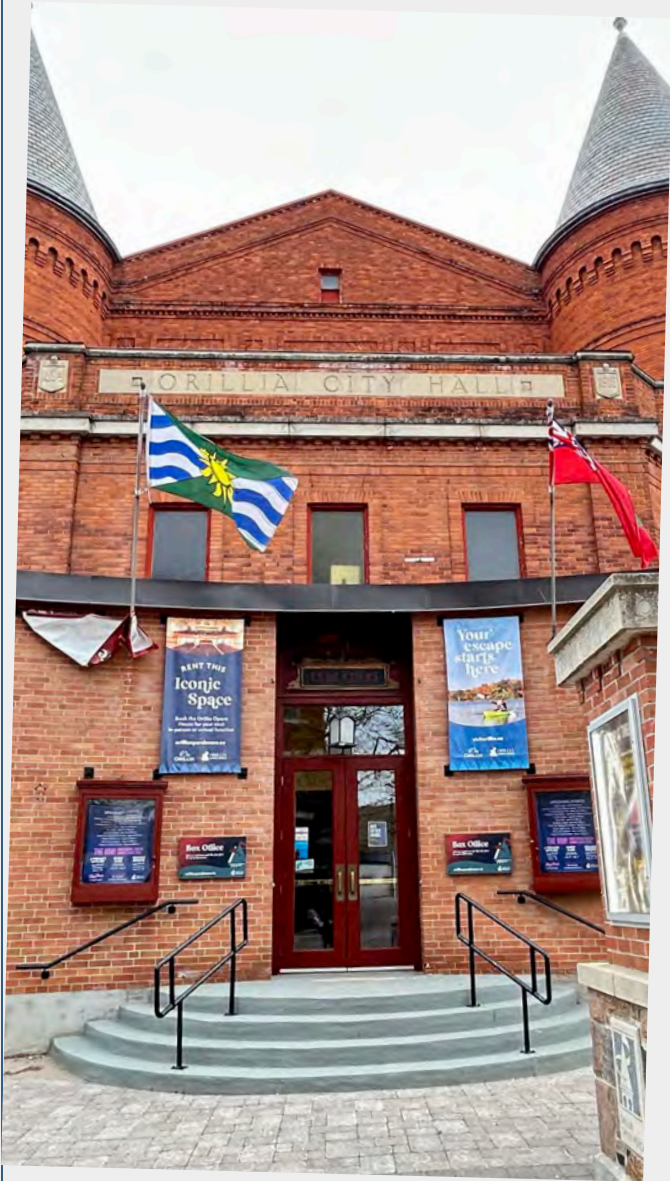
East entrance showing 3 historic windows above later addition.

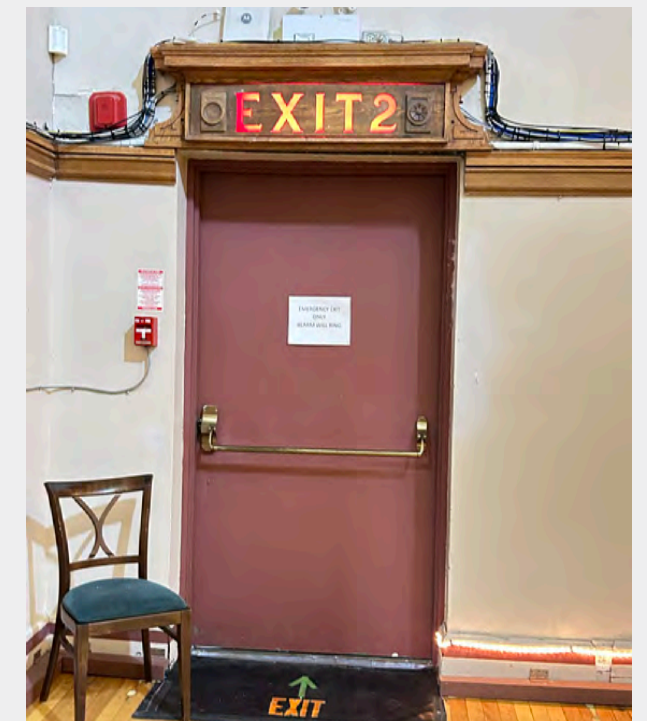
House exit doors with wiring above dado and panelling.

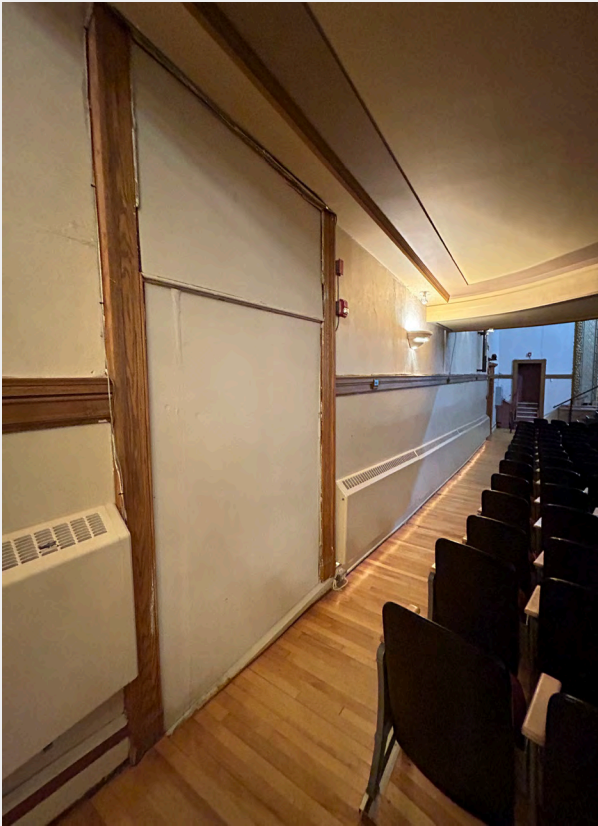
Former fire escape access door opening.

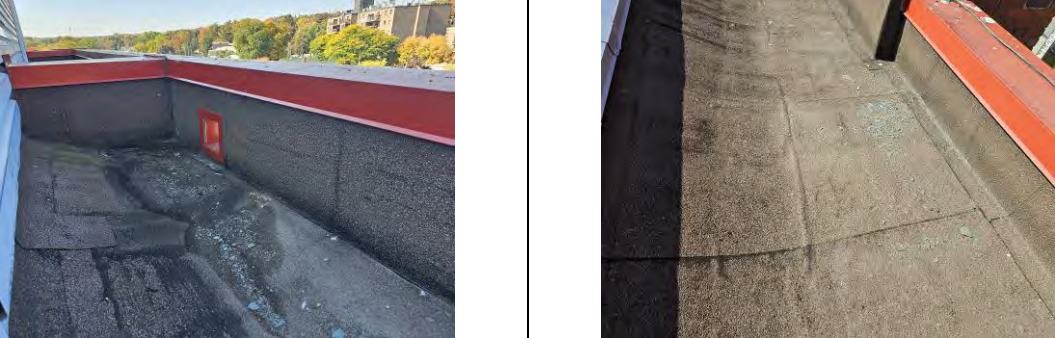
Element Name	Level 1 Major Group	Level 2 Group Element	Vintage	Service Life
Built Up Roof Assemblies	B Shell	B30 Roofing	1980	20
Description & Recommendation				
There are areas of grit loss, bubbling, and water pooling. The visible mastic has dried out and begun to crack apart. The material also had many patches evident from repairs over time. It is recommended that the roofing be replaced in the short term.

Condition Rating	Priority	Action	Action Year	Opinion of Probable Cost
Poor	Short Term	Replace	2027	-60,900

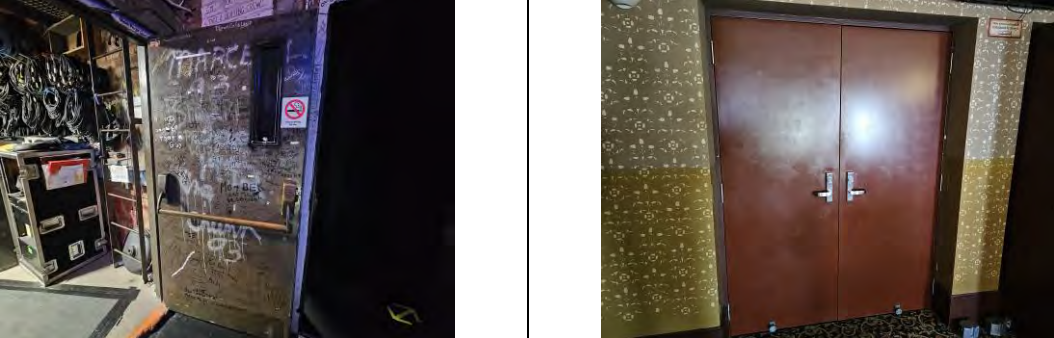
Element Name	Level 1 Major Group	Level 2 Group Element	Vintage	Service Life
Interior Metal Doors	C Interiors	C10 Interior Construction	1980	40
Description & Recommendation				
The metal doors within the building are painted either a blue-grey, black, or burgundy colour. The units in the backstage/working areas have denting due to the nature of their installed location. They also are adorned with signatures and notes from past theatre crews. The doors used by visitors tended to have scraping and paint chipping visible. The majority of units are expected to require replacement in the medium term.

Condition Rating	Priority	Action	Action Year	Opinion of Probable Cost
Fair	Medium Term	Replace	2029	-61,100

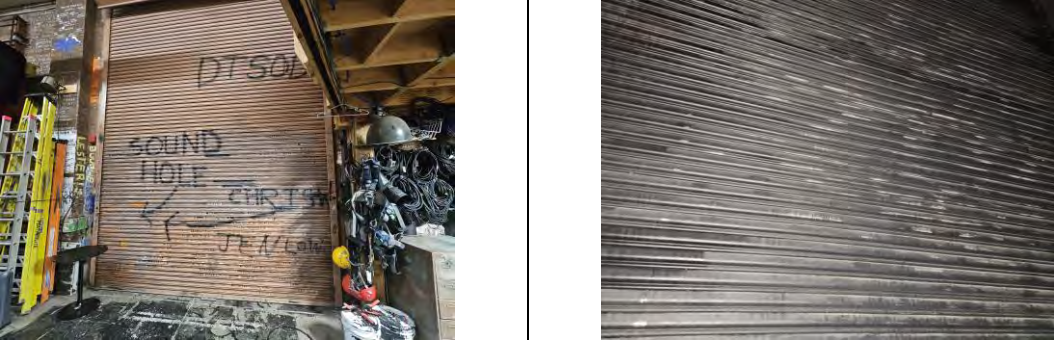
Element Name	Level 1 Major Group	Level 2 Group Element	Vintage	Service Life
Interior Bay Doors	C Interiors	C10 Interior Construction	1980	50
Description & Recommendation				
The bay door is installed in the main theatre space and used to move larger items to/from the stage. The unit is generally intact with scraping visible, and is also adorned with signatures from past theatre crews. The unit is expected to require replacement in the medium term.

Condition Rating	Priority	Action	Action Year	Opinion of Probable Cost
Poor	Medium Term	Replace	2034	-4,000

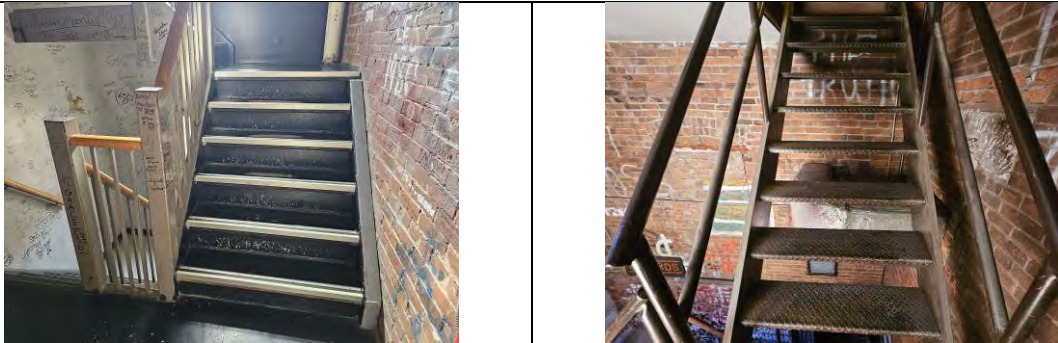
Element Name	Level 1 Major Group	Level 2 Group Element	Vintage	Service Life
Metal Staircases	C Interiors	C20 Stairs	1950	100
Description & Recommendation				
The metal staircases installed in the back of house areas are intact with no major concerns found. The material is stained and worn from use, where exposed, and includes signatures from past theatre crews. It is expected that the units will require replacement at the end of its expected useful life.

Condition Rating	Priority	Action	Action Year	Opinion of Probable Cost
Poor	End of Life	Replace	N/A	-

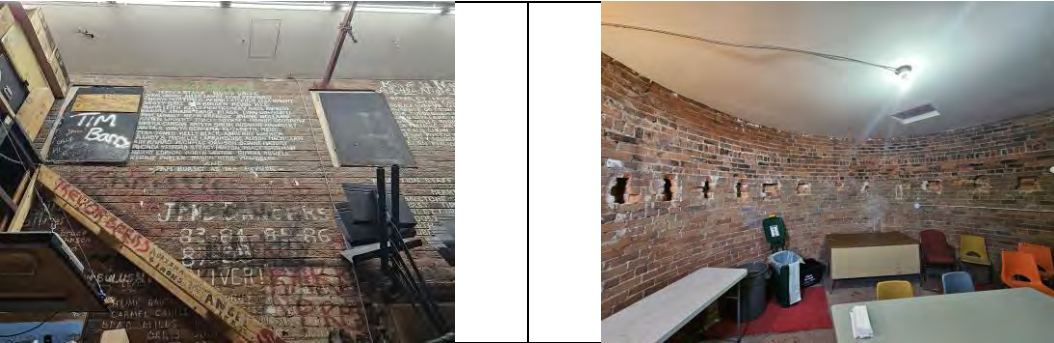
Element Name	Level 1 Major Group	Level 2 Group Element	Vintage	Service Life
Concrete Masonry Units	C Interiors	C30 Interior Finishes	1915	75
Description & Recommendation				
The bricking visible is original to the building. Many areas were seen to have missing, deteriorating, or damaged bricks; such as in the top of the turrets. It is recommended that the damaged and missing units be replaced. Due to the historical nature of the building it is highly recommended that the governing historical society be consulted with prior to undertaking any work.

Condition Rating	Priority	Action	Action Year	Opinion of Probable Cost
Poor	Medium Term	Replace	2034	-951,500

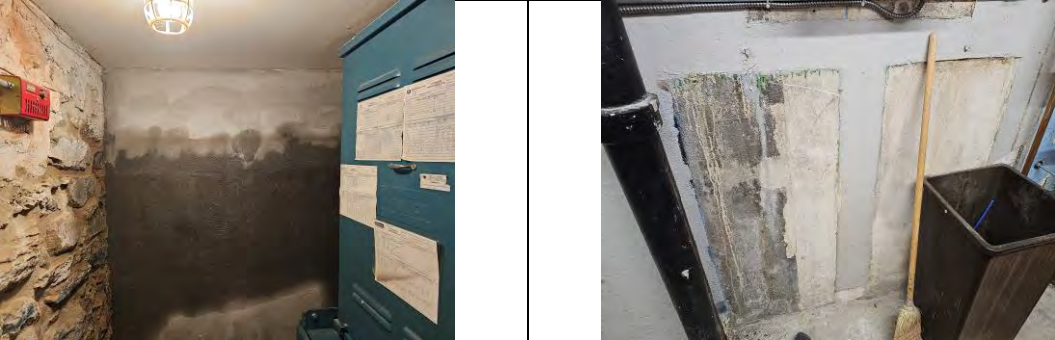
Element Name	Level 1 Major Group	Level 2 Group Element	Vintage	Service Life
Parging	C Interiors	C30 Interior Finishes	1980	30
Description & Recommendation				
The parging installed within the basement area was found to be stained and cracked in areas. Within the elevator room, hydraulic fluid is visible behind the finishing and felt oily when touched. The cracks identified were thin and likely due to temperature fluctuations over time. It is recommended that the finishing be replaced in the short term.

Condition Rating	Priority	Action	Action Year	Opinion of Probable Cost
Poor	Short Term	Replace	2026	-6,000

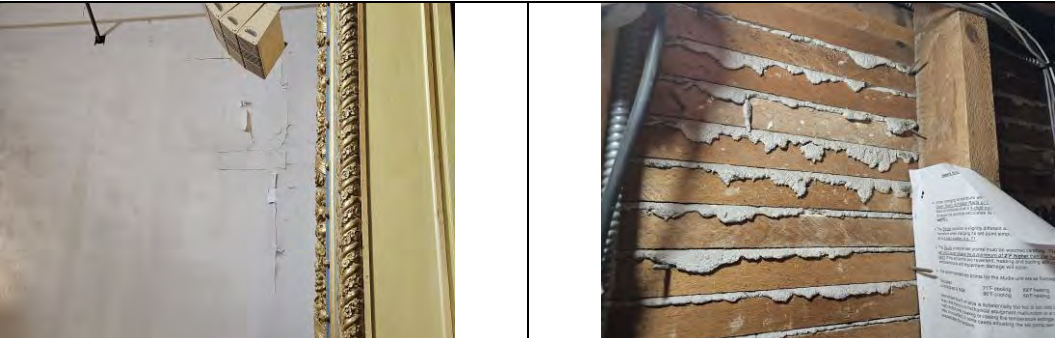
Element Name	Level 1 Major Group	Level 2 Group Element	Vintage	Service Life
Plaster Walls	C Interiors	C30 Interior Finishes	1915	100
Description & Recommendation				
The plaster walls installed are original to the building and are exhibiting damage and loss. It is recommended that the plaster walls be refinished in the short term. Due to the historical nature of the building it is highly recommended that the governing historical society be consulted with prior to undertaking any work.

Condition Rating	Priority	Action	Action Year	Opinion of Probable Cost
Poor	Short Term	Replace	2025	-1,107,000

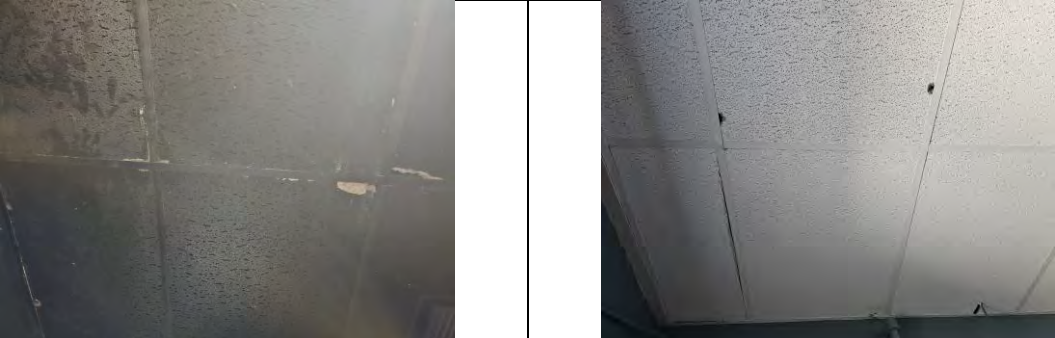
Element Name	Level 1 Major Group	Level 2 Group Element	Vintage	Service Life
Acoustic Ceiling Tiles	C Interiors	C30 Interior Finishes	1980	25
Description & Recommendation				
The drop ceiling tiles have visible damage, including missing material, cracks, and staining. It is recommended they be replaced in the short term.

Condition Rating	Priority	Action	Action Year	Opinion of Probable Cost
Poor	Short Term	Replace	2026	-6,600

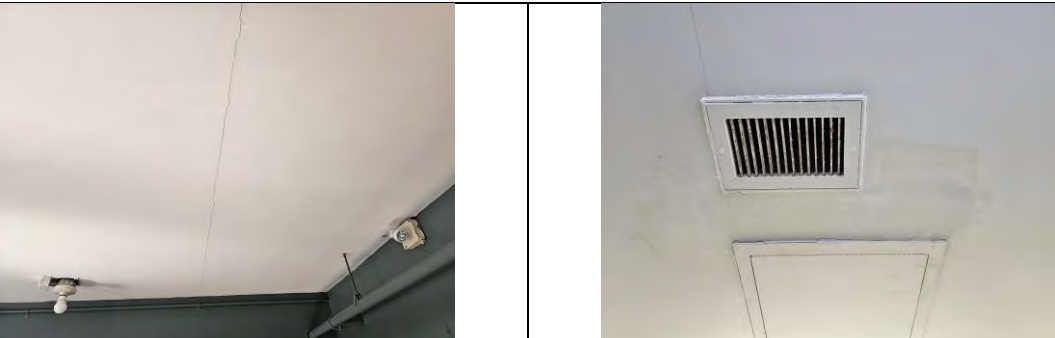
Element Name	Level 1 Major Group	Level 2 Group Element	Vintage	Service Life
Plaster Ceiling	C Interiors	C30 Interior Finishes	1950	50
Description & Recommendation				
The ceiling is largely original to the building construction and had areas of concern visible. These include holes, settlement cracks, and patchwork in many areas. It is recommended that the plaster be replaced in the short term.

Condition Rating	Priority	Action	Action Year	Opinion of Probable Cost
Poor	Short Term	Replace	2028	-73,500
