ORILLIA OPERA HOUSE | CONSERVATION PLAN UPDATE 2025

July 2nd, 2025 DRAFT

Orillia Opera House

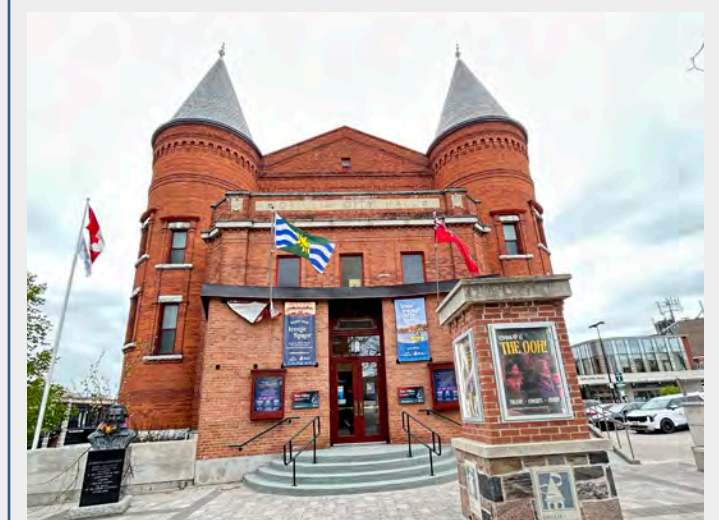
East Elevation

There are semi-circular concrete steps with metal railings at the main entrance. The concrete landing has minor cracks and rust from the metal railings and the railings do not meet current OBC requirements.

- Remove and replace existing metal railings to meet current O.B.C. requirements.
- Remove and replace the main entrance vestibule.

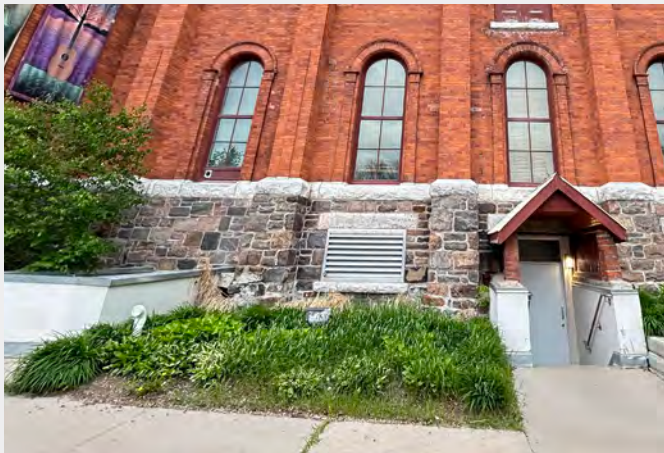
Entrances to (previous) public washrooms. One entrance remains (right) for Bus Driver access.

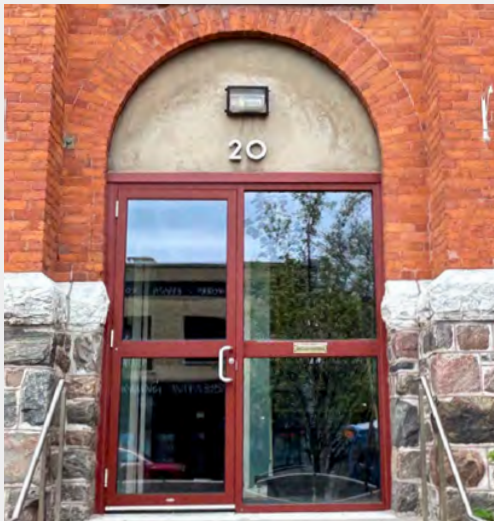
Administrative entrance

The administrative entrance for the Opera House is located at the south west corner of the building. The entrance is a new pre-painted aluminum door with sidelight set in a brick masonry arched opening. There are large cracks to either side of the masonry opening, currently being monitored to determine if the masonry is settled or if it continues to move. The crack to the west of the entrance continues up the wall to the stone banding above the second floor windows.

- Cut-out cracked, loose and missing mortar joints and repoint.

- Remove and replace existing entrance door, sidelight and glazing window. Provide support to brick arch with face brick and masonry backup. Provide new lintel over the opening.
- Remove and replace cracked and broken brick.

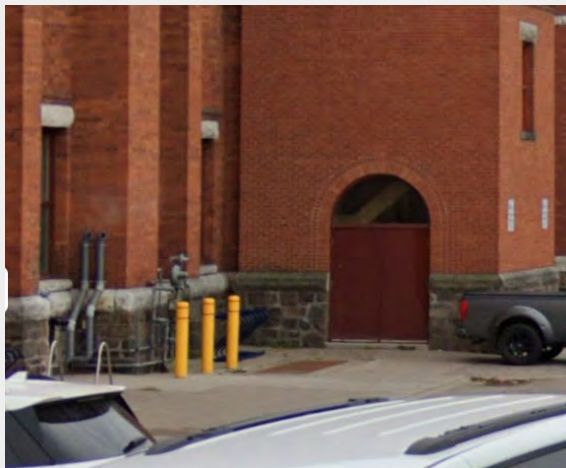
There was a covered basement entrance west of the north stair tower, constructed of brick masonry walls with a wood framed roof. With masonry walls in poor condition, deteriorated brick, significant cracks in the mortar joints and large voids between masonry units. Removal was recommended.

Covered basement entrance removed.

- Remove and replace entrance structure or repair and stabilize large voids between masonry units until entrance is fully removed and replaced.

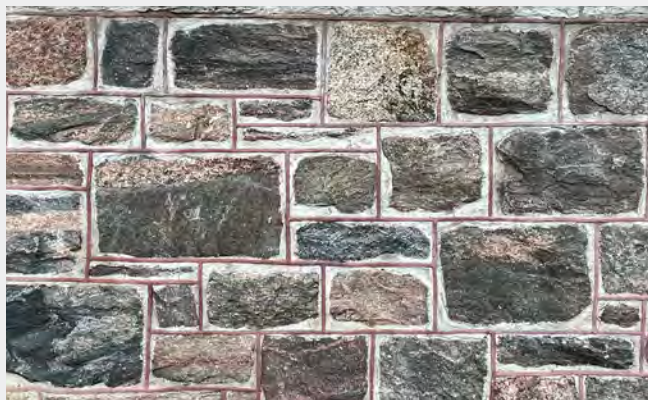
Ribbed joints at stone masonry foundation

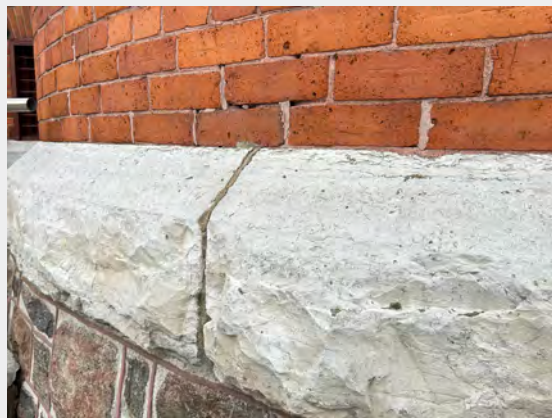
The stone masonry foundations are generally in very good condition. Vines were noted on the foundation stone of the south turret.

Vines on stone masonry foundation

- Routine Maintenance
- Vines removed and replaced with plantings on the Mississauga St W elevation.

- Routinely check the condition of the existing stone masonry foundations using a maintenance checklist.

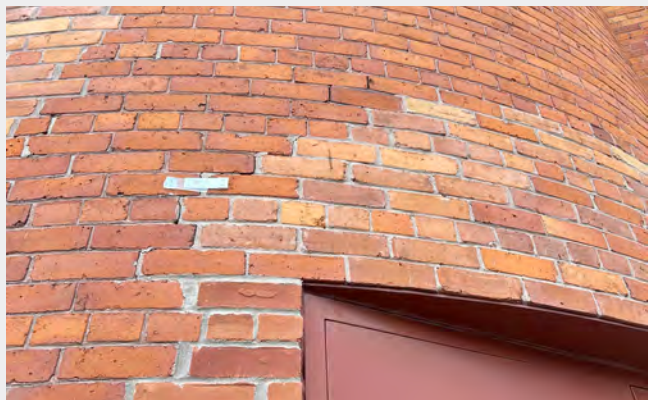
The exterior brick and stone masonry of the south turret was covered with vines and vegetation. Vines embedded in the masonry mortar joints have potential to cause deterioration of the mortar joints over time.

Vines on brick masonry have been removed.

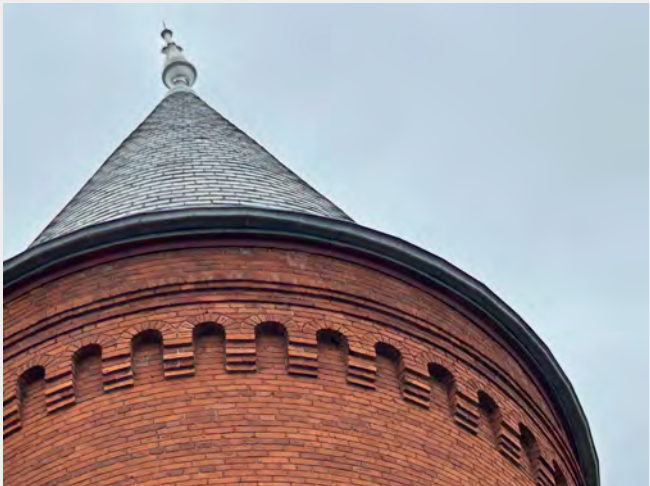
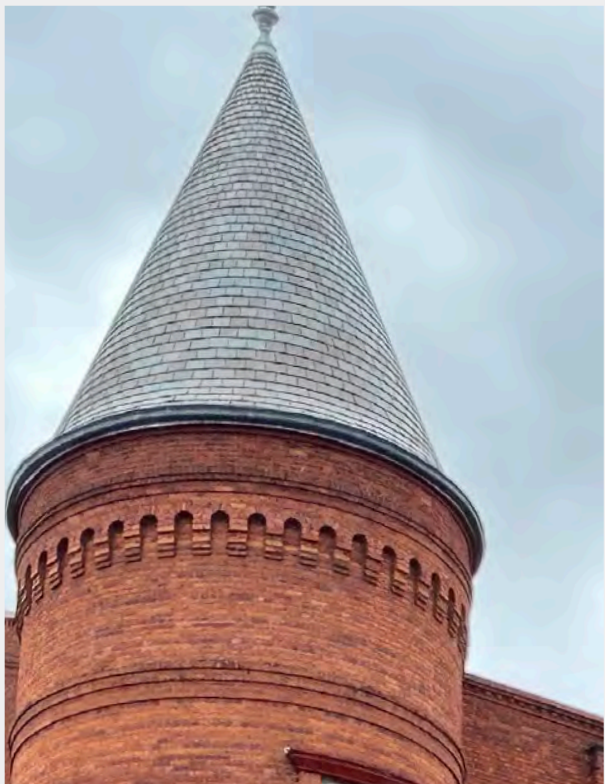
Turret views

- Performed localized repairs and replacement of slate roofing on turrets.
- Removed and replaced the pre-painted metal cornice.
- Finial restoration has been completed.
- Locally patched small openings in roof sheathing with plywood sheathing in thickness to match the existing on both the North Turret and the South Turret.

- Sistered additional 2x6s on each side of the damaged roof rafters with three nails at 12" o.c. Extended new rafters a minimum of 12" beyond the end of any observed splits.
- Provided new 2x6 ceiling ties at 900o.c. (perpendicular to the existing ties) at the North Turret.
- Reinstated connection from existing 2x6 ties to existing rafters in the North Turret.
- Provided new 2x6 solid blocking at 900 o.c. in the South Turret from the 2x6 ceiling joists to the existing wood sill plates.

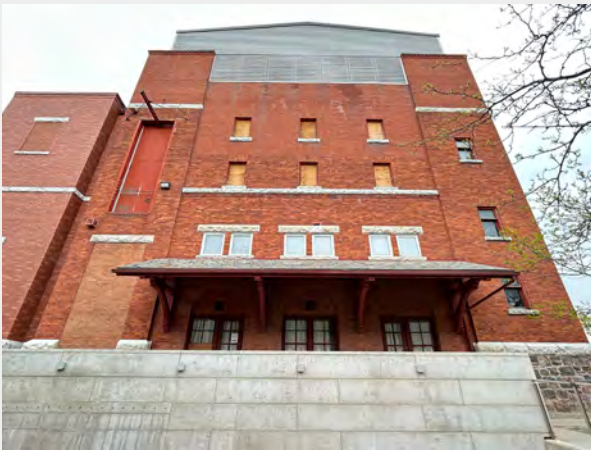
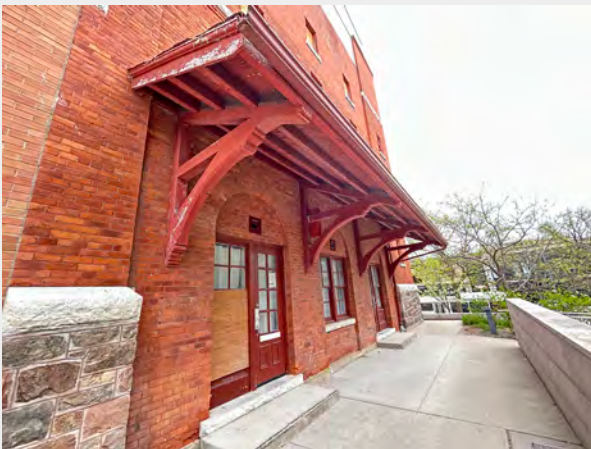
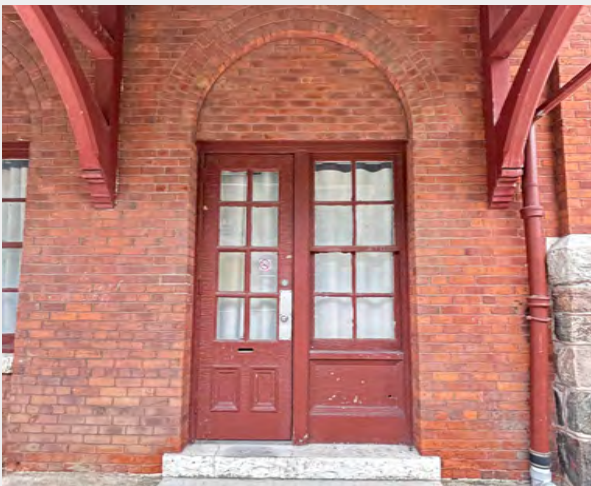
West Elevation windows and doors at the Farmers Market

Between the entrance doors is a set of double hung 4 over 4 painted wood windows with painted wood panels below. The windows are set in painted wood frames in a brick masonry opening. The paint on the windows is alligatored and there is some deterioration of the wood stops.

There are six windows above the former market entrance. These windows appear to be in fair/good condition, however the frames are white and do not match the colour of the OOH windows and doors.

There are six 2 over 4 painted wood windows in the centre bay of the west elevation that have fallen out and replaced with wood infill. These windows serve the backstage areas of the Opera House.

There are three 1 over 1 painted wood windows in the stair bay. These windows serve the backstage stairwell. The paint on the windows is alligatored and there is some wood deterioration.

There is a painted metal door and frame at the loading bay. Paint on the door and frame is weathered and damaged.

- Remove paint on wood doors, frames and windows back to bare wood. Cut back all deteriorated and damaged wood and apply epoxy consolidant. Provide Dutchman repairs where wood is significantly damaged. Remove wood stops and reset glass. Replace any cracked, broken, frosted or textured glass. Prime and paint wood doors, windows and frames to match heritage colour scheme. Remove and replace hardware with heritage hardware.

- Paint six new windows above the former market entrance to match the heritage colour scheme.
- Remove paint on wood windows, frames and sills back to bare wood. Cut back all deteriorated and damaged wood and apply epoxy consolidant. Provide Dutchman repairs where wood is significantly damaged. Replace single pane glass with thermally sealed units and rabbet units into sash. Prime and paint wood windows and frames to match heritage colour scheme.

- Remove paint on wood windows, frames and sills back to bare wood. Cut back all deteriorated and damaged wood and apply epoxy consolidant. Provide Dutchman repairs where wood is significantly damaged. Replace single pane glass with thermally sealed units and rabbet units into sash. Prime and paint wood windows and frames to match heritage colour scheme.

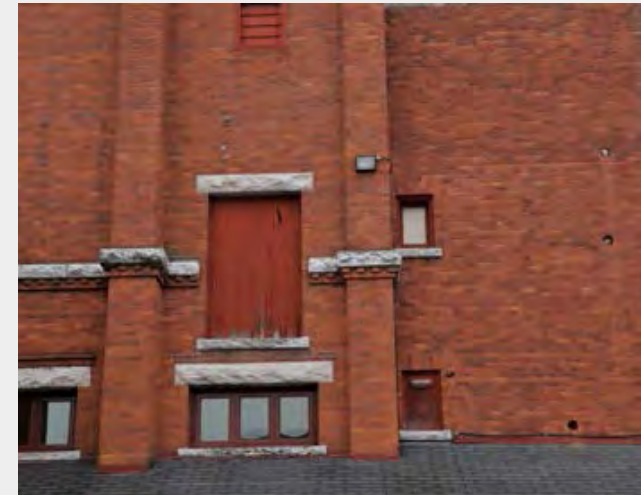
Openings above the north canopy entrance

There is a set of painted wood doors set in a painted wood frame above the north canopy entrance. The paint on the doors is flaking at the base and there is wood deterioration.

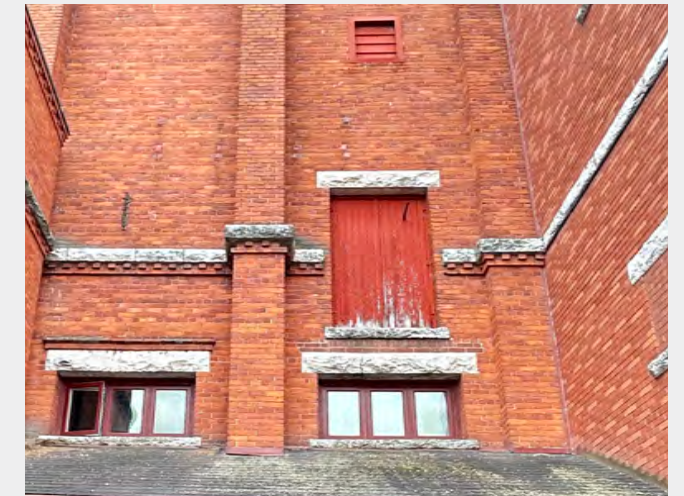
View showing new elevator addition on right side of canopy.

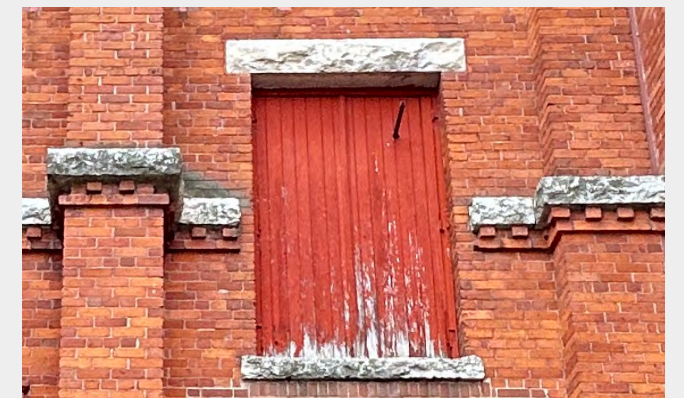
Wood door over north canopy entrance.

- Remove painted metal vent and plywood and replace with new pre-painted metal louvre to fill the opening.
- Remove paint on wood door frames and doors back to bare wood. Cut back all deteriorated and damaged wood and apply epoxy consolidant. Provide Dutchman repairs where wood is significantly damaged.
- Routinely check the condition of the spandrel windows using a maintenance checklist.
- Routinely check the condition of the wood doors using a maintenance checklist
- Remove painted metal vents and plywood and replace with new pre-painted metal louvres to fill the openings. Delete vents if no longer in use.

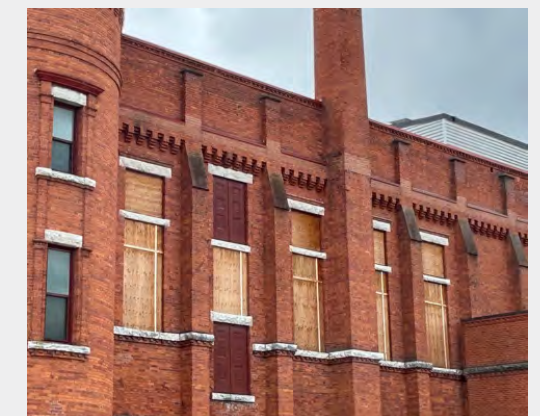
North elevation upper windows and doors.

All upper level spandrel window units (9) have fallen out and were replaced with wood infill in 2024, including former window locations at the orchestra and balcony levels and the window between the former exit doors. The spandrel windows were installed to prevent exterior light from entering the performance space. (Elevation drawings are provided in the appendix for reference.)

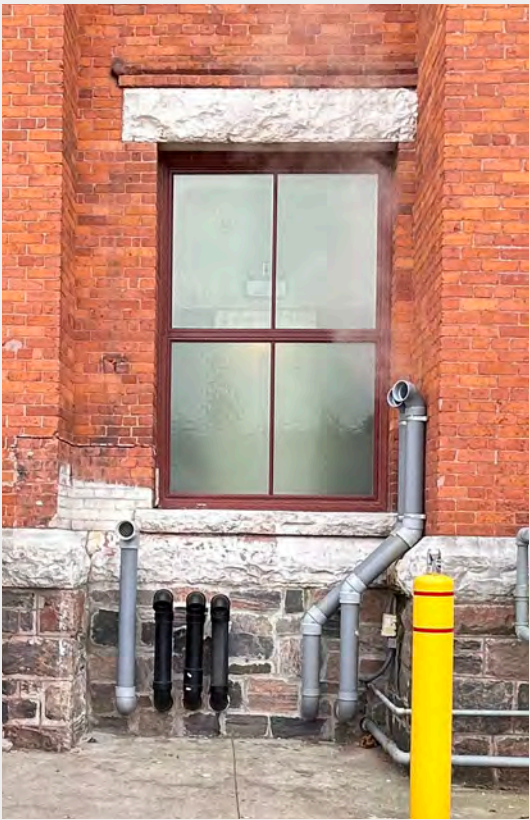
Main level two over two windows

There are four 2 over 2 painted metal windows set in painted wood frames. The type of glazing depends on the location of the window. The windows appear to be in fair condition. One of the former main level windows was previously filled with painted plywood and a painted metal vent.

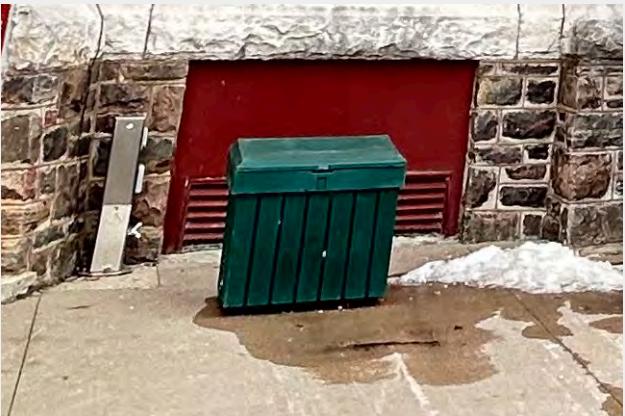
North elevation painted metal vents

Two of the former window openings in the stone masonry foundation are filled with a painted metal vent and painted plywood.

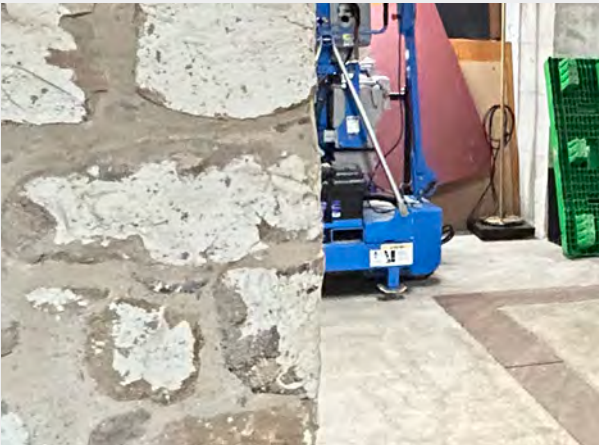
Stone masonry foundations

The stone masonry foundations are generally in very good condition. The stone masonry foundations were repaired and repointed in 2011. There is efflorescence on interior brick masonry in Fan Room 005 around existing water pipes.

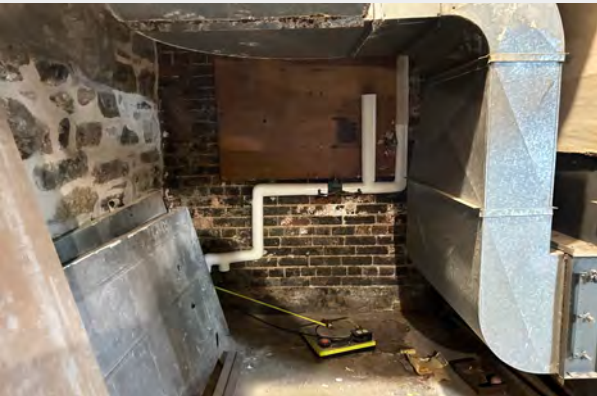
Fan Room, brick walls with efflorescence

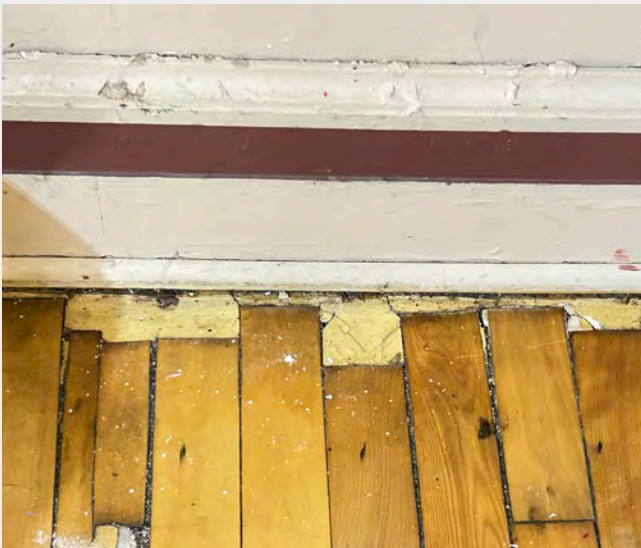
Wood base board house main level,

Generally the painted wood base board is worn throughout the House and the paint is flaking in several areas.

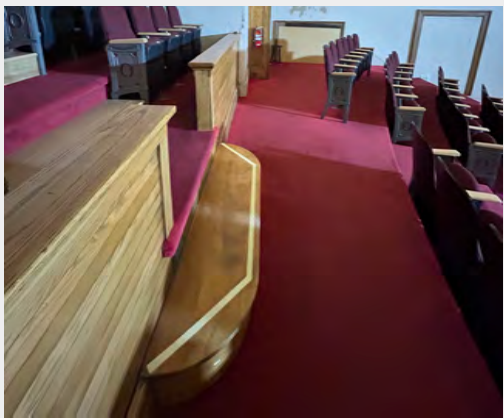
There is a wood step and guard at the rear of the balcony. The wood step and guard are generally in good condition.

Wood step and guard house balcony level, with refinishing and visibility strip on right.

- Repair and refinish wood step and guard when remainder of the house is restored.

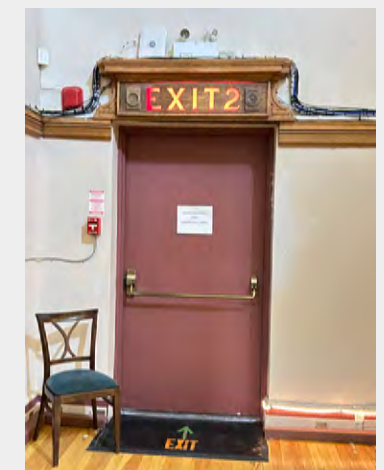
Exit 2 without wooden casement

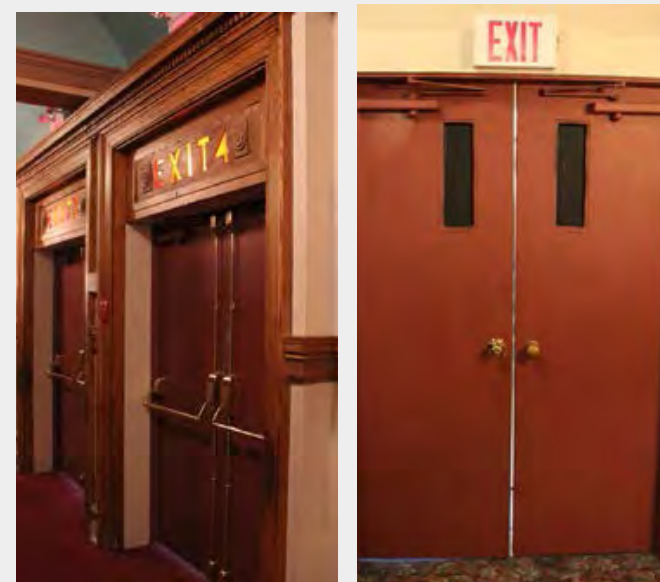
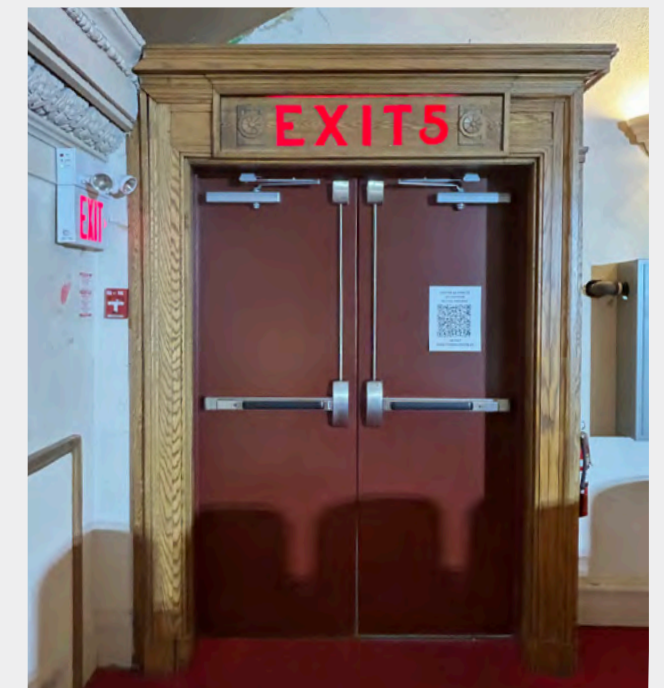
House exit doors with wiring above dado and panelling.

House exit doors

Completed

- Replace hollow metal exit doors with fire rated panelled wood doors.

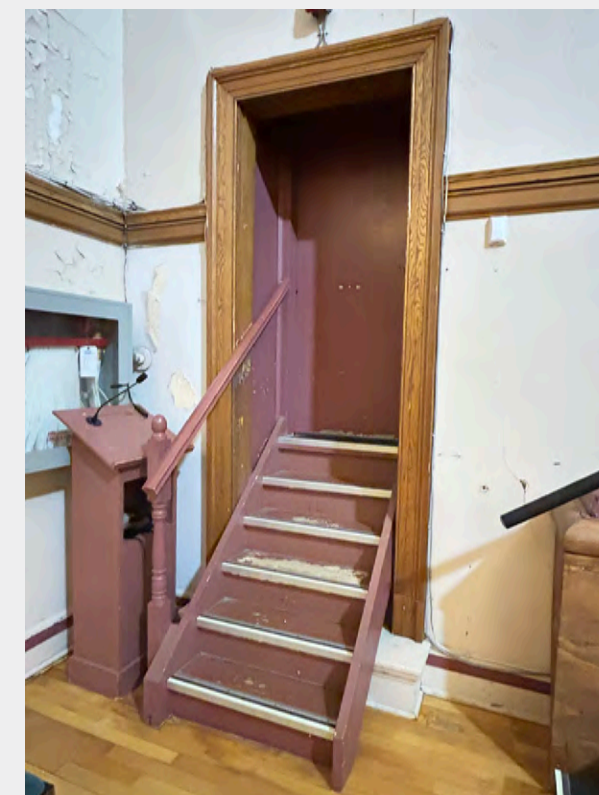
Stage Access Door

There is a flight of stairs and stage access door on the south side of the main stage. The door is painted hollow metal and set in the original opening. The door has brass turn knob handles. The door is relatively good condition.

- Replace the hollow metal stage access door with a panelled door to match the existing door for the fire hose cabinet on the north side of the main stage.
- Relocate the flight of stairs for access to the stage to the interior side of the door.
- Set the new wood door in its original location, in line with the wood trim casing.

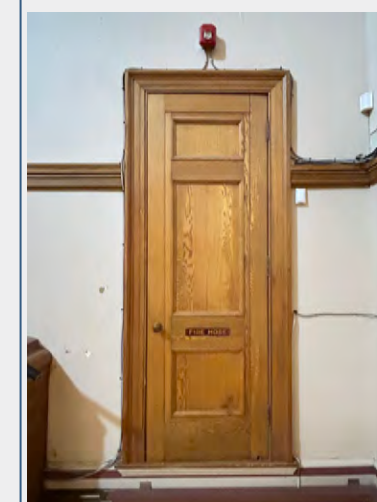
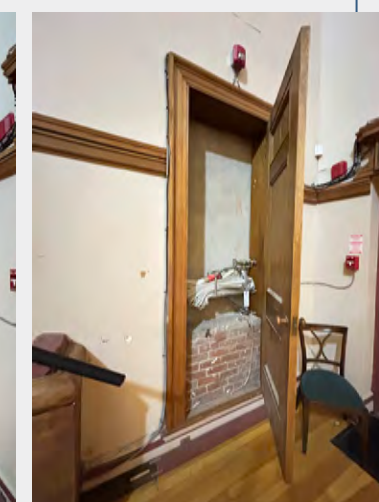
Fire Hose Cabinet Door

There is a fire hose cabinet on the north side of the main stage. The door for the cabinet is the original wood panel door. Generally the door is in good condition.

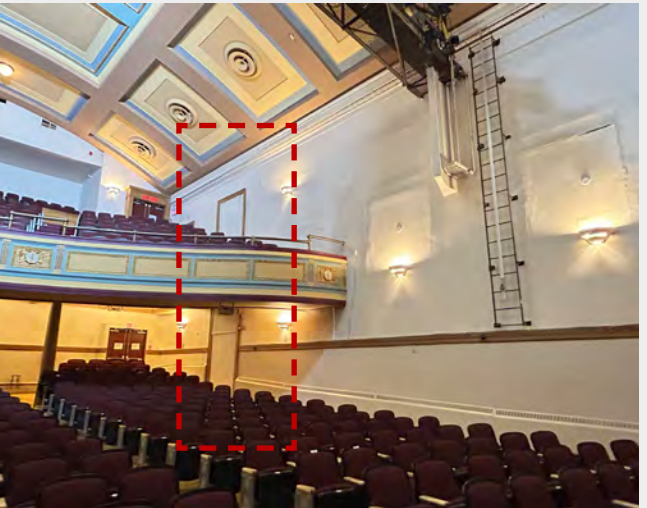
Former fire escape access (inside dashed lines) and telescoping plaster at previous windows to the right.

The 1985 survey recommended that the window heights be restored to the original pre-fire escape size and height. The 1985 survey also recommended the existing window closures be reconstructed in thick masonry, connected and sealed to the existing walls to produce a continuous heavy separation.

- Remove the infill panels on the interior side of the house to determine the composition of the infill (backup) beyond the wall panels.
- Fill the openings with brick masonry, if not already present.
- Cover the brick masonry with plaster or gypsum board with carefully detailed recessess reflecting
- the original window pattern, as recommended in the 1985 survey. Refer also to Section 2.1.2.4 Plaster.
- Note: if the intent is to install insulation and vapour barrier throughout the house, install insulation and vapour barrier in the opening prior to covering with plaster or gypsum board finish.

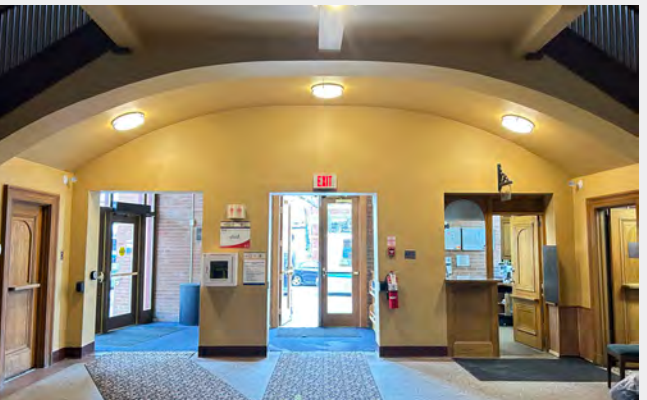
Entrance Foyer

There are three wood doors with wood trim in the entrance foyer for the box office, coat room and office. Each door has a centre panel with arched top. Centre panels in the coat room and office doors open up and have a ledge at the base of the openings. The doors are stained and varnish with brass hardware and generally in good condition.

- Routinely check the condition of the doors in the entrance foyer using a maintenance checklist.

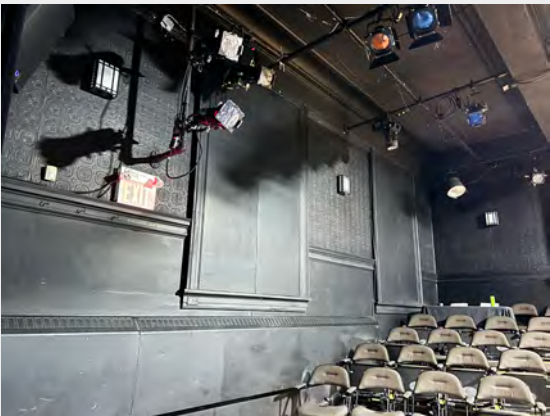
Studio Theatre former windows,

- Remove the infill panels on the interior side of the studio theatre to determine the composition of the infill (backup) beyond the interior wall panels.
- Fill the openings with brick masonry, if not already present.
- Cover the brick masonry with plaster or gypsum board with carefully detailed recesses reflecting the original window pattern, as recommended in the 1985 survey.

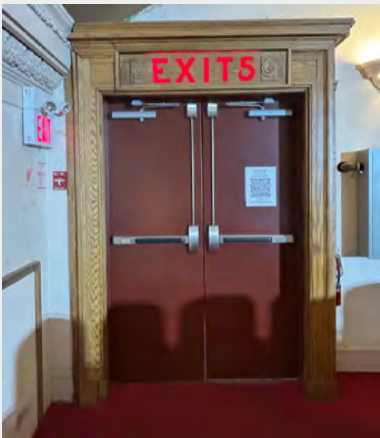
There is a set of hollow metal exit doors with small lites that open directly into the north turret from the upper balcony. The doors have new brass push-bar hardware and closers on the exit side, and lever handles and hold open devices on the upper foyer side. The doors are painted maroon and generally in good condition. There is a gap between the doors.

Upper Foyer exit door, replacement on right

- Replace hollow metal exit doors with fire rated panelled wood doors.

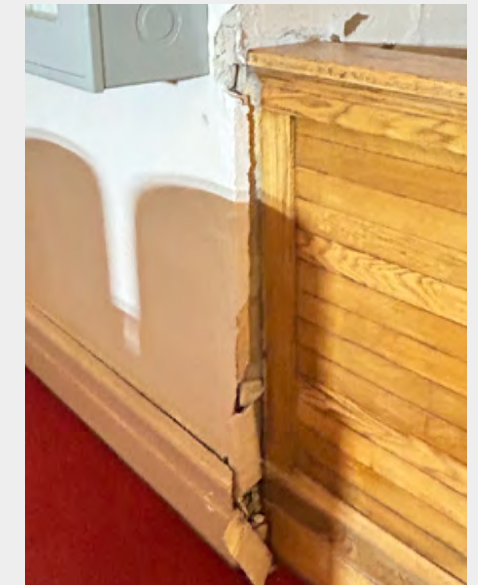
Areas of the existing plaster are loose, cracked and/or missing, especially at low level corners and below the wood dado trim. Plaster is also damaged around the perimeter of the radiators and immediately above the wood dado trim where the electrical wires and data cabling is installed.

Areas with loose, cracked and/or missing plaster have been repaired over time. These repairs are particularly visible above the wood dado trim and immediately below the house balcony. Generally the plaster repairs do not have smooth transitions with the adjacent original plaster.

Loose and cracked plaster at balcony wall and guard

- Remove / cut back deficient (loose, cracked and/or missing plaster) and replace with new to match the existing/adjacent plaster in composition, finish texture and colour.
- Remove the large plaster patch repairs. Refer also to Section 4.33 Windows and Doors.

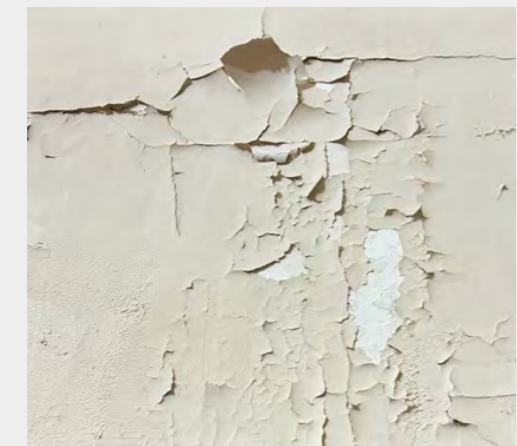
Loose and cracked plaster left, skim coat peeling right

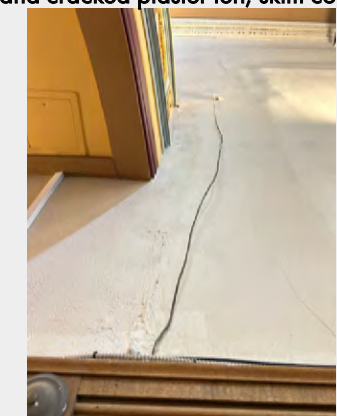
Exposed electrical wiring

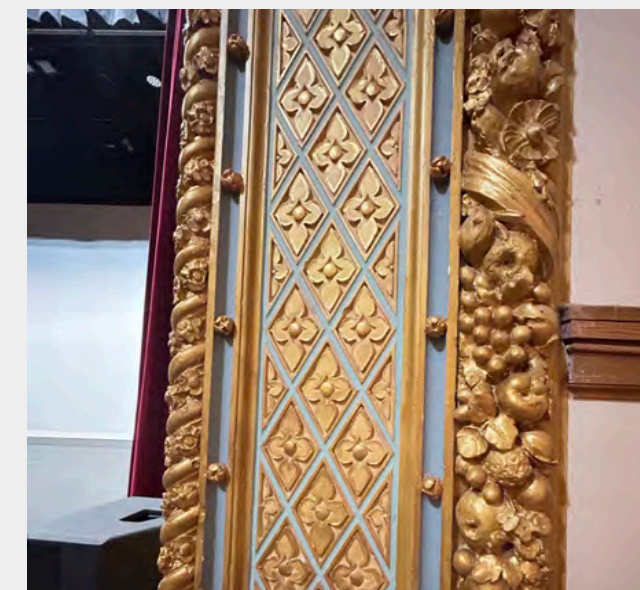
Plaster proscenium arch detail

- Repair plaster cornice details where damaged.
- Plaster proscenium arch and details have been restored.

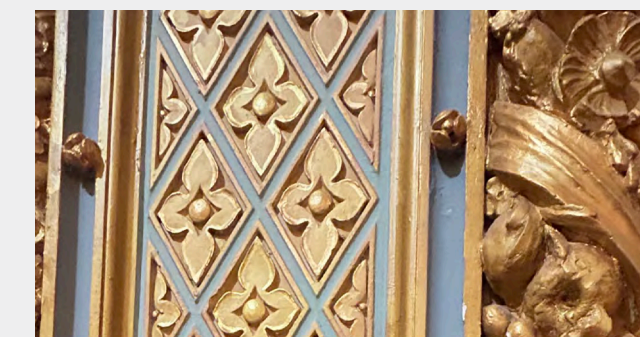
Plaster proscenium arch detail

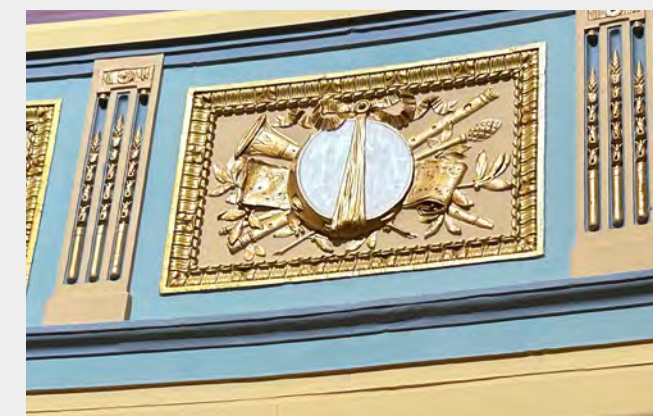
Plaster detail on balcony face

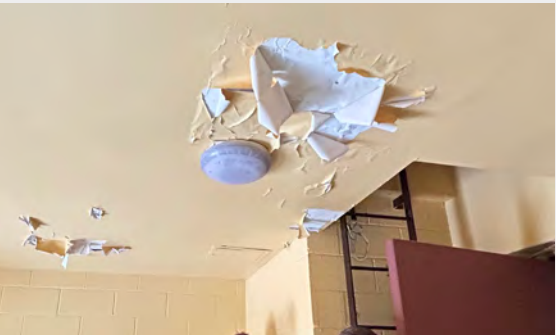
The ceiling of the stair addition on the north side of the house is damaged due to roof leaking above. The roof has been repaired and the plaster ceiling requires lath support and new plaster finish.

House Exit Stair damaged plaster ceiling.

- Condition of plaster ceiling to be investigated.
- Ceiling restoration repairs to follow the investigation.

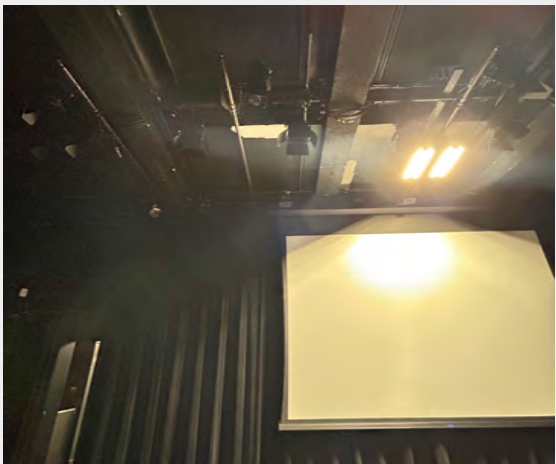
Studio Theatre ceiling plaster missing (top centre white area).

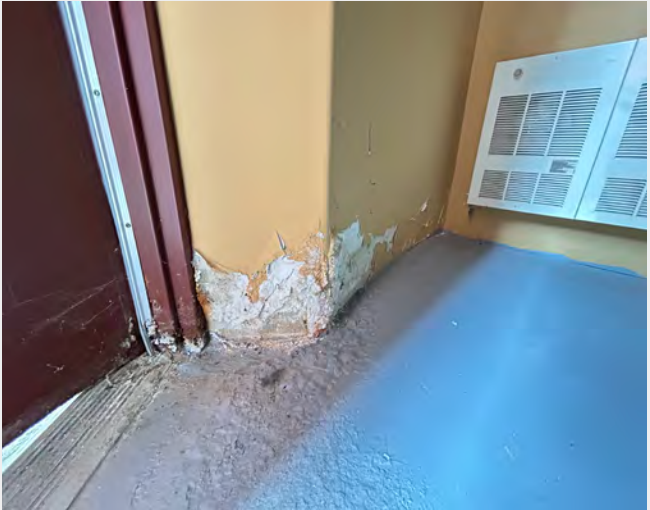
Turret stairwells at exit doors

- Conduct paint finishes investigation prior to plaster repair work on the walls and cornice to determine the earliest colour layers and propose heritage colour scheme.
- Prime and paint house in accordance with approved heritage colour scheme following plaster repair work.

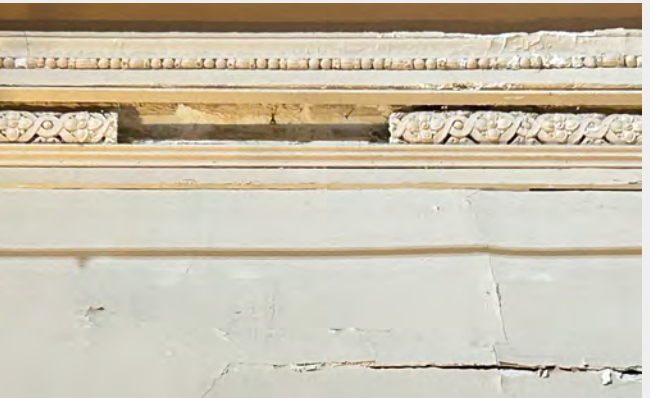
Plaster cornice,

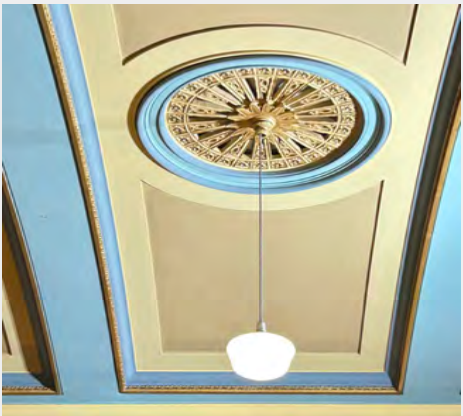
Panelled house ceiling,

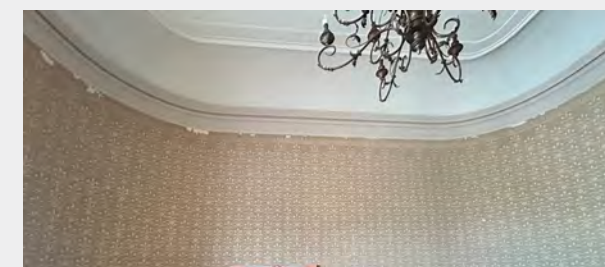
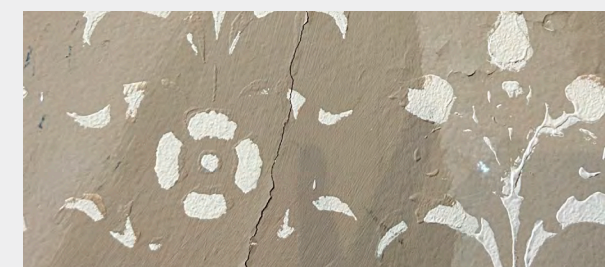
Foyer Stairwell paint stencil deterioration.

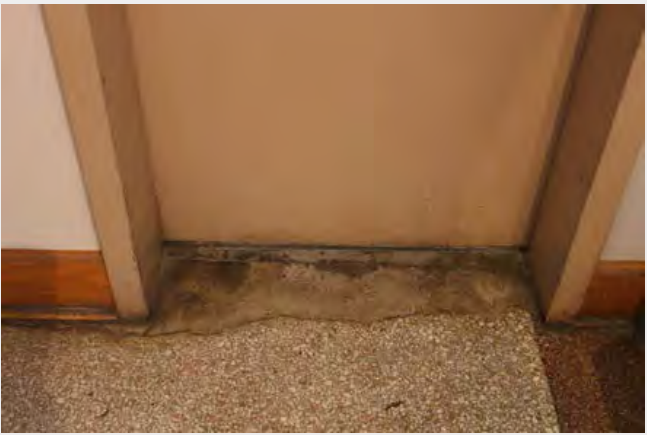
Terrazzo flooring at entrance to elevator in foyer

There are cracks and previous repairs in the terrazzo. A portion of the flooring was also previously removed and/or damaged at the entrance to the elevator.

- Repair/restore terrazzo flooring where damaged and previously repaired throughout the entrance foyer.

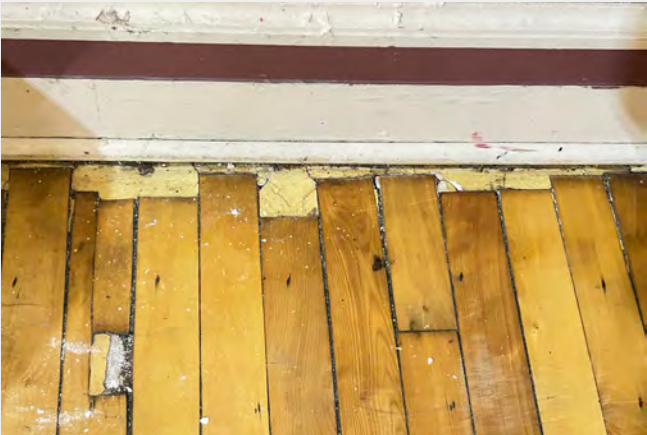
House main level wood floor ‘fillers’

- Remove wood ‘filler’ pieces and provide wood repairs to integrate with existing.
- Refinish wood flooring with clear coat every few years based on wear.

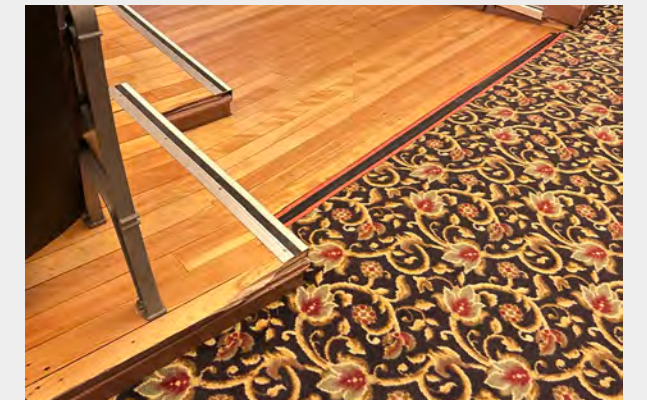
Flooring for the main level of the house consists of stained and varnished tongue and groove wood boards (refer to Woodwork section regarding the wood flooring). Carpet covering the aisles has been removed. The carpet at the upper level is generally in good condition.

House main level carpet,

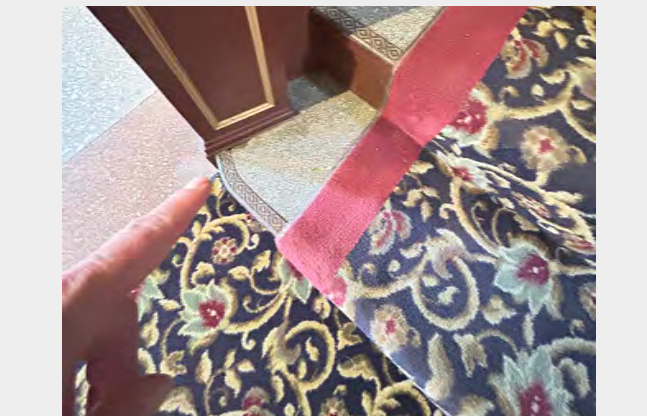
Carpet at upper foyer and stairwell,

- Add visually impaired warning strip at stair nosings of red balcony carpet.

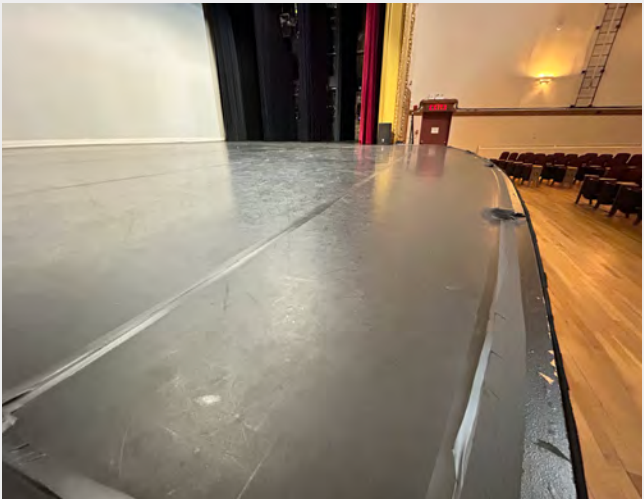
Stage flooring has been replaced with new panels. Maintenance required of taped seams and edging.

- Replacement of the stage floor finish.

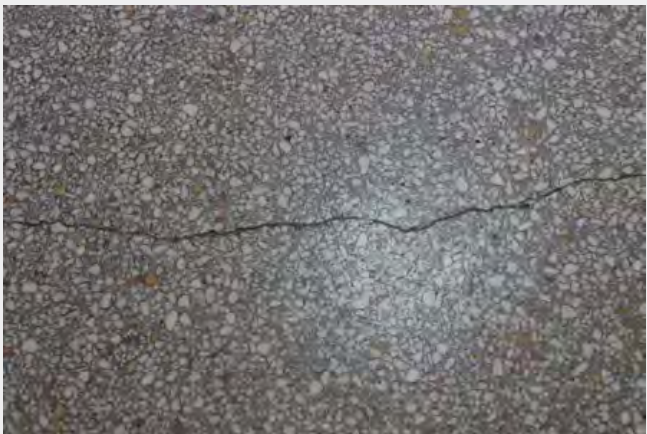
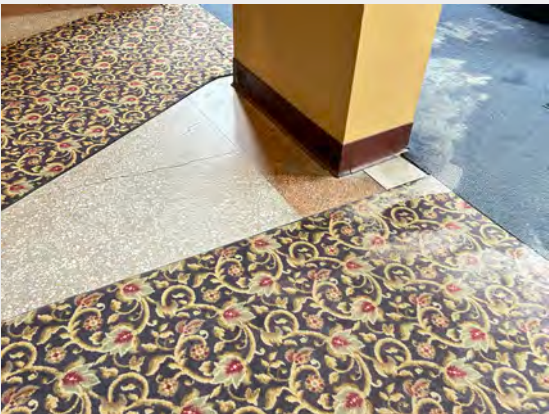
Terrazzo flooring in entrance foyer

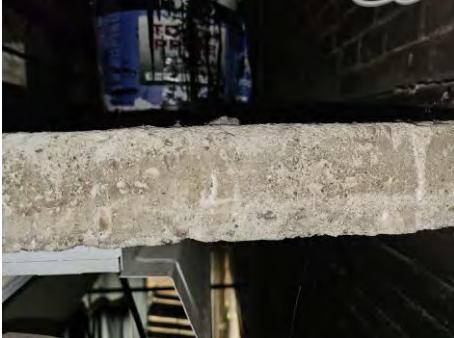
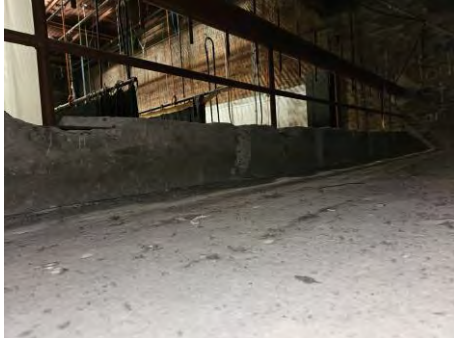
Element Name	Level 1 Major Group	Level 2 Group Element	Vintage	Service Life
Floor Decks & Slabs	B Shell	B10 Superstructure	1950	75
Description & Recommendation				
<p>The majority of the floor construction is obfuscated by interior finishing. The area where slabs were visible was within the main stage area. The slabs on stage left and right allow for show staff to rig their equipment. The reinforced material was unfinished and contained holes and damage from use over time. It is expected that the slabs will require major repairs within the medium term.</p>

Condition Rating	Priority	Action	Action Year	Opinion of Probable Cost
Poor	Medium Term	Repair	2029	-222,300

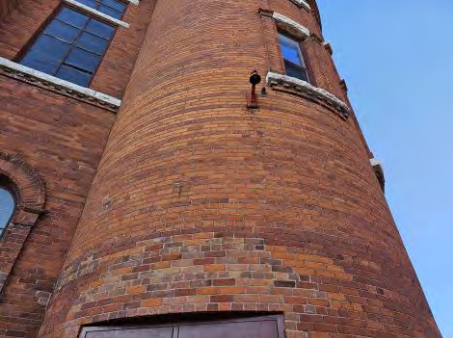
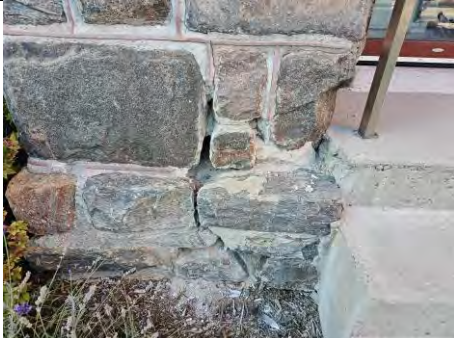
Element Name	Level 1 Major Group	Level 2 Group Element	Vintage	Service Life
Masonry Bricks	B Shell	B20 Exterior Enclosure	1915	50
Description & Recommendation				
The exterior brickwork is showing signs of its age as the faces appear worn, mortar joints have multiple areas of cracking or missing material, and there are sections where the brickwork was replaced. It is recommended that repointing be performed, with bricks/stones that are in poor repair replaced as part of it. Due to the historical nature of the building it is highly recommended that the governing historical society be consulted with prior to undertaking any work.

Condition Rating	Priority	Action	Action Year	Opinion of Probable Cost
Poor	Short Term	Repair	2028	-78,000

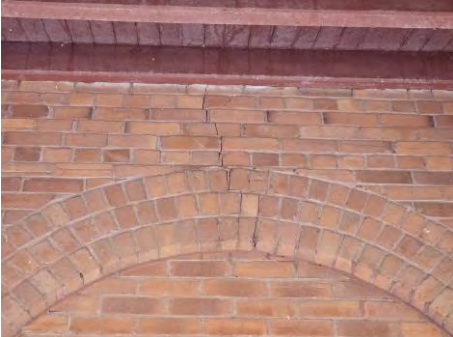
Element Name	Level 1 Major Group	Level 2 Group Element	Vintage	Service Life
Masonry Bricks	B Shell	B20 Exterior Enclosure	1950	50
Description & Recommendation				
The exterior brickwork is showing signs of its settlement and shifting, as identified by the measurement devices installed in multiple locations on the exterior. The brick faces appear worn,

mortar joints have multiple areas of cracking, and the wall joints have missing material. In addition, there are sections where the brickwork was replaced. It is recommended that the cause for the building shifting be identified prior to repairs. It is recommended that the bricking have repointing performed, with damaged bricks replaced as part of it. Due to the historical nature of the building it is highly recommended that the governing historical society be consulted with prior to undertaking any work.

Condition Rating	Priority	Action	Action Year	Opinion of Probable Cost
Poor	Medium Term	Repair	2031	-66,300

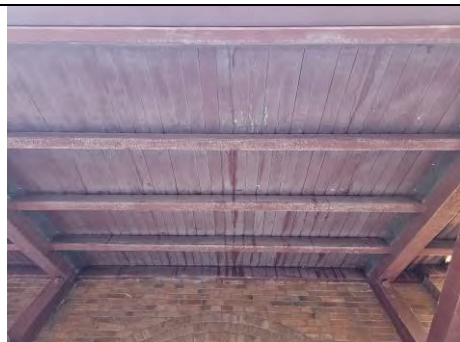
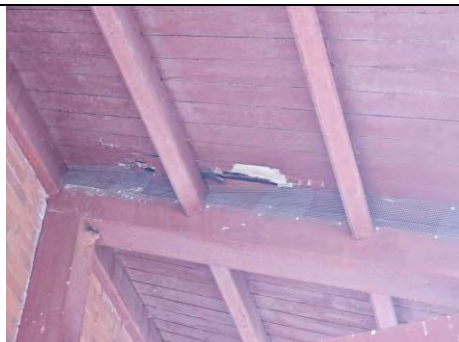
Element Name	Level 1 Major Group	Level 2 Group Element	Vintage	Service Life
Overhang	B Shell	B20 Exterior Enclosure	1950	50
Description & Recommendation				
The wood overhang that is installed to the exterior of the market room has evident water damage and perforations when viewed from below. The water marks and stains appear to be stemming from

above the decking, with the damaged areas appeared to be wide enough to allow both creatures and elements in. It is recommended that the damaged planks be replaced in the short term, with the cause of the damage investigated. Due to the historical nature of the building it is highly recommended that the governing historical society be consulted with prior to undertaking any work.

Condition Rating	Priority	Action	Action Year	Opinion of Probable Cost
Poor	Short Term	Replace	2026	-10,100

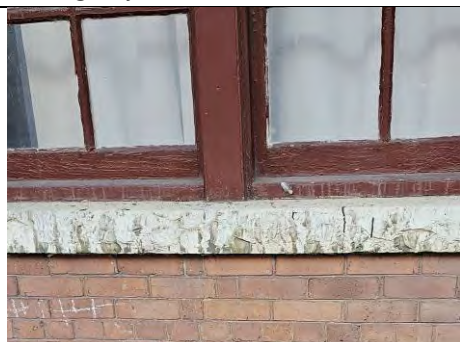
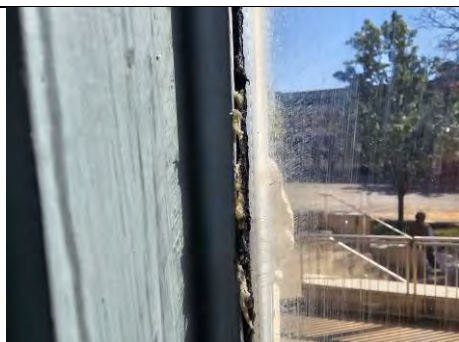
Element Name	Level 1 Major Group	Level 2 Group Element	Vintage	Service Life
Windows - Insulated Glazing Units	B Shell	B20 Exterior Enclosure	1915	30
Description & Recommendation				
The window units are original to the building and exhibit no damage to the glazing. The painted wood frames and trim work are intact physically with areas of paint loss and weathering. As these are historical, no action is required at this time. However, it is recommended that methods be implemented to lessen the gapping found along the unit edges. Due to the historical nature of the building it is highly recommended that the governing historical society be consulted with prior to undertaking any work.

Condition Rating	Priority	Action	Action Year	Opinion of Probable Cost
Poor	Medium Term	Maintain	2034	-42,900

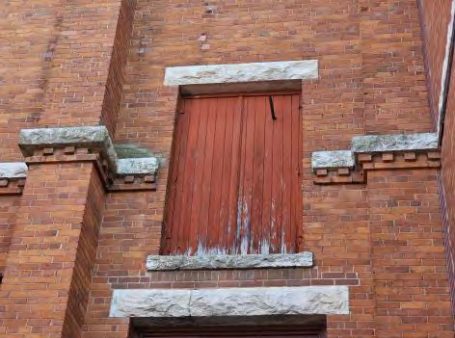
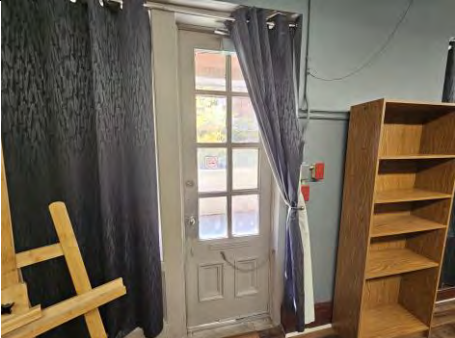
Element Name	Level 1 Major Group	Level 2 Group Element	Vintage	Service Life
Exterior Wood Doors	B Shell	B20 Exterior Enclosure	1915	30
Description & Recommendation				
The wood doors are original to the building construction and have been repainted over the years. From what could be decerned from the available vantage points on the ground, the units are exhibiting areas of concern and failure. It is recommended that the units be refinished and damage repaired. Due to the historical nature of the building it is highly recommended that the governing historical society be consulted with prior to undertaking any work.

Condition Rating	Priority	Action	Action Year	Opinion of Probable Cost
Poor	Medium Term	Replace	2034	-6,300

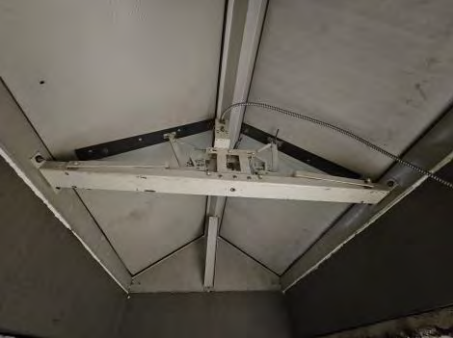
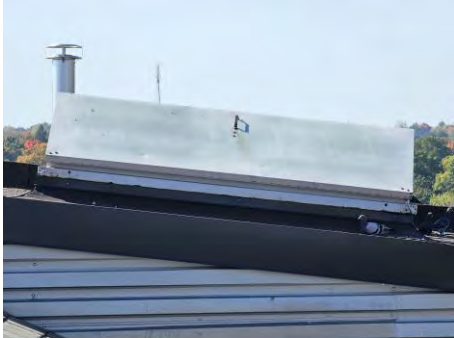
Element Name	Level 1 Major Group	Level 2 Group Element	Vintage	Service Life
Hatch	B Shell	B20 Exterior Enclosure	1980	30
Description & Recommendation				
The access hatches are showing signs of weathering. This is not impacting the functionality of the unit. The doors were able to be propped opened and closed with no issues. The gasketing is intact and had no areas of damage. It is expected the units will need replacement in the medium term.

Condition Rating	Priority	Action	Action Year	Opinion of Probable Cost
Fair	Medium Term	Replace	2030	-13,000

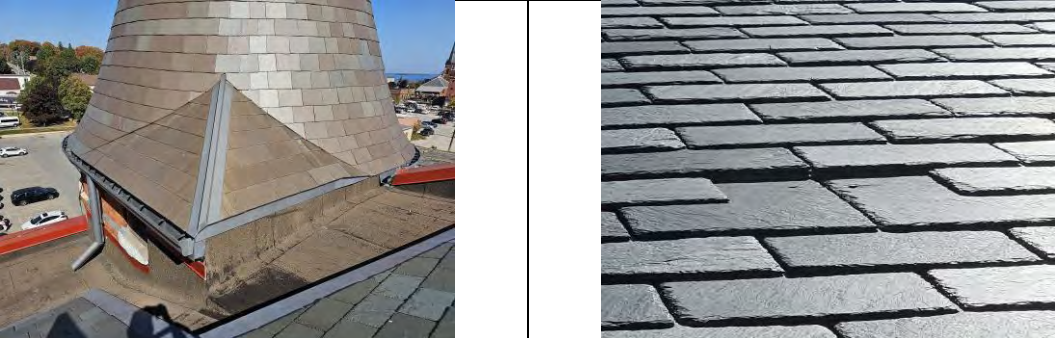
Element Name	Level 1 Major Group	Level 2 Group Element	Vintage	Service Life
Slate	B Shell	B30 Roofing	2021	100
Description & Recommendation				
The slate on the uppermost roof was installed in 2021. It was seen to have multiple tiles missing from the installation, which were found on the flat roof with some damage. It is recommended that the missing tiles be replaced, with a major replacement expected at the end of its expected useful life.

Condition Rating	Priority	Action	Action Year	Opinion of Probable Cost
Good	End of Life	Repair	N/A	-
