ORILLIA OPERA HOUSE | CONSERVATION PLAN UPDATE 2025

July 2nd, 2025 DRAFT

Orillia Opera House

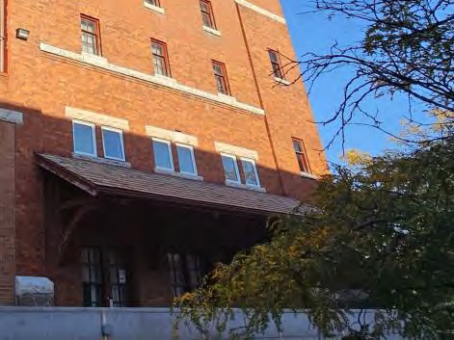
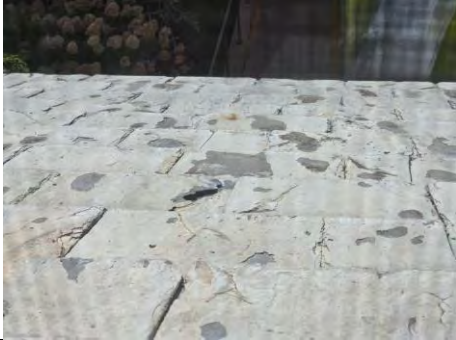
Element Name	Level 1 Major Group	Level 2 Group Element	Vintage	Service Life
Slate	B Shell	B30 Roofing	1915	100

Description & Recommendation				
The slate on the building projections are original to the building erection. It was seen to have multiple tiles damaged, weathered, and missing from available vantage points. It is recommended that the tiles be replaced in the short term.

Condition Rating	Priority	Action	Action Year	Opinion of Probable Cost
Poor	Short Term	Replace	2027	-14,000

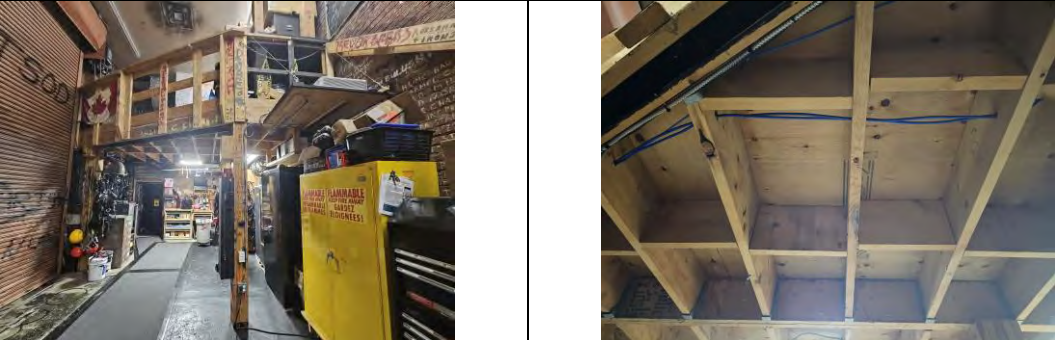
Element Name	Level 1 Major Group	Level 2 Group Element	Vintage	Service Life
Mezzanine	C Interiors	C10 Interior Construction	1980	75
Description & Recommendation				
A wooden storage mezzanine is installed backstage of the main theatre space. The structure is intact, anchored into the concrete floor, and the material is adorned by signatures. It is expected that the structure will require replacement at the end of its expected useful life.

Condition Rating	Priority	Action	Action Year	Opinion of Probable Cost
Fair	End of Life	No Action	N/A	-

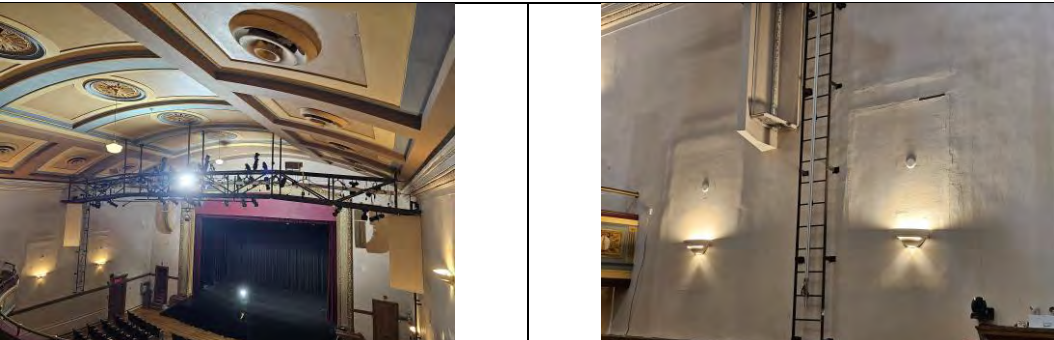
Element Name	Level 1 Major Group	Level 2 Group Element	Vintage	Service Life
Railings - Metal	C Interiors	C10 Interior Construction	1980	75
Description & Recommendation				
The catwalk and associated ladders were visible from ground level. The unit was last inspected in 2023 and did not appear to have concerns in relation to it. A replacement of the unit is expected at the end of its expected useful life.

Condition Rating	Priority	Action	Action Year	Opinion of Probable Cost
Fair	End of Life	No Action	N/A	-

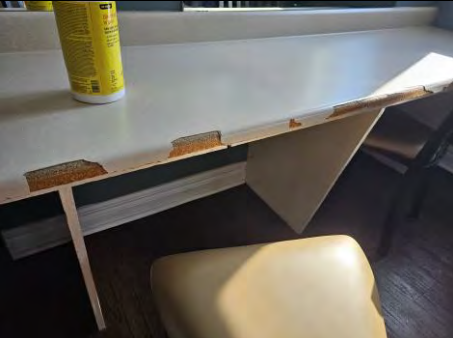
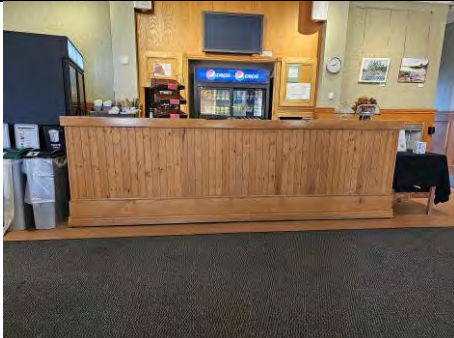
Element Name	Level 1 Major Group	Level 2 Group Element	Vintage	Service Life
Millwork	C Interiors	C10 Interior Construction	1980	25
Description & Recommendation				
The millwork installed in the facility includes the counters within the washrooms and green rooms. These are manufactured from wood and finished with melamine. The units have evident areas of damage and material loss along the edges. It is recommended that the units be replaced in the short term.

Condition Rating	Priority	Action	Action Year	Opinion of Probable Cost
Poor	Short Term	Replace	2028	-58,300

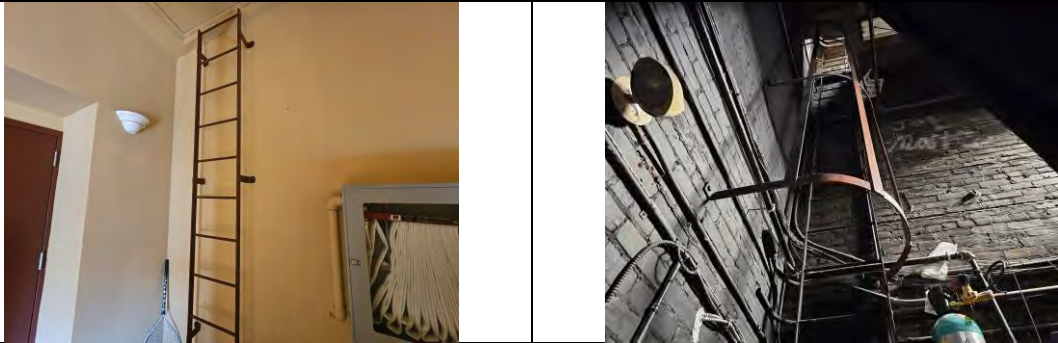
Element Name	Level 1 Major Group	Level 2 Group Element	Vintage	Service Life
Metal Staircases	C Interiors	C20 Stairs	1980	80
Description & Recommendation				
The ladders installed within the building are anchored into the walls. The finishing is wearing away due to use, exposing both the metal or previous coats of paint. The treads are without suitable traction tape, but the taller units do have safety devices are installed around them. It is recommended that the units be refinished, with traction tape installed, in the short term. It is expected that the units will require replacement at the end of their expected useful life.

Condition Rating	Priority	Action	Action Year	Opinion of Probable Cost
Fair	End of Life	Replace	N/A	-

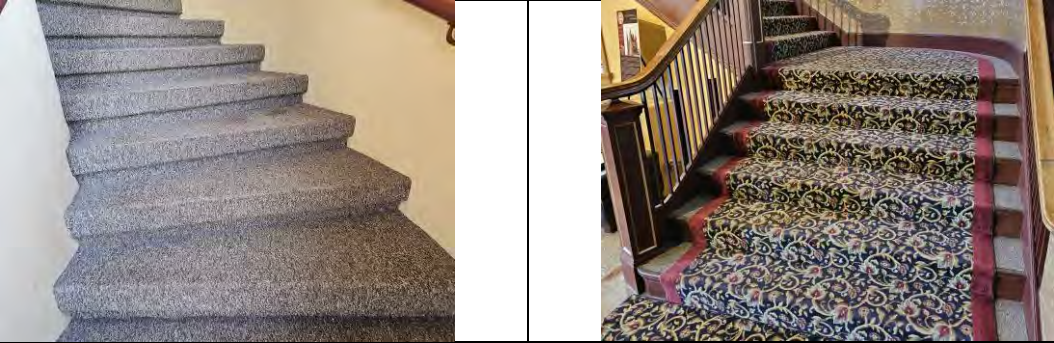
Element Name	Level 1 Major Group	Level 2 Group Element	Vintage	Service Life
Concrete Stair Finishes	C Interiors	C20 Stairs	2012	30
Description & Recommendation				
The carpeting installed is free of visible damage or fraying. It is expected that it will require replacement in the long term.

Condition Rating	Priority	Action	Action Year	Opinion of Probable Cost
Fair	Long Term	Replace	2042	-15,300

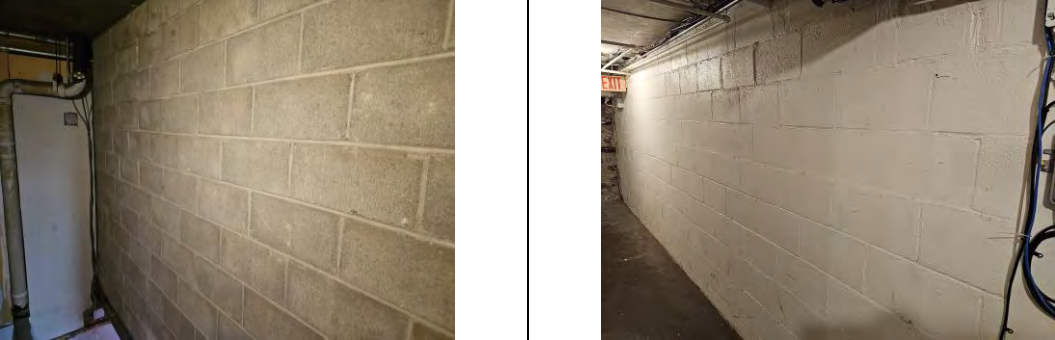
Element Name	Level 1 Major Group	Level 2 Group Element	Vintage	Service Life
Concrete Masonry Units	C Interiors	C30 Interior Finishes	1950	100
Description & Recommendation				
The blocks are physically intact but do show signs of repairs and wearing from interactions over time. The units are also finished in a coat of paint in most areas, of which are generally intact with minor chipping. It is expected that the walls will last the life of the building. No action is recommended at this time, outside of typical building O&M.

Condition Rating	Priority	Action	Action Year	Opinion of Probable Cost
Fair	End of Life	No Action	N/A	-

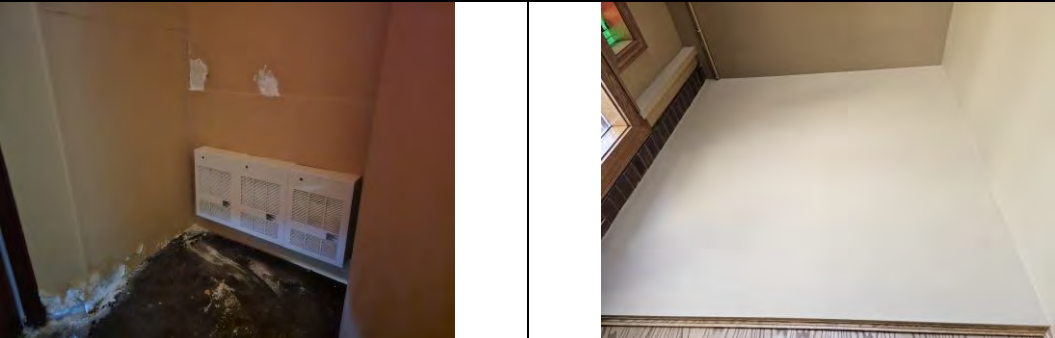
Element Name	Level 1 Major Group	Level 2 Group Element	Vintage	Service Life
Gypsum Board Walls	C Interiors	C30 Interior Finishes	1980	75
Description & Recommendation				
The drywall within the building is largely intact with a coat of paint applied. The areas where damage was viewed was on the ground floor of the turrets where the emergency exits are located. The walls have holes and deterioration evident adjacent to the doorway. It is recommended that the damage be patched as part of building O&M. No replacement is expected to be required until the end of its effective useful life.

Condition Rating	Priority	Action	Action Year	Opinion of Probable Cost
Good	End of Life	Repair	N/A	-

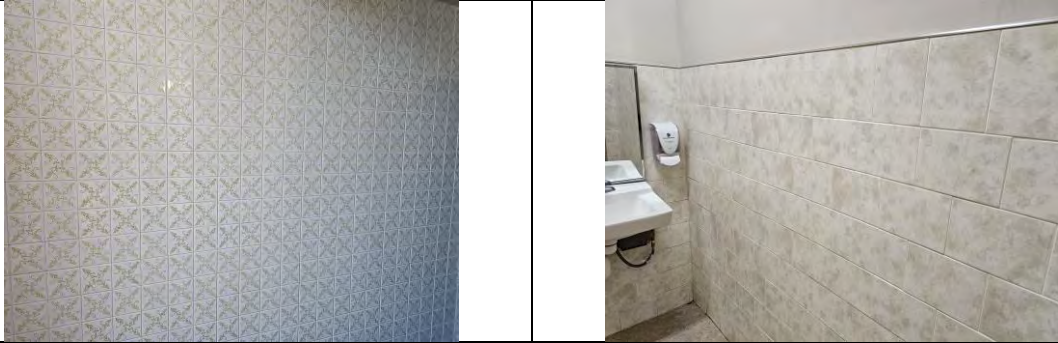
Element Name	Level 1 Major Group	Level 2 Group Element	Vintage	Service Life
Ceramic Tiles	C Interiors	C30 Interior Finishes	2017	50
Description & Recommendation				
The tiles viewed were found to be free of damage or concerns. The grouting was also seen to be without issues. It is expected that the material will last until the end its expected useful life.

Condition Rating	Priority	Action	Action Year	Opinion of Probable Cost
Good	End of Life	No Action	N/A	-

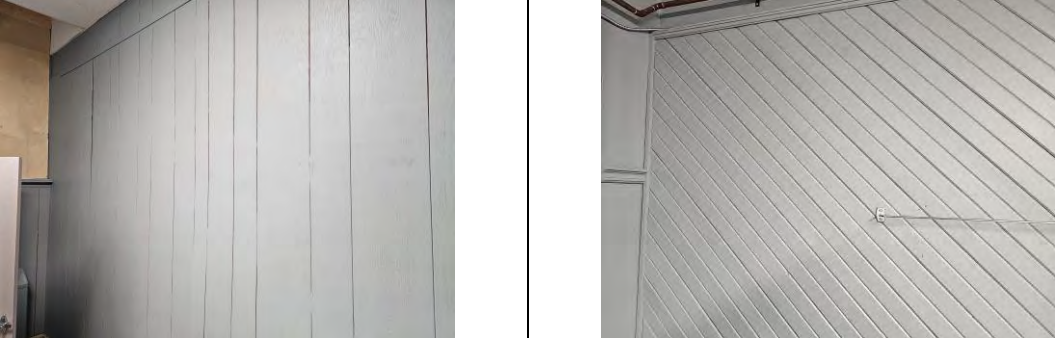
Element Name	Level 1 Major Group	Level 2 Group Element	Vintage	Service Life
Wood Panel	C Interiors	C30 Interior Finishes	1950	30
Description & Recommendation				
The wood finish is installed within the market room and coated in a grey-tone paint. The material appeared to be intact and adhered well to the wall. It is expected that the finishing will require replacement in the long term.

Condition Rating	Priority	Action	Action Year	Opinion of Probable Cost
Fair	Long Term	Replace	2035	-18,900

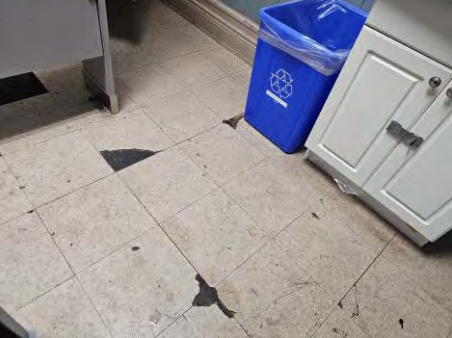
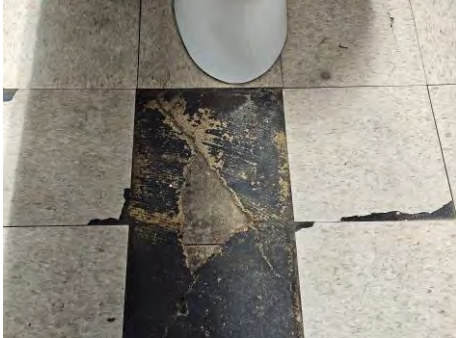
Description & Recommendation				
The vinyl tile flooring is damaged and missing material in multiple areas. It is recommended that the flooring be replaced in the short term, with caution made to the potential of asbestos within the mastic.

Condition Rating	Priority	Action	Action Year	Opinion of Probable Cost
Very poor/Failing	Short Term	Replace	2025	-50,400

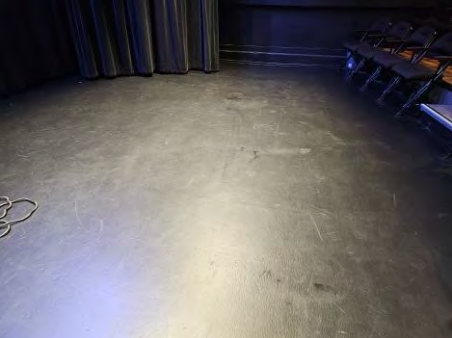
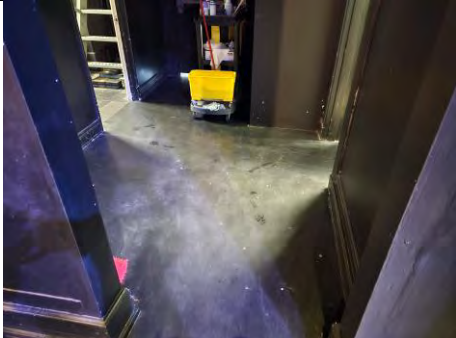
Element Name	Level 1 Major Group	Level 2 Group Element	Vintage	Service Life
Sheet Vinyl Flooring	C Interiors	C30 Interior Finishes	2015	20
Description & Recommendation				
The flooring is installed within the smaller theatre space as the performance floor and hallway finishing. The material has areas of scuffs and staining, but is intact with no heavily worn areas visible. It is recommended that the flooring be replaced in the medium term.

Condition Rating	Priority	Action	Action Year	Opinion of Probable Cost
Fair	Medium Term	Replace	2032	-13,500

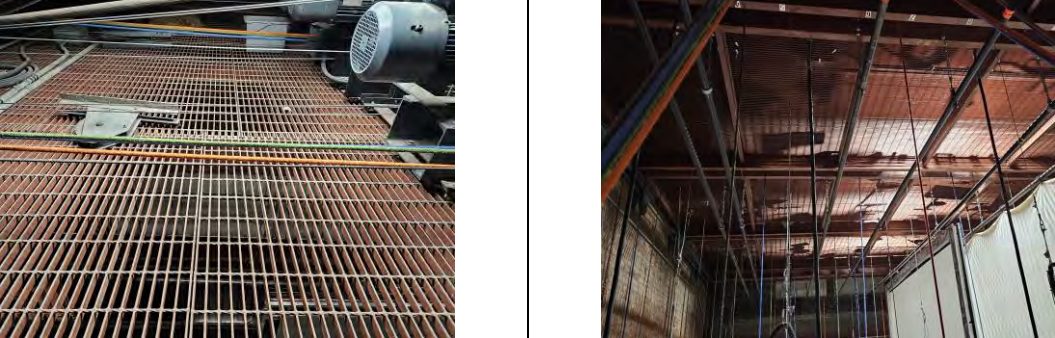
Element Name	Level 1 Major Group	Level 2 Group Element	Vintage	Service Life
Metal Flooring	C Interiors	C30 Interior Finishes	1980	80
Description & Recommendation				
The open metal flooring installed above the main stage is intact and secure based on the available vantage and access points. The metal has lost most of its paint along the top. It is expected that the flooring will require replacement at the end of its expected useful life.

Condition Rating	Priority	Action	Action Year	Opinion of Probable Cost
Fair	End of Life	No Action	N/A	-

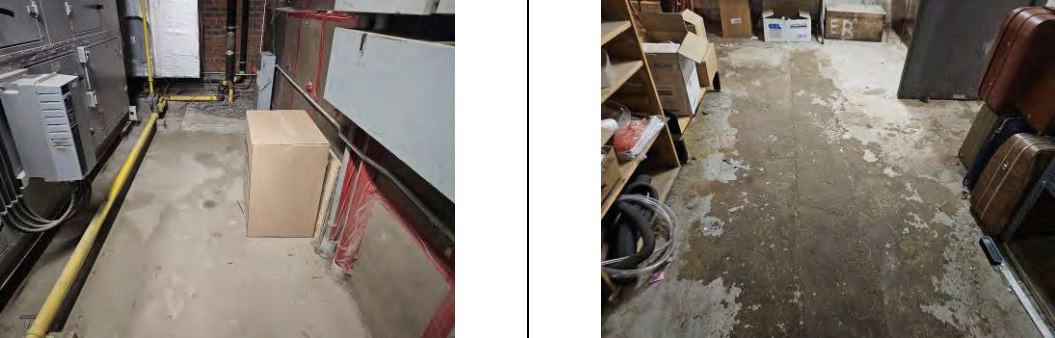
Element Name	Level 1 Major Group	Level 2 Group Element	Vintage	Service Life
Concrete Flooring	C Interiors	C30 Interior Finishes	1950	100
Description & Recommendation				
The concrete flooring has areas of settlement cracking and staining. Loss of paint is occurring in multiple areas, exposing the material below. It is expected that the material will last the life of the building. It is recommended that the floor finishing be repaired as part of building O&M.

Condition Rating	Priority	Action	Action Year	Opinion of Probable Cost
Fair	End of Life	Replace	N/A	-

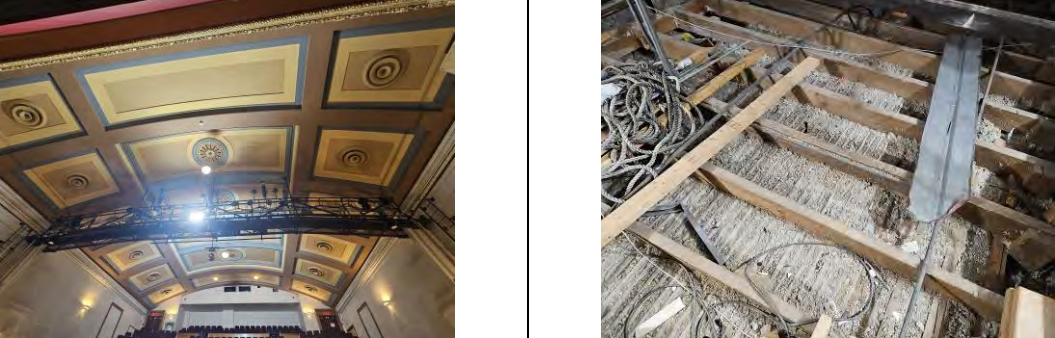
Element Name	Level 1 Major Group	Level 2 Group Element	Vintage	Service Life
Plaster Ceiling	C Interiors	C30 Interior Finishes	2017	100
Description & Recommendation				
The ceiling was redone in 2017 and, from what was visible from the available vantage points, has no areas of concern. It is expected that the plaster will require a replacement at the end of its expected useful life.

Condition Rating	Priority	Action	Action Year	Opinion of Probable Cost
Very good	End of Life	No Action	N/A	-

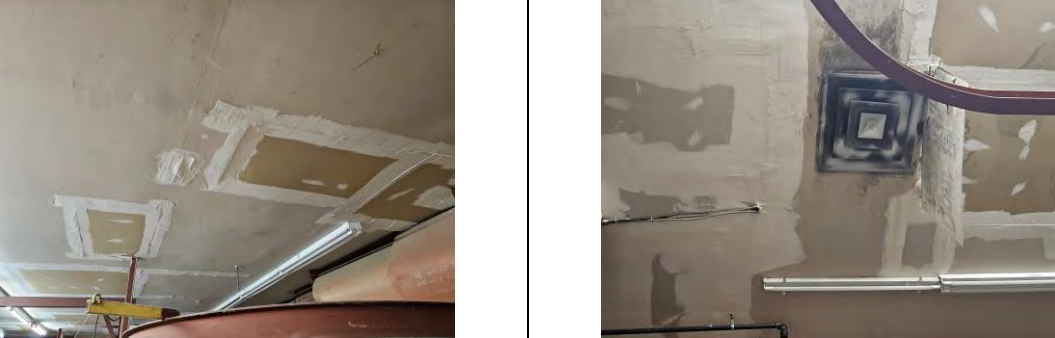
Element Name	Level 1 Major Group	Level 2 Group Element	Vintage	Service Life
Gypsum Board Ceilings	C Interiors	C30 Interior Finishes	1950	75
Description & Recommendation				
The drywall ceiling is largely original to the building and had areas of concern visible. These include holes, staining, and patchwork in many areas. It is recommended that the damaged panels be replaced in the short term.

Condition Rating	Priority	Action	Action Year	Opinion of Probable Cost
Poor	Short Term	Replace	2028	-89,100

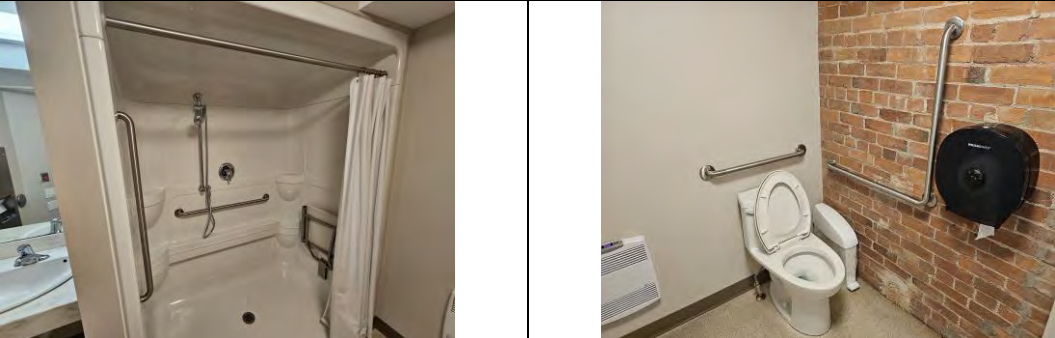
Element Name	Level 1 Major Group	Level 2 Group Element	Vintage	Service Life
AODA Components	C Interiors	C33 AODA	2017	15
Description & Recommendation				
The accessibility devices include grab bars within the washrooms, insulation on the exposed drainage pipes of washroom sinks, and powered door operators with button activation. These devices were intact and operational. In addition, the seating within the main theatre has certain aisle seats that are able to be removed to allow for wheelchair accommodation. No action is required at this time. It is expected that the accessibility devices will require replacement in the medium term.

Condition Rating	Priority	Action	Action Year	Opinion of Probable Cost
Fair	Medium Term	Replace	2033	-19,100

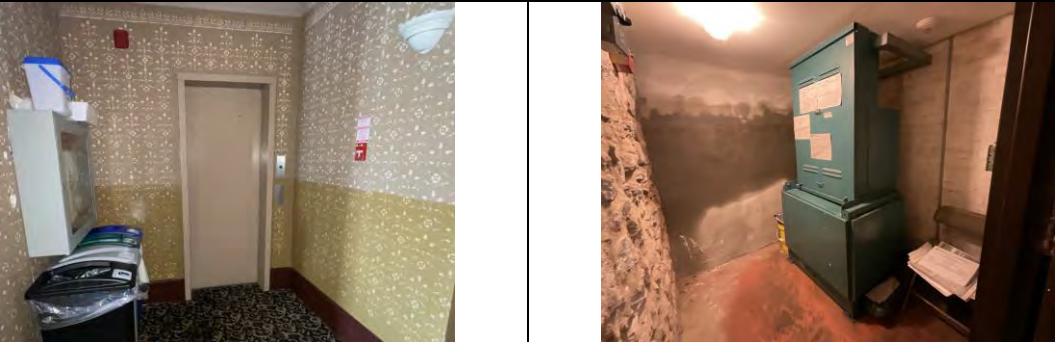
Element Name	Level 1 Major Group	Level 2 Group Element	Vintage	Service Life
Passenger Elevator	D Services	D10 Conveying	1982	30
Description & Recommendation				
<p>A ThyssenKrupp passenger elevator is located in the main lobby and provides access to the gallery of the Lightfoot Theatre. The cabin is operated with a hydraulic controller in the form of a 15HP Rota-Flow power unit (model RP-60-15; serial E-66847) manufactured by Dover circa 1982. The hydraulic device has failed and the elevator is currently non-operational. The elevator cabin was not accessed during the site assessment. It is recommended to modernize the elevator control system and refurbish the cabin interiors in the immediate term. Refer to 'Elevators - Investigation' for additional recommendations.</p>

Condition Rating	Priority	Action	Action Year	Opinion of Probable Cost
Very poor/Failing	Immediate	Replace	2024	-159,500

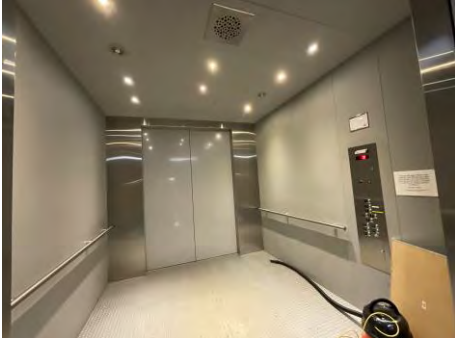
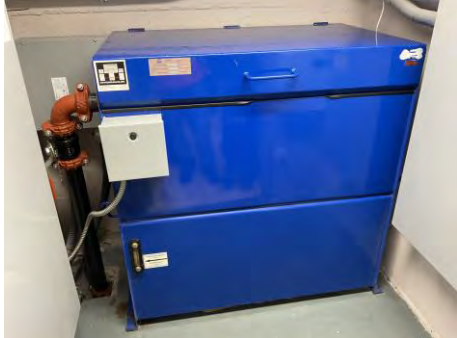
Element Name	Level 1 Major Group	Level 2 Group Element	Vintage	Service Life
Freight Elevator	D Services	D10 Conveying	2013	30
Description & Recommendation				
<p>A freight elevator with a capacity of 5,500 kgs (12,125 lbs), or 73 persons, is present in the west end of facility. It provides access between the basement and level 2. The elevator has a 2013 vintage and is operated with a I.T.I Hydauik controller (Part no. 3462/015 C4PIC-276P; serial NF38622-2). The cabin finishes include metal flooring, stainless steel handrails and laminated panel walls. The asset is in fair condition however it has frequent breakdowns with repair and maintenance conducted by Elevator1. Cabin renovation and control replacement are anticipated in the long term. Refer to 'Elevators - Investigation' for immediate term recommendations.</p>

Condition Rating	Priority	Action	Action Year	Opinion of Probable Cost
Fair	Long Term	Refurbish	2043	-366,300

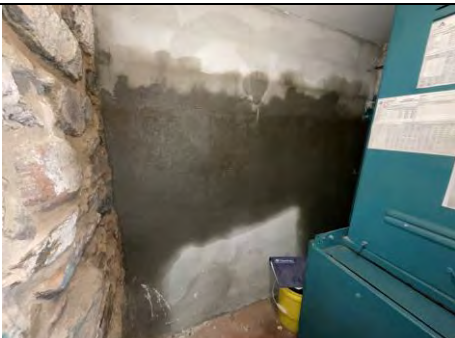
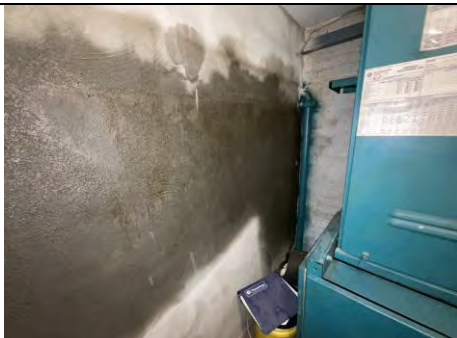
Element Name	Level 1 Major Group	Level 2 Group Element	Vintage	Service Life
Elevators - Investigation	D Services	D10 Conveying	1982	30
Description & Recommendation				
The passenger elevator is currently out of service. Staining from hydraulic fluid is present on the south wall in the basement machine room. Investigation is required by an elevator specialist to determine source and extent of hydraulic leak as well as any remediation concerns. The Freight Elevator witnesses intermittent service disruptions in the form of door jams, malfunctioning control mechanisms, and leveling adjustments. It is recommended the freight elevator is recommissioned to operate as intended. The assistance of a qualified service provider in determining the scope of the problem and offering solution, with professional oversight is recommended. An allowance for an investigational study on both elevators is provided in the immediate term.

Condition Rating	Priority	Action	Action Year	Opinion of Probable Cost
Poor	Immediate	Investigate	2024	-8,000

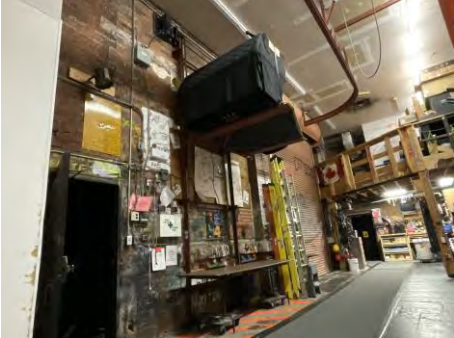
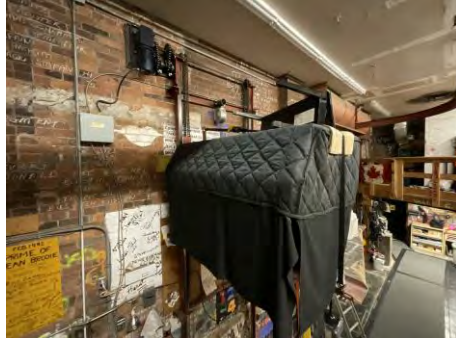
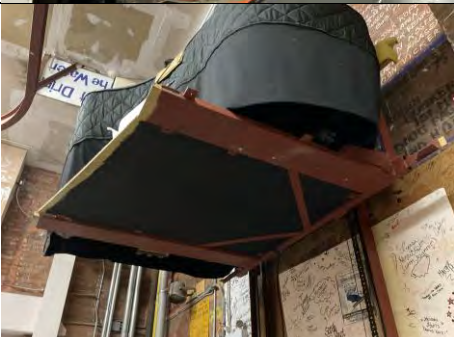
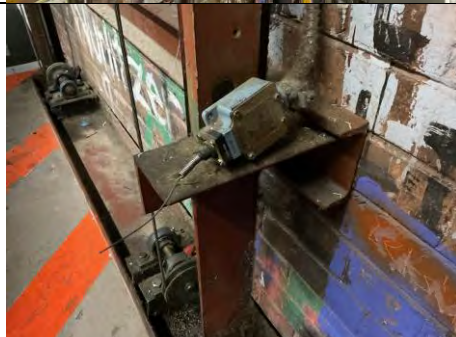
Element Name	Level 1 Major Group	Level 2 Group Element	Vintage	Service Life
Piano Lift	D Services	D10 Conveying	1917	100
Description & Recommendation				
<p>A piano lift is located back stage of the Lightfoot Theatre. The structure consists of four (4) horizontal steel beams anchored to the wall supporting two (2) vertical posts. Mechanical components include a power unit (motor), drive shaft, leaf chain, wire rope, and limit switch. A wall mounted push button</p>

switch is utilized to raise and lower the platform hoist. The system is used to store a grand piano away from foot traffic. The piano lift is assumed to be original to 1917 with implementation occurring during the rebuilding of the Opera House after the fire in 1915. It receives routine inspections with the last review occurring September 12 2023, by Zelus Material Handling. The inspection process includes visual inspection, compliance check, lubrication, and wear analysis. Individual mechanical components are replaced as needed (hoist, cables, etc.). Replacement should be guided by maintenance regime. No work is foreseen in the short or medium term other than general preventative maintenance assuming normal use is continued. The piano lift is anticipated to function adequately for another 10 years.

Condition Rating	Priority	Action	Action Year	Opinion of Probable Cost
Fair	Long Term	Refurbish	2035	-21,300

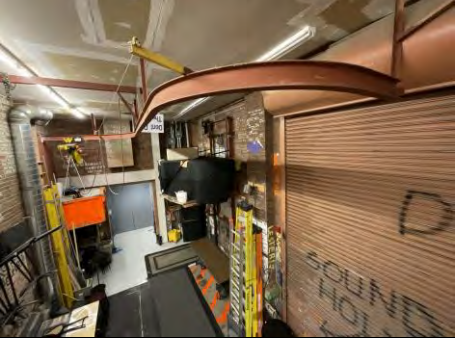
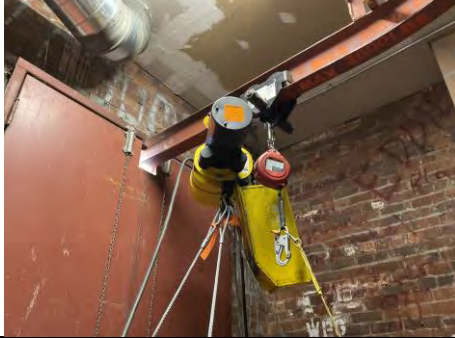
Element Name	Level 1 Major Group	Level 2 Group Element	Vintage	Service Life
Hoist - 1 Ton	D Services	D10 Conveying	1917	100
Description & Recommendation				
<p>There is an 'S' shaped track fitted with a 1-ton hoist located in the back stage of the Lightfoot Theatre. The steel I-Beam is fixed in place with lengths of steel angle that are attached to the buildings superstructure. The electrical hoist can be used to transport items from the buildings exterior to the stage, via a large access hatch in the west exterior wall. The entire system receives routine inspections by Zelus Material Handling. Overall it is in fair condition with no deficiencies noted. Vintage of electrical hoist equipment is unknown however it is suspected to be approximately 5 years old. Replacement should be guided by maintenance regime. No work is foreseen in the short or medium term other than general preventative maintenance assuming normal use is continued. The 1-ton hoist is anticipated to function adequately for another 10 years.</p>

Condition Rating	Priority	Action	Action Year	Opinion of Probable Cost
Fair	Long Term	Refurbish	2035	-21,300

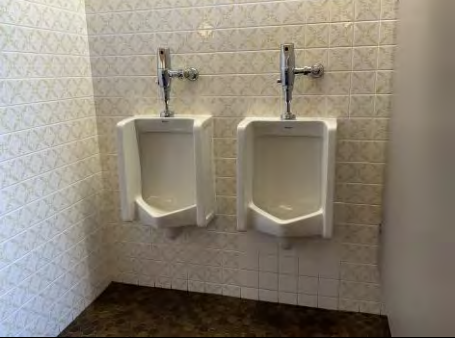
Element Name	Level 1 Major Group	Level 2 Group Element	Vintage	Service Life
Urinal	D Services	D20 Plumbing	2013	20
Description & Recommendation				
The male washroom off the Green room contains two (2) wall mounted urinals equipped with sensor activated flush valves. The urinals are in fair operating condition with no deficiencies noted. Replacement is anticipated in the medium term.

Condition Rating	Priority	Action	Action Year	Opinion of Probable Cost
Fair	Medium Term	Replace	2033	-2,200

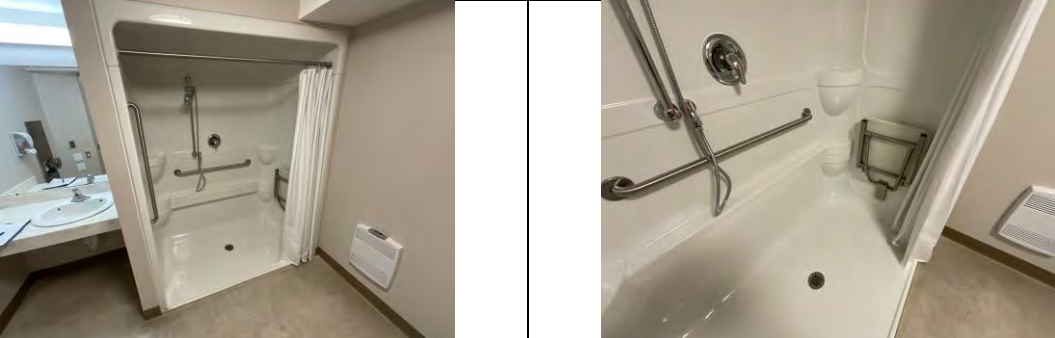
Element Name	Level 1 Major Group	Level 2 Group Element	Vintage	Service Life
Shower	D Services	D20 Plumbing	2013	30
Description & Recommendation				
<p>There is a one-piece 'roll-in' fiberglass shower stall located in the 2nd floor Dressing Room Area equipped with a shower head, thermostatic control valve, drain, "grab-bars", a basic shower curtain, and a foldable seat. It is AODA compliant and in good condition. Replacement is not anticipated in the next 15 years.</p>

Condition Rating	Priority	Action	Action Year	Opinion of Probable Cost
Good	Long Term	Replace	2043	-4,800

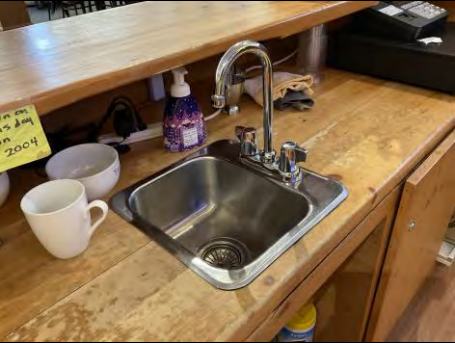
Element Name	Level 1 Major Group	Level 2 Group Element	Vintage	Service Life
Stainless Steel Sinks	D Services	D20 Plumbing	2013	20
Description & Recommendation				
<p>There are stainless steel sinks present in the green room (single bowl) and the Farmer Market (single bowl & double bowl). The sinks are in fair condition. Sink replacement is anticipated in the long term and replacement of faucets are anticipated to occur on an as fail basis and to be covered under the O&M budget.</p>

Condition Rating	Priority	Action	Action Year	Opinion of Probable Cost
Fair	Long Term	Replace	2035	-2,400

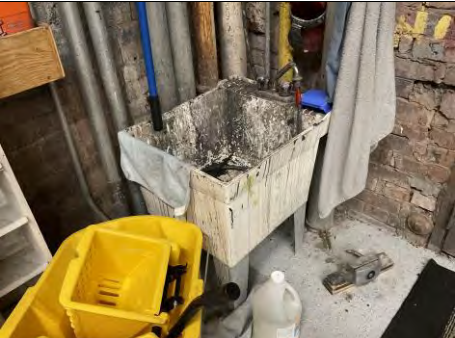
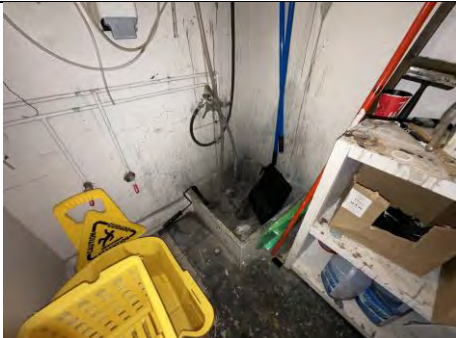
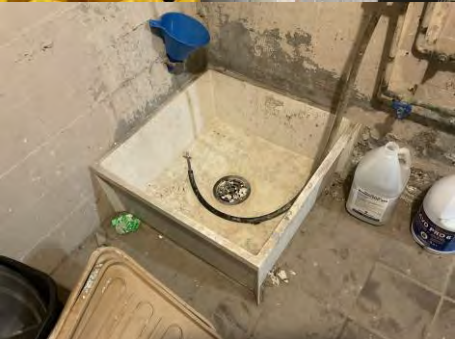
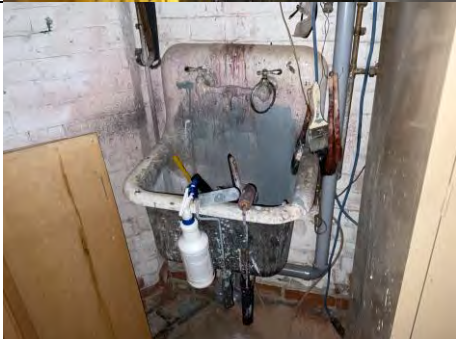
Element Name	Level 1 Major Group	Level 2 Group Element	Vintage	Service Life
Service Sink	D Services	D20 Plumbing	1986	20
Description & Recommendation				
Four (4) service sinks are located on site. There is a free standing utility sink located backstage of the Lightfoot Theatre which shows heavy use. There are floor mounted fiberglass wash basins located in the Studio Theatre Custodial closet and in the basement near AHU-4. There is a wall mounted cast iron tub located in the basement near the boilers. All the units are scuffed and stained. Replacements are recommended on an as fail basis. Action is anticipated in the medium term.

Condition Rating	Priority	Action	Action Year	Opinion of Probable Cost
Poor	Medium Term	Replace	2029	-3,200

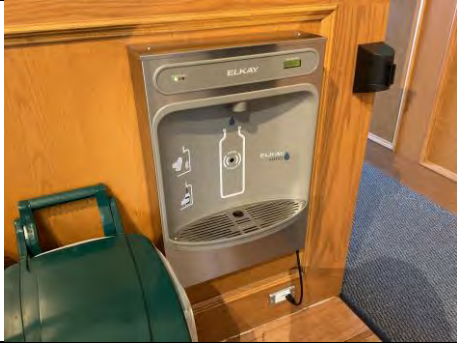
Element Name	Level 1 Major Group	Level 2 Group Element	Vintage	Service Life
Water Fountain	D Services	D20 Plumbing	2022	30
Description & Recommendation				
There are two (2) cold water Elkay drinking fountains in the facility with a unit in the Green Room and another located in the 2nd floor Dressing Room area. The water fountains are in very good condition and have a 2022 vintage. Replacement is not anticipated in the term of analysis.

Condition Rating	Priority	Action	Action Year	Opinion of Probable Cost
Very good	End of Life	Replace	N/A	-

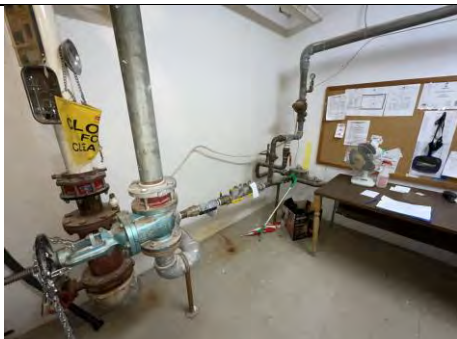
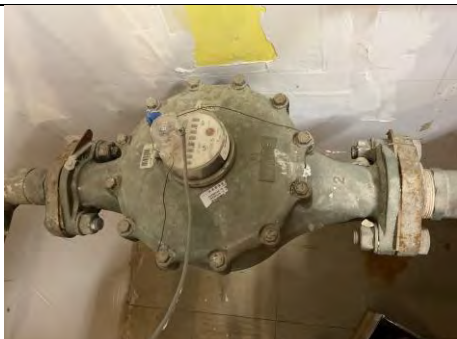
Element Name	Level 1 Major Group	Level 2 Group Element	Vintage	Service Life
Domestic Water Distribution	D Services	D20 Plumbing	1917	60
Description & Recommendation				
Main incoming water enters the building through an uninsulated pipe located in the basement on the east end near transport services. The water service is metered and equipped with shut-off valves and a backflow preventer. Copper piping is used as the primary means of domestic water distribution. Upgrades to portions of the distribution piping occurs during equipment upgrades such as bathroom renovations (circa 2013) and DHW heater replacement (circa 2020). The majority of pipe lengths are insulated with pipe wrap to prevent heat loss and condensation, as well to reduce noise transmission. The assessment noted a combination of chrome brass and PVC drain piping present under sinks with braided stainless steel water lines to faucets. There is no evidence to suggest any immediate issues with the domestic water distribution piping. The facility experiences water leaks at infrequent intervals and conducts repair as necessary. Overall the domestic water distribution is in fair condition, however the infrastructure is aging and will require increased corrective maintenance with time. A cost for complete replacement is provided in the medium term.

Condition Rating	Priority	Action	Action Year	Opinion of Probable Cost
Fair	Medium Term	Replace	2034	-88,500

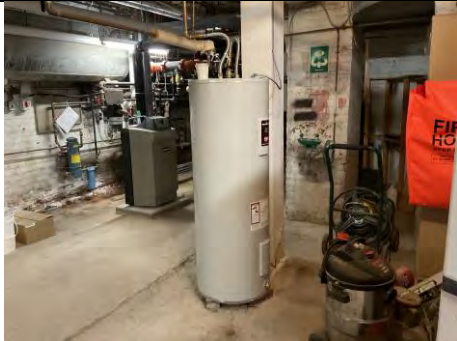
Element Name	Level 1 Major Group	Level 2 Group Element	Vintage	Service Life
Domestic Water Heater	D Services	D20 Plumbing	2020	12
Description & Recommendation				
Domestic Hot Water (DHW) for the facility is provided by one (1) 4.5 kW heater/tank manufactured by Bradford White. The unit (model RE265T6-1NCWW; serial WK46791887) has a 2020 vintage and a 231 Litre (61 USG) capacity. There is no evidence of rust, corrosion, or leaks from the tank and it is in good condition overall. Pipe insulation should be applied on distribution lines to reduce heat loss. Replacement is anticipated in the medium term and end of expected useful life.

Condition Rating	Priority	Action	Action Year	Opinion of Probable Cost
Good	Medium Term	Replace	2032	-3,300

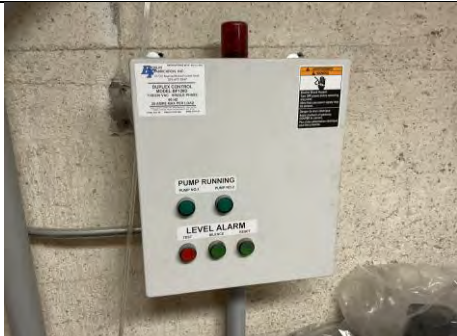
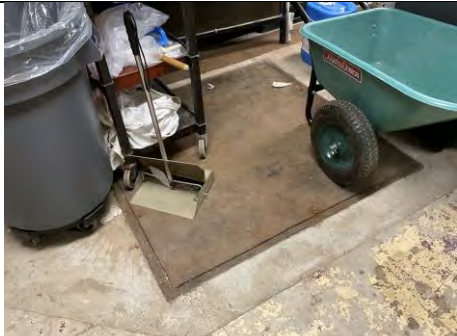
Element Name	Level 1 Major Group	Level 2 Group Element	Vintage	Service Life
Sump Pumps - Elevator Pit	D Services	D20 Plumbing	2013	10
Description & Recommendation				
Two (2) sumps are located in the basement serving the elevator pit which are automatically controlled via a Duplex waterproof control panel (model BF120D). Typical expected useful life is 10 years. Replacement is recommended on an as-fail basis. Action is anticipated in the short term.

Condition Rating	Priority	Action	Action Year	Opinion of Probable Cost
Fair	Short Term	Replace	2026	-8,400

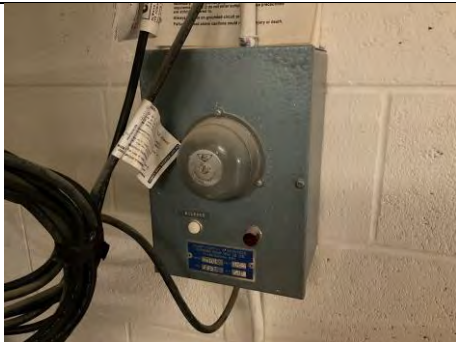
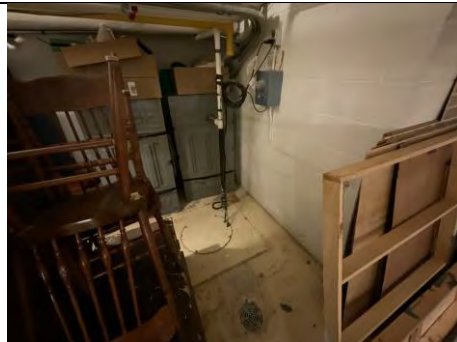
One (1) sump pump is located in the basement for stormwater and is connected to the sanitary sewer. The sump is automatically controlled via a wall mounted panel equipped with a high level alarm. Documentation posted on a nearby wall indicates the sump is a Hydromatic Pump (model SW25A) with a 1991 vintage. The sump is operating beyond its expected useful life and replacement is recommended in the immediate term.

Condition Rating	Priority	Action	Action Year	Opinion of Probable Cost
Poor	Immediate	Replace	2024	-4,200

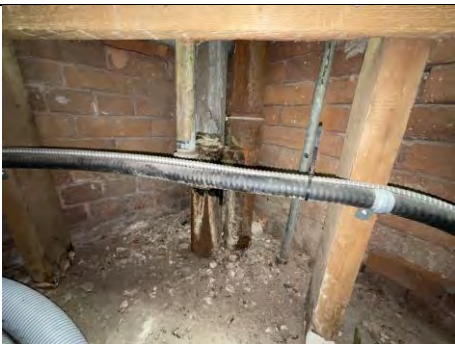
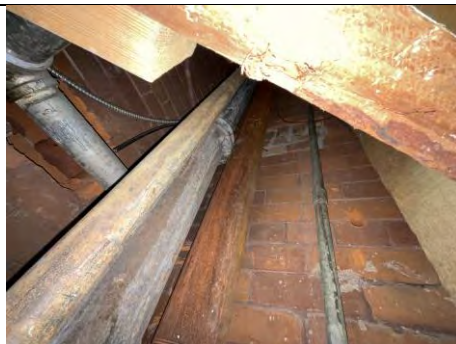
Storm water from roof and area drains is collected in drain stacks and transported by gravity to the municipal sewer system. The existing drain pipes are cast iron piping/fittings. A portion of the drain stack was viewed in the crawl space under the south stairs to the Lightfoot Gallery. Staining from water residue and rust formation was visible. Replacement with PVC drain pipes is recommended in the medium term. It is estimated there is approximately 400 ft of cast iron drain pipe present in the facility.

Condition Rating	Priority	Action	Action Year	Opinion of Probable Cost
Poor	Medium Term	Replace	2029	-76,000

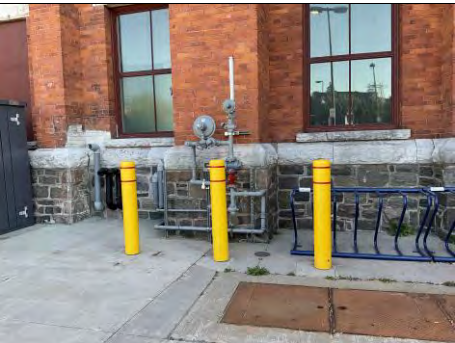
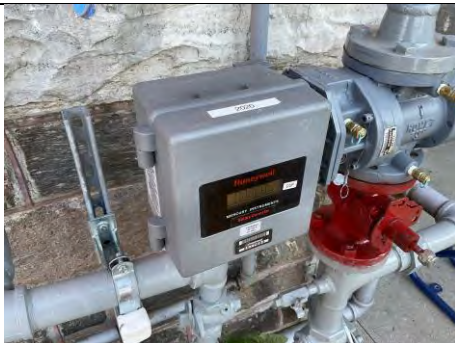
Element Name	Level 1 Major Group	Level 2 Group Element	Vintage	Service Life
Gas Supply System	D Services	D30 HVAC	2020	25
Description & Recommendation				
Incoming natural gas enters the facility on the north elevation of the building envelope. A Honeywell rotary corrector (utility grade meter) was installed circa 2020. No issues identified with the meters which are owned and operated by the utility. No action required.

Condition Rating	Priority	Action	Action Year	Opinion of Probable Cost
Good	N/A	No Action	2045	-0

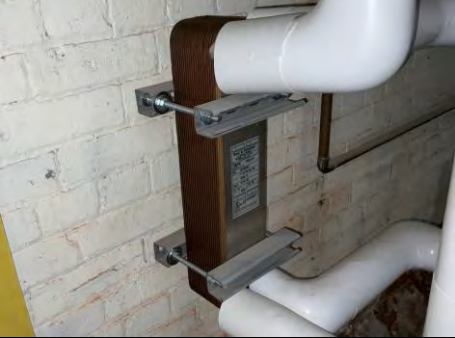
Element Name	Level 1 Major Group	Level 2 Group Element	Vintage	Service Life
Heat Exchanger	D Services	D30 HVAC	2018	30
Description & Recommendation				
There is a Bell & Gossett plate & frame heat exchanger located in the basement. The unit (model BP 415-040; serial 56860504003) is fed from the boilers to heat the glycol loop serving the heating coil in AHU-4. The life expectancy for plate & frame heat exchangers is 30 years based on industry standard. Replacement is anticipated in the long term.

Condition Rating	Priority	Action	Action Year	Opinion of Probable Cost
Good	Long Term	Replace	2048	-9,400

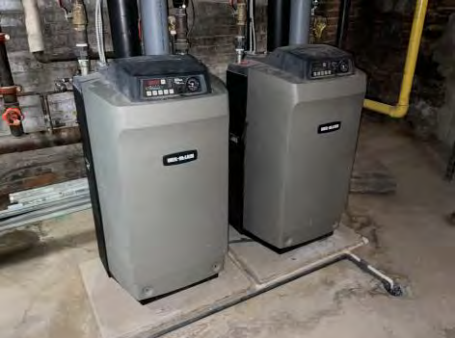
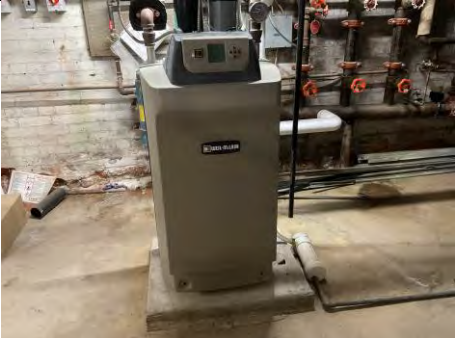
Element Name	Level 1 Major Group	Level 2 Group Element	Vintage	Service Life
Hot Water Boilers	D Services	D30 HVAC	2017	20
Description & Recommendation				
<p>There are three (3) hot water boilers (B-1, B-2, & B-3) located in the basement which serve the hot water radiators, plate & frame heat exchanger, and heating coil in AHU-5. B-1 & B-2 are rated at 310 MBH (model Ultra 310; serial B-1 550207755; serial B-2 N/A) and B-3 is rated at 230 MBH (model Ultra 230; serial B-3 550201464). The units have a 2017 vintage and are in good condition. Replacement is recommended in the long term at end of expected useful life.</p>

Condition Rating	Priority	Action	Action Year	Opinion of Probable Cost
Good	Long Term	Replace	2037	-80,700

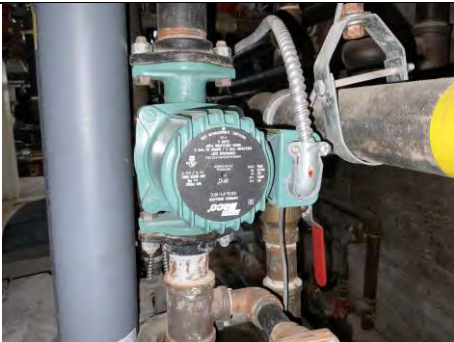
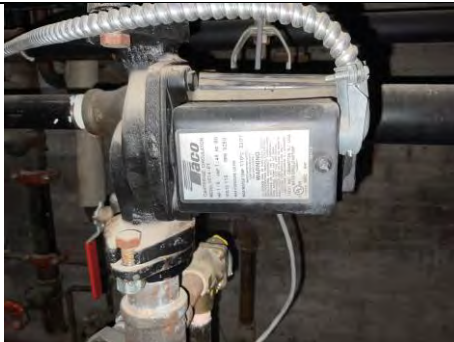
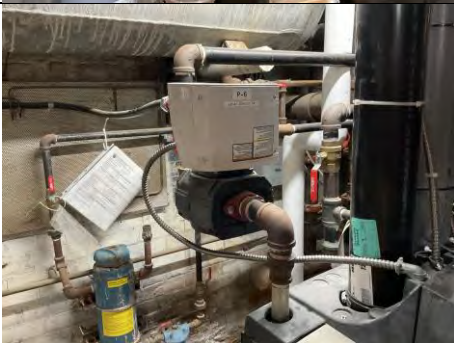
Element Name	Level 1 Major Group	Level 2 Group Element	Vintage	Service Life
Boiler Circulation Pumps	D Services	D30 HVAC	2017	15
Description & Recommendation				
<p>Each boiler is equipped with a fractional horsepower circulation pump. B-1 is served by a Taco cartridge circulator (model 0014-F1-1IFC; serial N/A). B-2 is served by a Taco cartridge circulator (model 0014-F1; serial N/A). B-3 is served by a Bell & Gossett high efficiency circulator pump (model ecocirc XL 55-45; serial 01227). Pumps failures can be handled as necessary. Replacement is anticipated in the medium term.</p>

Condition Rating	Priority	Action	Action Year	Opinion of Probable Cost
Fair	Medium Term	Replace	2032	-11,400

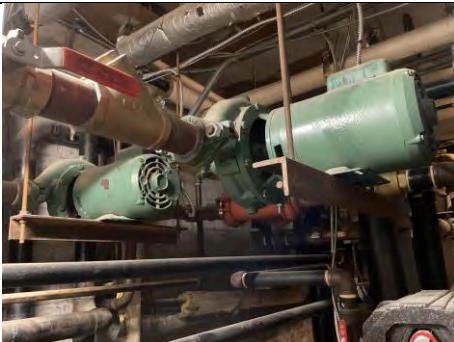
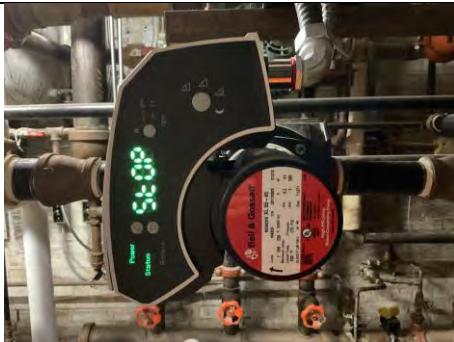
Element Name	Level 1 Major Group	Level 2 Group Element	Vintage	Service Life
Heating Distribution Pumps	D Services	D30 HVAC	2017	15
Description & Recommendation				
There are three (3) fractional horsepower circulator pumps for the hot water loop. P-1 and P-2 are Taco circulators equipped with 3/4 HP WEG motors which serve the hot water radiators in the facility. P-5 is a Bell & Gosset high efficiency circulating pump (model ecocirc XL 55-45; serial 01310) suspected to be dedicated to the plate & frame heat exchanger. Pumps failures can be handled as necessary. Replacement is anticipated in the medium term.

Condition Rating	Priority	Action	Action Year	Opinion of Probable Cost
Fair	Medium Term	Replace	2032	-11,400

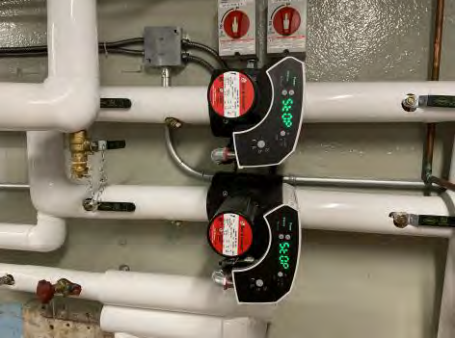
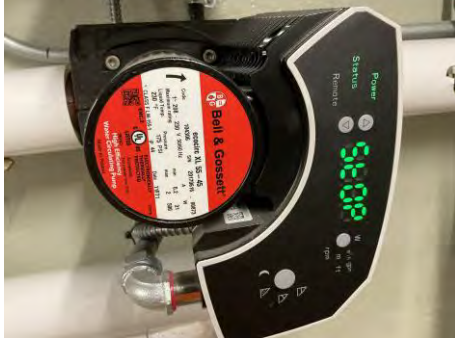
Element Name	Level 1 Major Group	Level 2 Group Element	Vintage	Service Life
Glycol Pumps	D Services	D30 HVAC	2017	15
Description & Recommendation				
The glycol loop for the heating coil in AHU-4 is served by two (2) fractional horsepower Bell & Gossett high efficiency circulating pumps (model ecocirc XL 55-45; serial P-7 01307; serial P-8 00873) that operate in duty/standby configuration. The pumps have a 2017 vintage and are in good condition. Replacement is anticipated in the medium term at end of expected useful life.

Condition Rating	Priority	Action	Action Year	Opinion of Probable Cost
Good	Medium Term	Replace	2033	-7,600

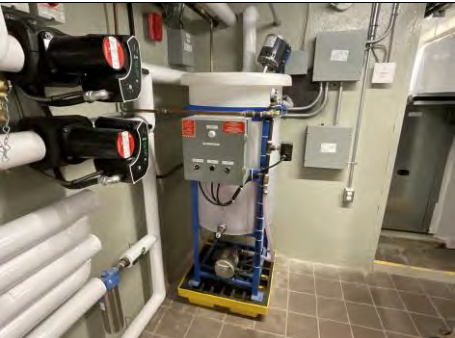
Element Name	Level 1 Major Group	Level 2 Group Element	Vintage	Service Life
Glycol Feed Package	D Services	D30 HVAC	2021	20
Description & Recommendation				
There is a glycol fill system equipped with a fractional HP pump located in the basement next to AHU-4. No deficiencies noted and the Glycol Feed Package is in good condition. Replacement is anticipated in the long term.

Condition Rating	Priority	Action	Action Year	Opinion of Probable Cost
Good	Long Term	Replace	2041	-10,600

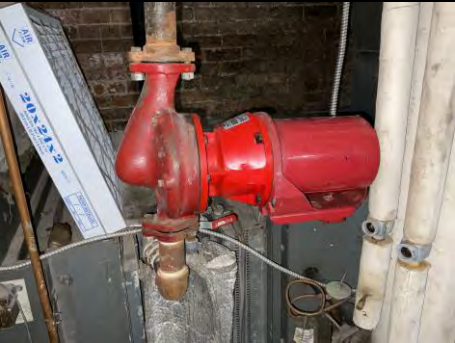
Element Name	Level 1 Major Group	Level 2 Group Element	Vintage	Service Life
Heating Distribution Pump - AHU-5	D Services	D30 HVAC	2021	15
Description & Recommendation				
The heating coil in AHU-5 is served by one (1) Armstrong pump (model 816032MF-000) with a fractional HP A.O. Smith motor. The pump has a 2021 vintage and is in good condition. Replacement is anticipated in the long term, however any modifications to AHU-5 may expedite need for earlier action.

Condition Rating	Priority	Action	Action Year	Opinion of Probable Cost
Good	Long Term	Replace	2036	-3,800

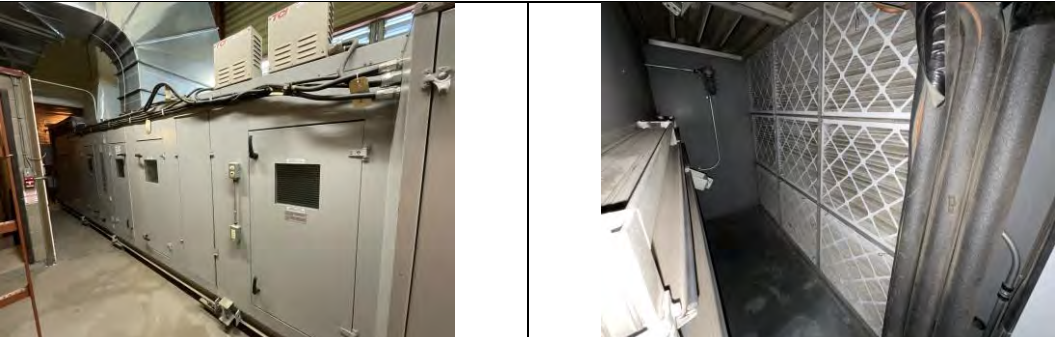
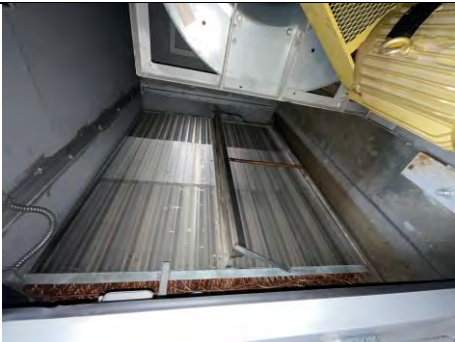
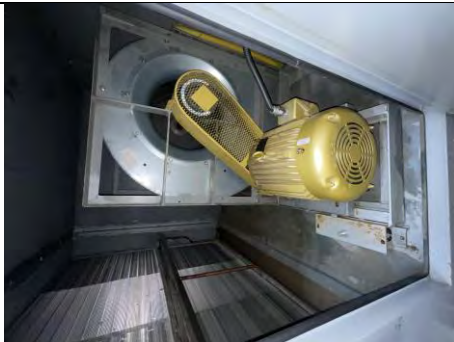
Element Name	Level 1 Major Group	Level 2 Group Element	Vintage	Service Life
Interior Air Handling Unit - AHU-1	D Services	D30 HVAC	2017	30
Description & Recommendation				
AHU-1 is located in the mechanical penthouse and provides fresh air, heating, and cooling for the Gordon Lightfoot Theatre. The packaged Variable Air Volume (VAV) Engineered Air unit (model FW453/DJE140; serial 56520 RT-1) is equipped with a C-TRAC3 controller, two (2) Direct Expansion (DX) cooling coils, a natural gas indirect fired burner (1,100 MBH input capacity), a 15 horsepower (HP) supply fan, and a 7.5 HP return fan. Both fan motors are equipped with Variable Frequency Drives (VFD). The 15,000 CFM Air Handling Unit (AHU) has a 2017 vintage and is in good condition with no deficiencies noted. The expected service life for indoor AHUs is 25-30 years. Individual component parts are inspected in routine maintenance procedures (fan belts, motors, filter banks, etc.). Replacement is anticipated in the long term.

Condition Rating	Priority	Action	Action Year	Opinion of Probable Cost
Good	Long Term	Replace	2047	-165,200

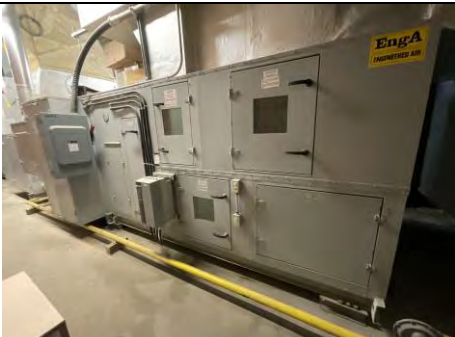
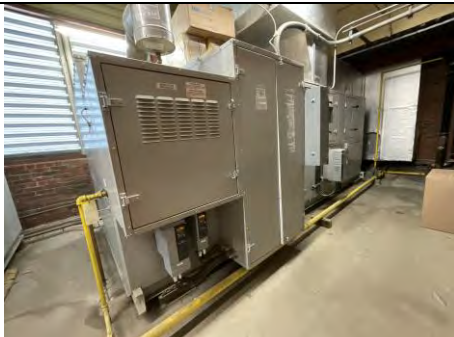
AHU-2 is located in the mechanical penthouse and provides fresh air, heating, and cooling for the Theatre Stage. The packaged Variable Air Volume (VAV) Engineered Air unit (model FW163/DJS40; serial 56520 RT-2) is equipped with a DJM controller, two (2) Direct Expansion (DX) cooling coils, a natural gas indirect fired burner (325 MBH input capacity), a 7.5 HP supply fan, and a 3 HP return fan. Both fan motors are equipped with Variable Frequency Drives (VFD). The 6,000 CFM unit has a 2017 vintage and is in good condition with no deficiencies noted. Replacement is anticipated in the long term.

Condition Rating	Priority	Action	Action Year	Opinion of Probable Cost
Good	Long Term	Replace	2047	-75,500

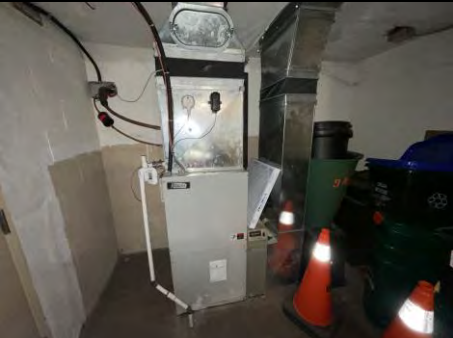
Element Name	Level 1 Major Group	Level 2 Group Element	Vintage	Service Life
Furnace	D Services	D30 HVAC	1991	18
Description & Recommendation				
Heating and ventilation for the backstage area of the Studio Theatre is provided by a Keeprite furnace (ID Furnace-3) located in the basement. The unit (model NBCM036XKB2; serial L911969107) has a 1991 vintage and is operating beyond its expected useful life. Replacement is recommended in the immediate term.

Condition Rating	Priority	Action	Action Year	Opinion of Probable Cost
Poor	Immediate	Replace	2024	-11,900
