ORILLIA OPERA HOUSE | CONSERVATION PLAN UPDATE 2025

July 2nd, 2025 DRAFT

Orillia Opera House

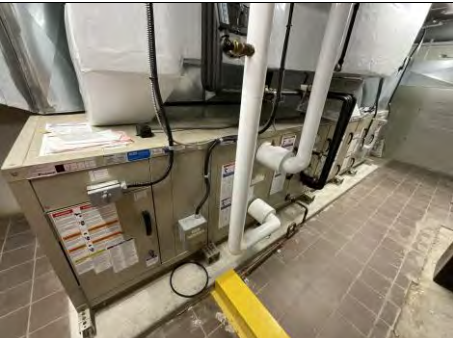
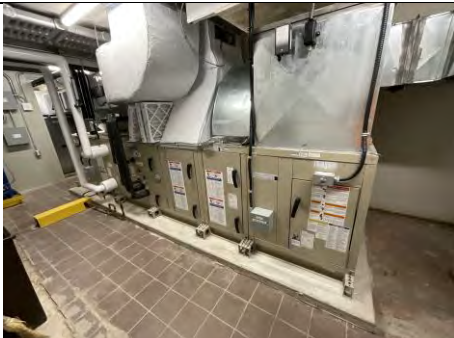
Element Name	Level 1 Major Group	Level 2 Group Element	Vintage	Service Life
Interior Air Handling Unit - AHU-4	D Services	D30 HVAC	2018	30
Description & Recommendation				
AHU-4 is located in the basement and provides fresh air, heating, and cooling for the Studio Theatre. The Constant Air Volume (CAV) Daikin unit (model CAH006GDAM; serial FBOU180100836) is equipped with two (2) Direct Expansion (DX) cooling coils, a glycol heating coil (served by the Weil-McLain boilers via Bell & Gossett heat exchanger), a 5 HP supply fan, and a 3 HP return fan. The unit has a 2018 vintage and an estimated 2,500 CFM airflow capacity. It is in good condition with no deficiencies noted. Replacement is anticipated in the long term.

Condition Rating	Priority	Action	Action Year	Opinion of Probable Cost
Good	Long Term	Replace	2048	-51,400

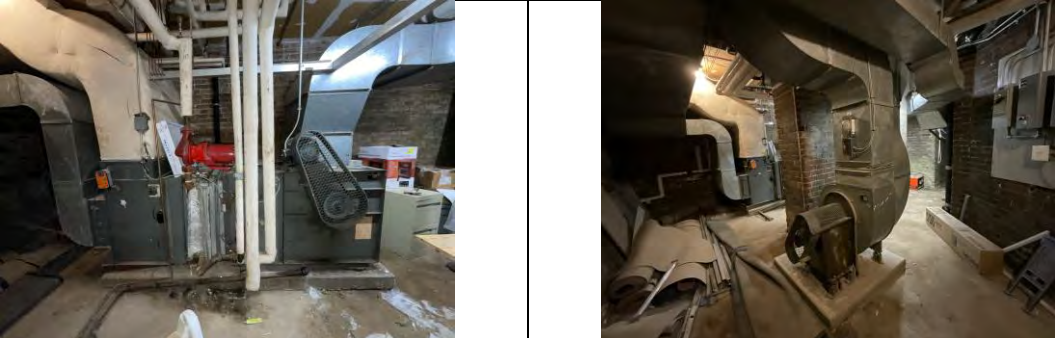
Element Name	Level 1 Major Group	Level 2 Group Element	Vintage	Service Life
Interior Air Handling Unit - AHU-5	D Services	D30 HVAC	1982	30
Description & Recommendation				
<p>AHU-5 is located in the basement and provides fresh air, heating, and cooling for the Green Room. The Constant Air Volume (CAV) Trane Climate Changer (model 8MP-HFFVU; serial 633079) is equipped with two (2) Direct Expansion (DX) cooling coils, a hot water heating coil (served by the Weil-McLain boilers), a 3 HP supply fan, and a 1 HP return fan. Exact vintage of AHU is unknown and estimated to be roughly 40 years old. Individual component parts are replaced through ad-hoc and routine maintenance procedures (fan belts, motors, filter banks, pump for heating coil, etc.). Modifications to convert the unit to Direct Digital Control (DDC) occurred during implementation of the BAS. Overall the unit is aging, in poor condition, and receives recurrent maintenance to remain operational. Replacement/refurbishment is anticipated in the immediate term. Suggested upgrades to AHU include new heating coils, DX coils, and supply/return fans with Variable Frequency Drives (VFDs).</p>

Condition Rating	Priority	Action	Action Year	Opinion of Probable Cost
Poor	Immediate	Replace	2024	-51,400

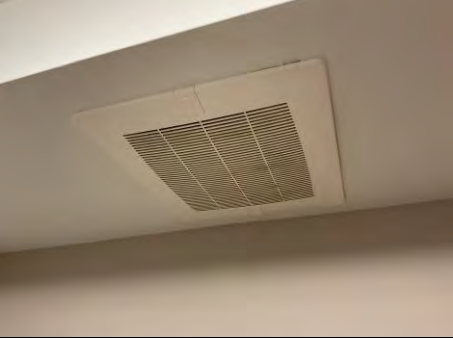
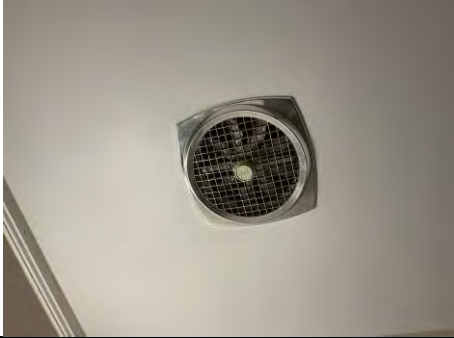
Element Name	Level 1 Major Group	Level 2 Group Element	Vintage	Service Life
Exhaust Fans - Washrooms	D Services	D30 HVAC	1982	20
Description & Recommendation				
<p>Each washroom contains an exhaust fan which is interlocked with the lighting circuit. Fans in the public washrooms (near Green room) and accessible washrooms (main lobby & 2nd floor dressing room) have a circa 2013 vintage. Fan units serving the Studio Theatre washrooms and bathrooms in the basement have reached the end of their life expectancy and require renewal. Replacement is recommended in the short term.</p>

Condition Rating	Priority	Action	Action Year	Opinion of Probable Cost
Fair	Short Term	Replace	2025	-11,200

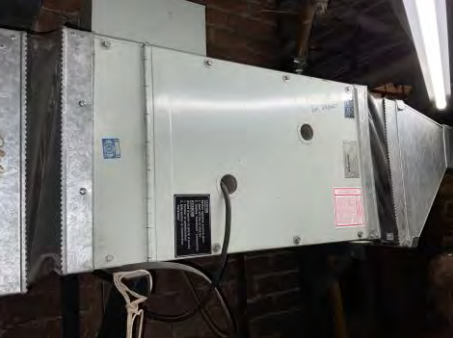
Element Name	Level 1 Major Group	Level 2 Group Element	Vintage	Service Life
Exhaust Fan - Elevator Machine Room	D Services	D30 HVAC	1982	20
Description & Recommendation				
The elevator machine room for the passenger lift is equipped with an exhaust fan. The Greenheck unit (model SQD-10-B; serial 20331) has a fractional horsepower motor and is in fair condition. Replacement is anticipated in the immediate term to coincide with upgrades to the passenger elevator.

Condition Rating	Priority	Action	Action Year	Opinion of Probable Cost
Fair	Immediate	Replace	2024	-1,400

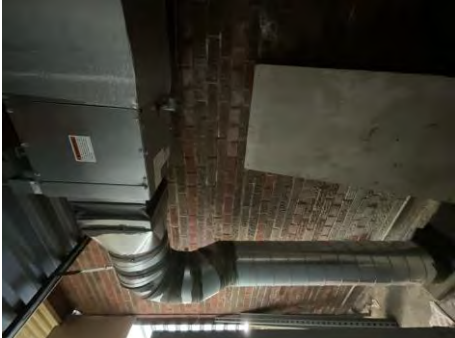
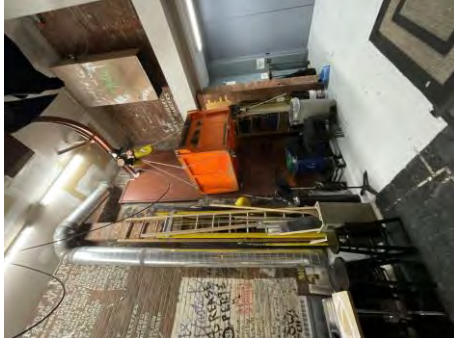
Element Name	Level 1 Major Group	Level 2 Group Element	Vintage	Service Life
Exhaust Fan - Penthouse	D Services	D30 HVAC	2018	20
Description & Recommendation				
There is an exhaust fan located in the penthouse with duct work running through the floor backstage of the Lightfoot Theatre. It is suspected to serve the basement however we request the City of Orillia confirm purpose and report back. The Greenheck unit (model SQ-90-DGEX-QD; serial 15185369) has a fractional horsepower motor and is in fair condition. Replacement is anticipated in the long term.

Condition Rating	Priority	Action	Action Year	Opinion of Probable Cost
Fair	Long Term	Replace	2038	-1,400

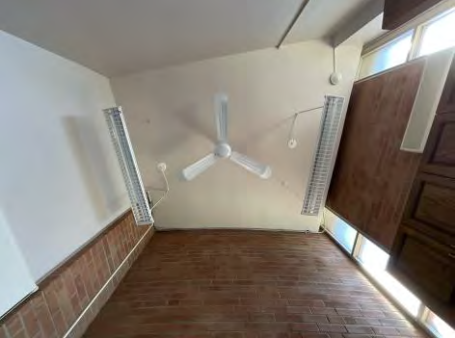
Element Name	Level 1 Major Group	Level 2 Group Element	Vintage	Service Life
Ceiling Fan	D Services	D30 HVAC	2013	20
Description & Recommendation				
There is a ceiling fan installed in the Ticket Office. The fan is manually operated via a wall mounted toggle switch to provide air circulation and evaporative cooling for occupants. Replacement is anticipated in the medium term on an as-fail basis.

Condition Rating	Priority	Action	Action Year	Opinion of Probable Cost
Fair	Medium Term	Replace	2033	-1,100

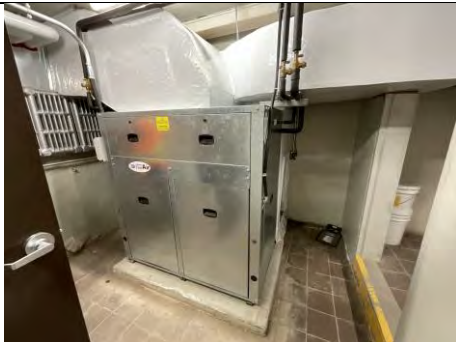
There is a 10-ton air cooled condenser located in the basement which serves AHU-4. The United Coolair unit (model BVA10G3AHA-X; serial 1803005) is equipped with one (1) 5 HP condenser motor and two (2) compressors charged with R-410A. It has a 2018 vintage and is in good condition. Replacement is anticipated in the long term.

Condition Rating	Priority	Action	Action Year	Opinion of Probable Cost
Good	Long Term	Replace	2035	-25,300

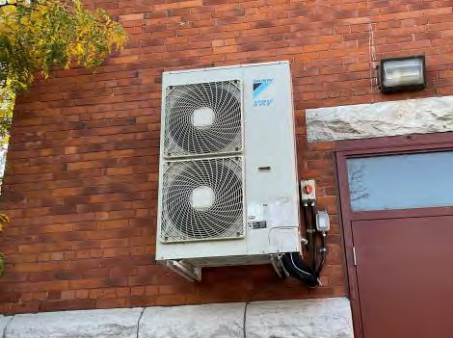
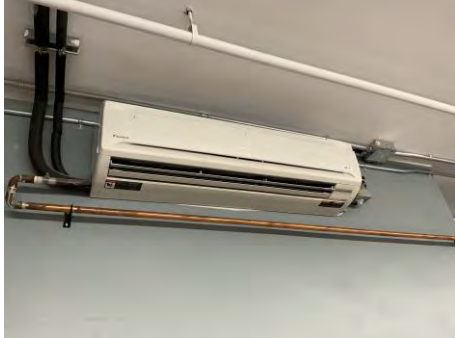
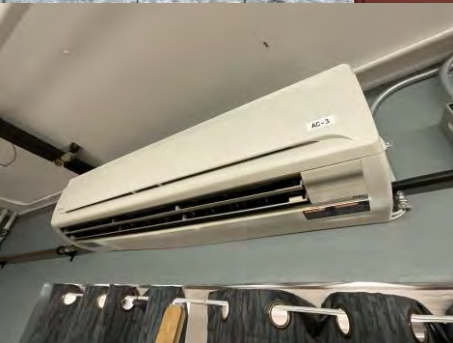
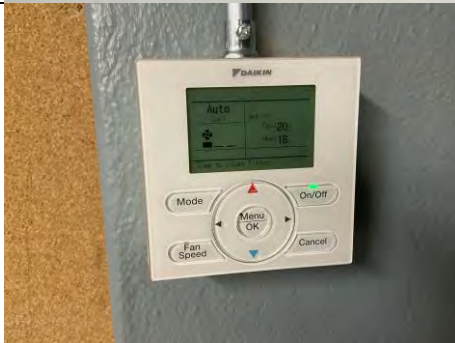
Element Name	Level 1 Major Group	Level 2 Group Element	Vintage	Service Life
VRF Heat Pump System (5-ton)	D Services	D30 HVAC	2018	15
Description & Recommendation				
<p>There is a Daikin Variable Refrigerant Flow (VRF) heat pump system serving the Farmer Market. There is an outdoor unit (model RXTQ60TAVJU; serial F002429) exteriorly located on wall mounted metal support rack at the south-west elevation of the building envelope. There are three (3) FCUs (model FXAQ18PVJU; serial FCU-1 E010057; serial FCU-2 E010046; serial FCU-3 E010049) located within market. The VRF heat pump has a 2018 vintage and utilizes R-410a refrigerant. Temperature control setpoints are provided via a wall mounted digital thermostat. Replacement is anticipated in the medium term.</p>

Condition Rating	Priority	Action	Action Year	Opinion of Probable Cost
Fair	Medium Term	Replace	2034	-32,400

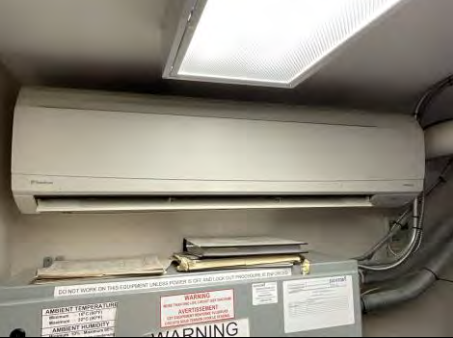
Element Name	Level 1 Major Group	Level 2 Group Element	Vintage	Service Life
Split AC System - Elevator	D Services	D30 HVAC	2013	15
Description & Recommendation				
<p>There is a Daikin split Air Conditioning (A/C) system providing cooling for the elevator machine room. There is a condenser unit (model RKS30LVJU; serial N/A) exteriorly located on the roof with an evaporator unit in the form of a Fan Coil Unit (FCU model FTXS30LVJU; serial E001021) located in the basement. The 2.5 ton unit was manufactured in 2013 and is charged with R-410A. Temperature set points are controlled with a wall mounted programmable thermostat. The system appears adequately sized for the space it serves. Routine service/maintenance is recommended every Spring to ensure cooling needs are provided to the elevators hydraulic controller. Replacement is anticipated in the short term at end of expected useful life.</p>

Condition Rating	Priority	Action	Action Year	Opinion of Probable Cost
Fair	Short Term	Replace	2028	-10,400

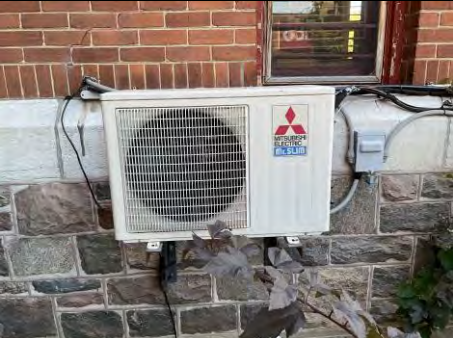
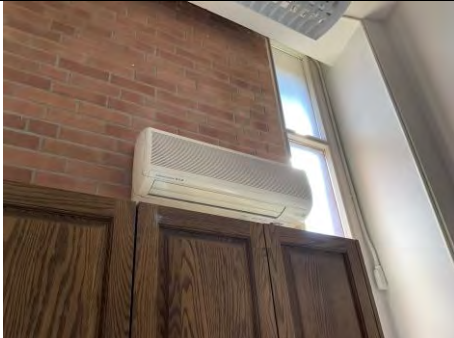
Element Name	Level 1 Major Group	Level 2 Group Element	Vintage	Service Life
Split AC System - Box Office	D Services	D30 HVAC	2004	15
Description & Recommendation				
<p>There is a Mitsubishi split Air Conditioning (A/C) system providing cooling for the box office. There is a condenser unit (model MU09TW; serial 4000055) exteriorly located on wall mounted metal support rack at the south-east elevation of the building envelope with an evaporator unit in the form of a Fan Coil Unit (FCU model MS09TW; serial 4000100) located in the box office. The 3/4 ton unit was manufactured in 2004 and is charged with R-22 (Freon) which is a HCFC refrigerant being phased out in Canada due to its harsh environmental impact. Temperature set points are controlled with a remote controller. Replacement is anticipated in the short term as the unit is operating beyond its expected useful life.</p>

Condition Rating	Priority	Action	Action Year	Opinion of Probable Cost
Fair	Short Term	Replace	2025	-8,200

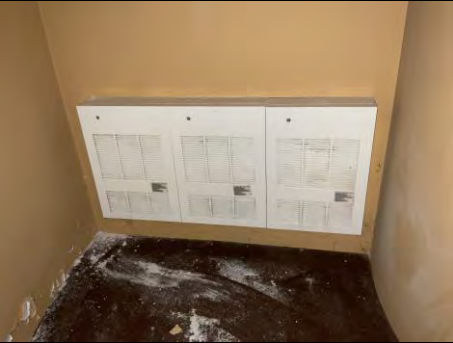
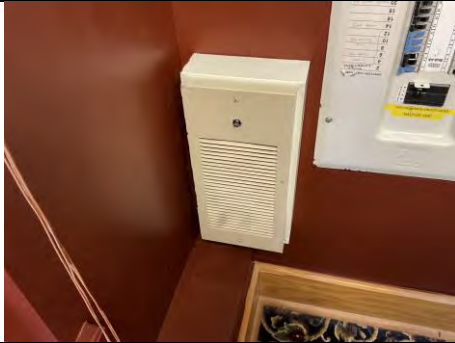
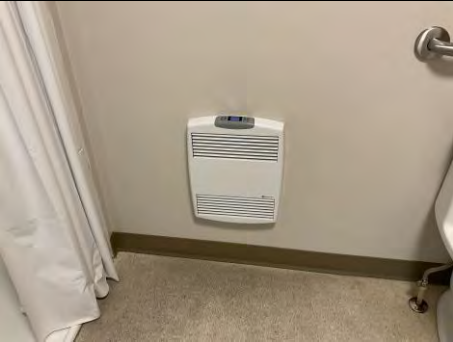
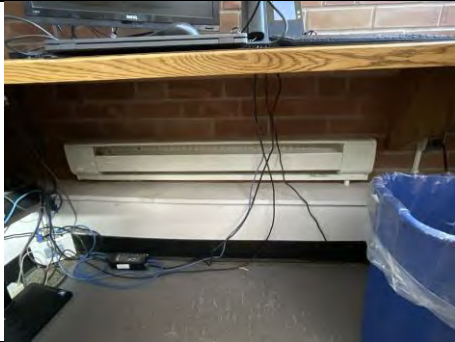
Element Name	Level 1 Major Group	Level 2 Group Element	Vintage	Service Life
Electric Heating Sources	D Services	D30 HVAC	2013	18
Description & Recommendation				
Electric wall heaters are present in select locations in the facility. There are units located near the exterior doors of the turrets, and units used for supplemental heating sources in the Front Office and Accessible Washroom. Electric baseboard heaters are also used for supplemental heating in areas such as the Box Office and Farmers Market. Overall the electric wall heating systems are in fair condition. Replacement is recommended on an as-fail basis. Action is anticipated in the medium term.

Condition Rating	Priority	Action	Action Year	Opinion of Probable Cost
Fair	Medium Term	Replace	2031	-8,000

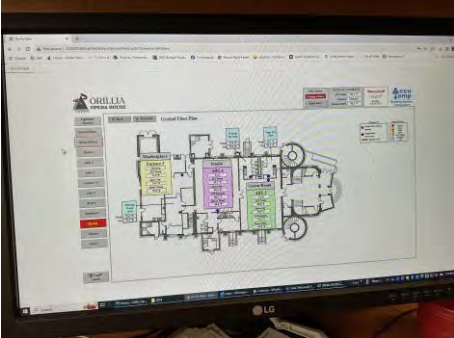
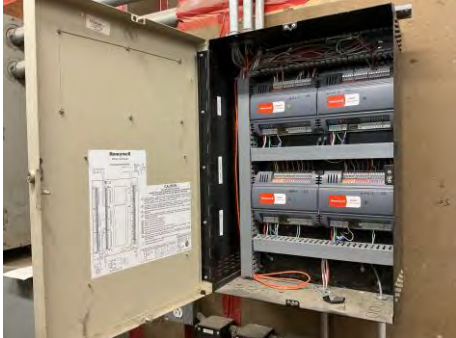
Element Name	Level 1 Major Group	Level 2 Group Element	Vintage	Service Life
BAS - DDC	D Services	D30 HVAC	2018	20
Description & Recommendation				
All major HVAC components are controlled by a Honeywell Building Automation System (BAS) with interface design executed by AccuTemp. Honeywell's Niagara Framework WEBs-N4 version 4.3.58.22.5 is installed on a workstation located in the second floor office area. The graphical interface includes real-time troubleshooting, advanced alarming, reporting, and remote connectivity. There are estimated to be 100 control points connected with various HVAC equipment on site such as boilers, hydronic radiators, and Air Handling Units (AHUs). No major issues reported with BAS system, however building operators noted the Furnace and AHU-4 need manual engagement to switch from heating to cooling, and vice-versa. Overall the BAS system is in good condition. Expected useful life is 20 years for controls and instrumentation systems. Replacement is anticipated in the long term.

Condition Rating	Priority	Action	Action Year	Opinion of Probable Cost
Good	Long Term	Replace	2038	-36,700

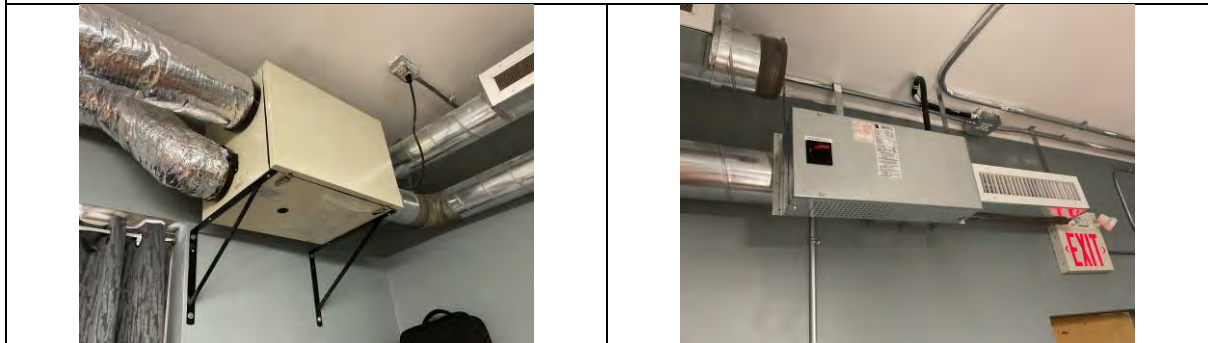
Element Name	Level 1 Major Group	Level 2 Group Element	Vintage	Service Life
Heat Recovery Ventilator	D Services	D30 HVAC	2018	18
Description & Recommendation				
Fresh air and ventilation for the Farmer Market is provided by a Venmar Fantech (model SHR150; serial N/A) Heat Recovery Ventilator (HRV) which serves as a Dedicated Outdoor Air System (DOAS). The air-to-air heat exchanger has a 2018 vintage and recovers sensible heat from exhaust air. The unit is equipped with a 4.0 kW Thermolec duct heater (model FC-CTPBX; serial 389804-001) to provide additional heating capacity during cold weather. Replacement is anticipated at end of useful life expectancy.

Condition Rating	Priority	Action	Action Year	Opinion of Probable Cost
Fair	Long Term	Replace	2036	-5,300

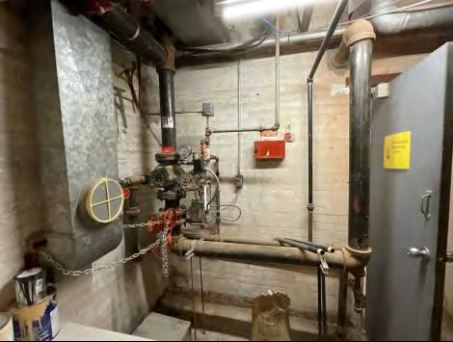
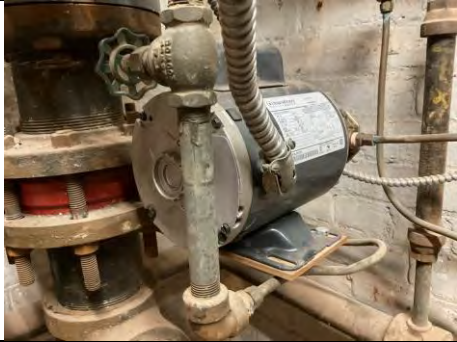
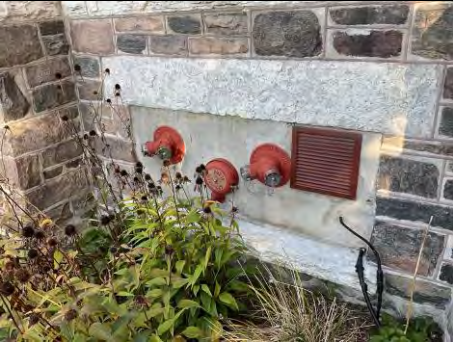
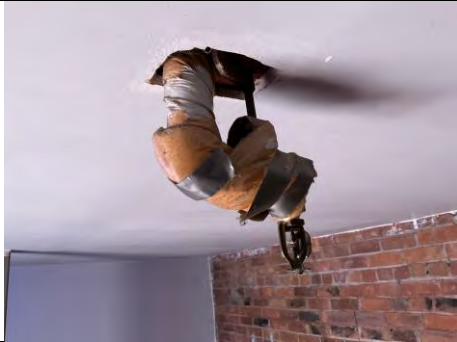
Element Name	Level 1 Major Group	Level 2 Group Element	Vintage	Service Life
Wet Sprinkler System	D Services	D40 Fire Protection	2016	75
Description & Recommendation				
<p>Fire suppression for the building is served by a wet sprinkler system. There are no sprinklers in the Foyer, Dressing Room #110, Office #111, Auditorium, and Stage. The main shutoff valve and jockey pump (Marathon electric model 5KC36MNB527X; serial K16J300126) is located on the incoming standpipe in the basement boiler room. A fire department Siamese connection is installed on the exterior wall of the at the south elevation. Expected useful life of standpipes systems 75 years. It is recommended to conduct a complete maintenance inspection for testing of valves, pipework, fittings, hanger/seismic bracing, and the sprinklers themselves in the long term.</p>

Good	Long Term	Maintain	2049	-31,900

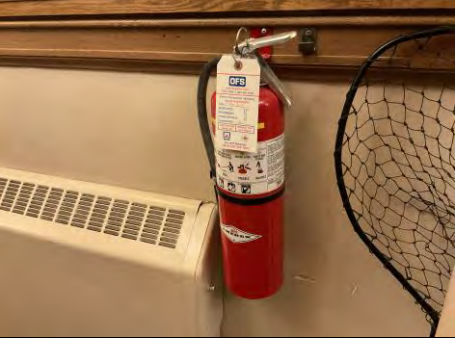
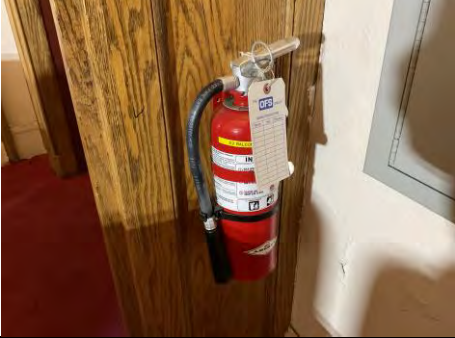
Element Name	Level 1 Major Group	Level 2 Group Element	Vintage	Service Life
Fire Extinguishers, Dry Chem, Portable	D Services	D40 Fire Protection	2006	8
Description & Recommendation				
Fire extinguishers are located throughout the building. The fire extinguishers are appropriately charged with their indicator dial set in the green zone. Unit vintages vary (1987, 2006, 2012, etc.) and the fire extinguishers are in fair condition overall. Replacement is anticipated in the short term and should be guided by routine life safety inspections.

Condition Rating	Priority	Action	Action Year	Opinion of Probable Cost
Fair	Short Term	Replace	2028	-3,500

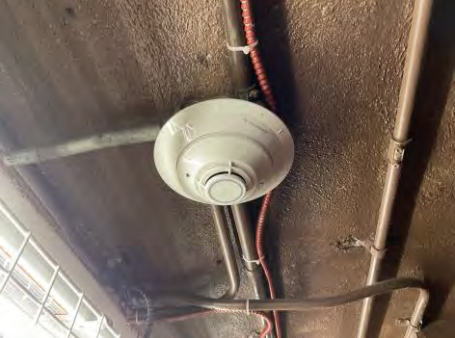
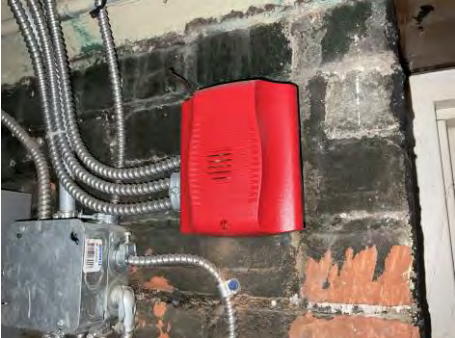
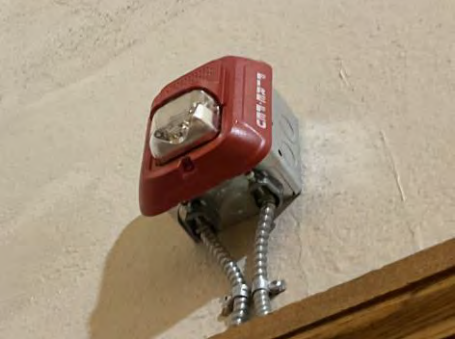
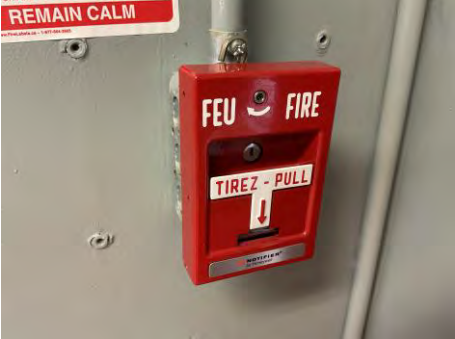
Element Name	Level 1 Major Group	Level 2 Group Element	Vintage	Service Life
Fire Protection Specialties	D Services	D40 Fire Protection	2018	20
Description & Recommendation				
Hardwired smoke and heat detectors, strobe alarms, and pull stations are installed throughout the building. The components are Notifier/Honeywell brand, which coincides with the manufacturer of the fire alarm control panel. No issues identified and overall the components are in good condition. Replacement should be guided by fire safety inspection program and is recommended to occur every 10-20 years. Action is anticipated in the long term.

Condition Rating	Priority	Action	Action Year	Opinion of Probable Cost
Good	Long Term	Replace	2038	-55,300

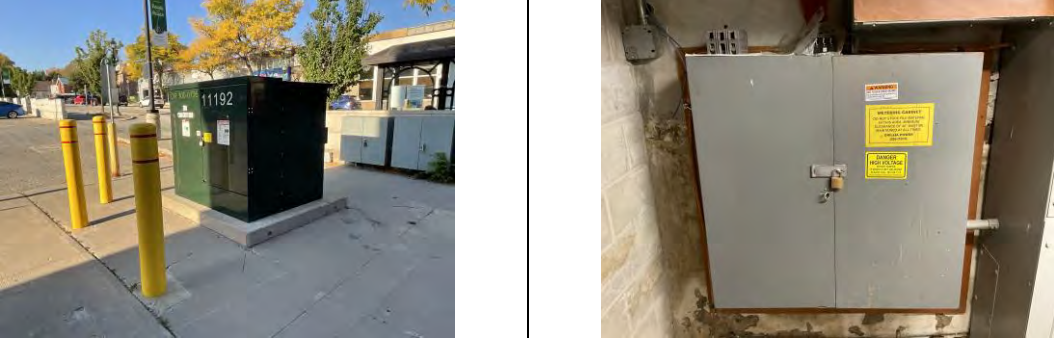
Element Name	Level 1 Major Group	Level 2 Group Element	Vintage	Service Life
Primary Transformer	D Services	D50 Electrical	2022	40
Description & Recommendation				
The electric feed from the utility is directed to one (1) 300 kVA pad mounted Cam Tran Co. Ltd. transformer located outside the building on the north-east elevation. High voltage (13.86 kV) is stepped down to a 120/208V service for the building. There is a utility grade meter located in a cabinet in the basement electrical room. No issues were identified with the transformer and meter, which are owned and operated under the responsibility of the local utility.

Condition Rating	Priority	Action	Action Year	Opinion of Probable Cost
Good	N/A	No Action	N/A	-

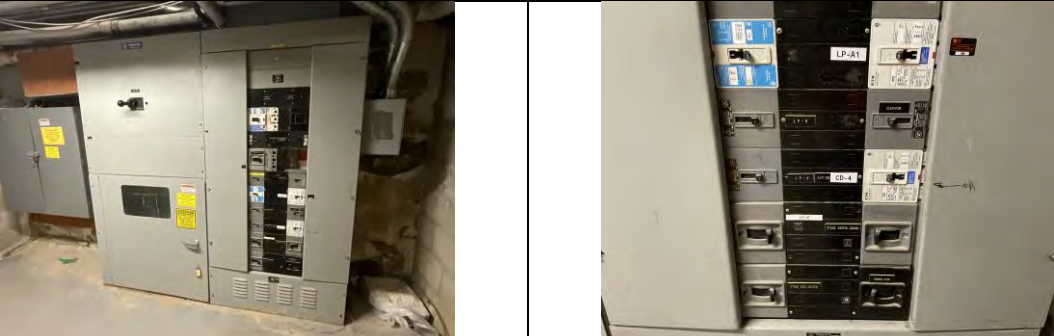
Element Name	Level 1 Major Group	Level 2 Group Element	Vintage	Service Life
Switchgear	D Services	D50 Electrical	1982	40
Description & Recommendation				
Power from the primary transformer is directed to a 1,200-amp Westinghouse switchgear unit located in the basement Electrical room. The switchgear vintage is assumed to be 1982. The expected useful life for commercial grade electrical systems is generally 30-40 years, if properly maintained. The assessment noted breaker switches have been replaced with Eaton units, which may be a result of the maintenance program identifying potential overheating locations within the switchboard, or the installation of new equipment. The switchgear is recommended for replacement in the short term as it is at the end of its life cycle.

Condition Rating	Priority	Action	Action Year	Opinion of Probable Cost
Poor	Short Term	Replace	2025	-33,200

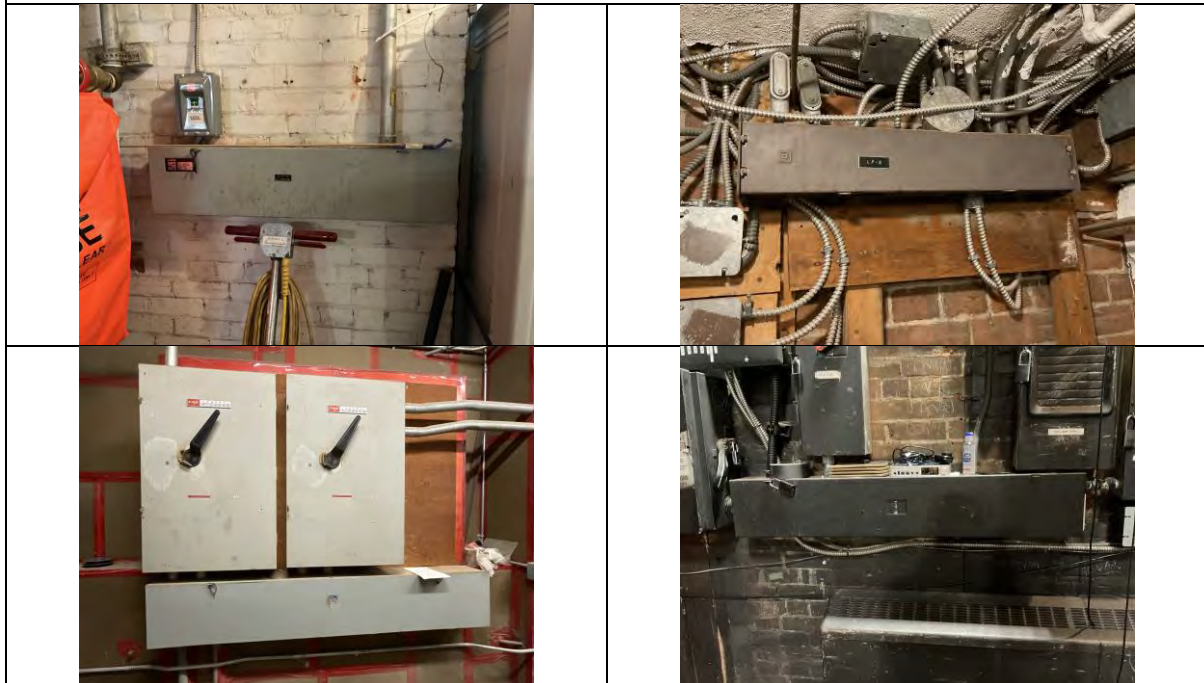
The assessment identified five (5) splitter boxes. There is a Stelpro unit serving the DHW heater, a Square D unit serving subpanel LP-E, a BEL inc unit in the penthouse serving disconnects for AHU-1 & AHU-2, and two (2) splitters (make N/A) on the Lightfoot theatre stage for auxiliary equipment. During the site investigation, no testing of systems were undertaken and the enclosures were not opened to verify internal components. Splitter vintages are expected to date to the 1980s era, putting them at the end of their expected useful life. Replacement is recommended in the short term.

Condition Rating	Priority	Action	Action Year	Opinion of Probable Cost
Poor	Short Term	Replace	2025	-43,500

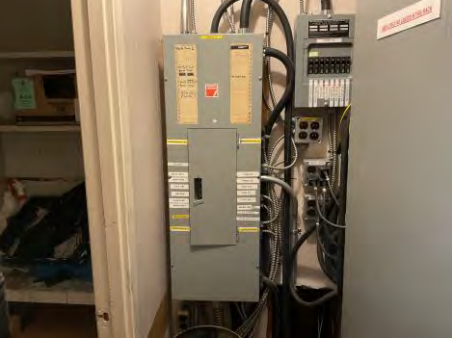
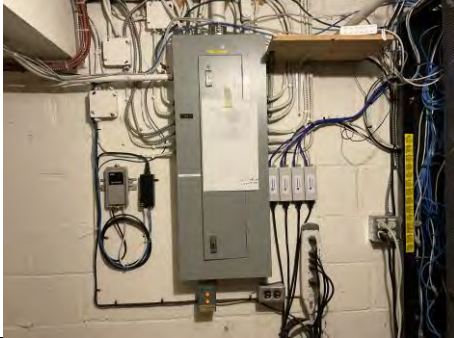
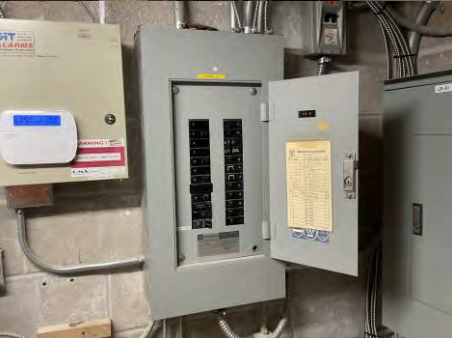
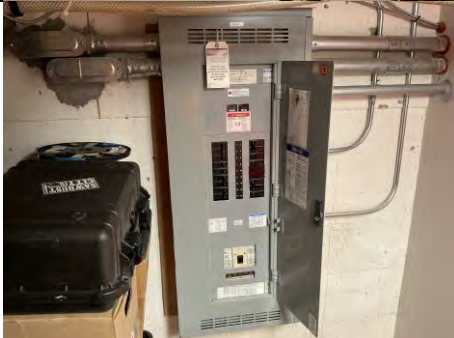
Description & Recommendation				
<p>The electrical delivery consists of 120/208V distribution panels, branch panels, and breaker switches for power to building equipment, lighting, and receptacles loads. Panels include one (1) Westinghouse (Panel 2), two (2) Federal Pioneer (Panel 4 & Panel 8), and two (2) Eaton (Panel LP-A1 & Panel LP-B). The Westinghouse and Federal Pioneer panels have reached the end of their expected useful life of 40 years. Replacement is anticipated in the short term and should be guided by the maintenance program. Eaton panels have a 2013 vintage and are in good condition. Replacement is not anticipated in term of analysis.</p>

Condition Rating	Priority	Action	Action Year	Opinion of Probable Cost
Poor	Short Term	Replace	2025	-30,900

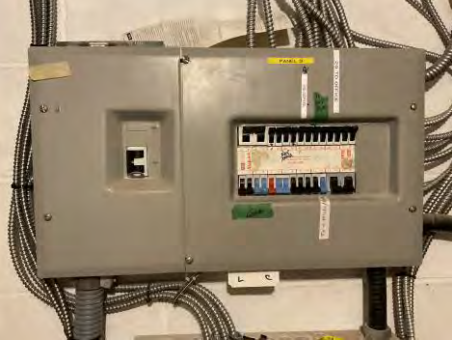
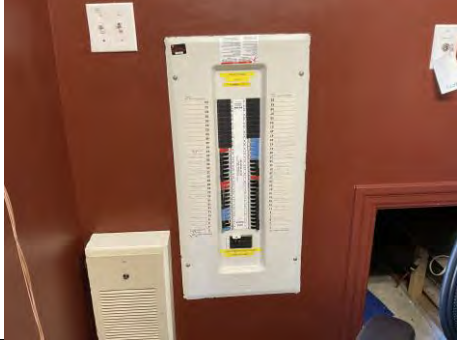
Description & Recommendation				
There are four (4) 125-amp and one (1) 225-amp Stab Lok panels on site, including Panel 3 (basement), Panel 3A (basement), Panel 5 (Studio Theatre Server Room), Panel 7 (Front Office), and Panel 8B (Lightfoot Theatre Stage). Stab-lok panels have been found to fail safety requirement testing and therefore are considered a safety risk. Replacement is recommended in the immediate term.

Condition Rating	Priority	Action	Action Year	Opinion of Probable Cost
Poor	Immediate	Replace	2024	-24,000

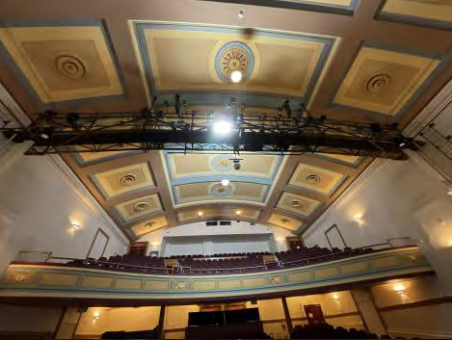
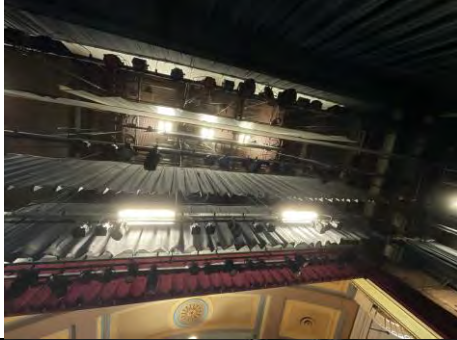
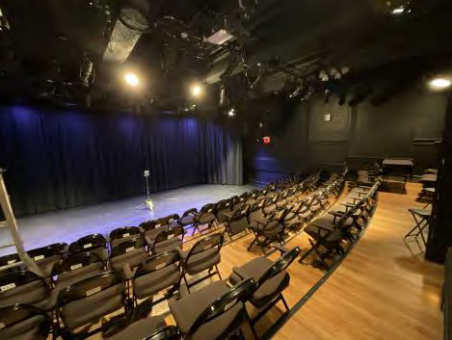
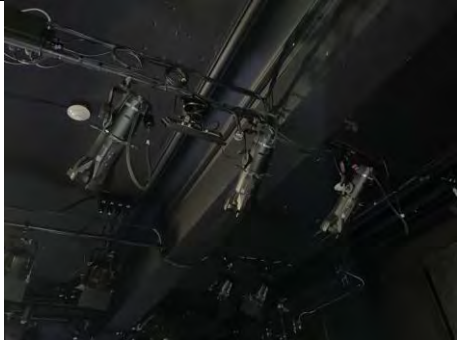
Element Name	Level 1 Major Group	Level 2 Group Element	Vintage	Service Life
Theatre Lighting	D Services	D50 Electrical	2016	20
Description & Recommendation				
Both theatres are fully equipped with professional lighting equipment. The specialty lighting systems were updated in 2016 and are in good condition overall. Replacement is anticipated in the long term.

Condition Rating	Priority	Action	Action Year	Opinion of Probable Cost
Good	Long Term	Replace	2036	-215,000

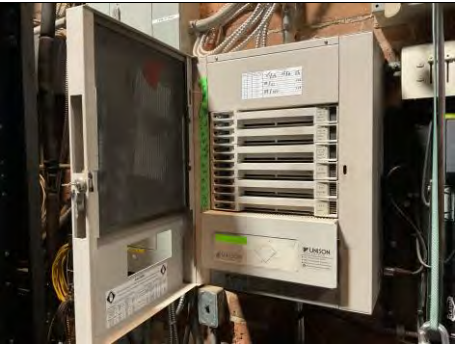
Element Name	Level 1 Major Group	Level 2 Group Element	Vintage	Service Life
Lighting Control System	D Services	D50 Electrical	1999	20
Description & Recommendation				
Lighting equipment for the Lightfoot Theatre is operated with an Unison lighting control panel (model DR6; serial N/A). The controller has an assumed 1999 vintage and is in fair condition. Replacement is anticipated in the short term.

Condition Rating	Priority	Action	Action Year	Opinion of Probable Cost
Fair	Short Term	Replace	2025	-13,000

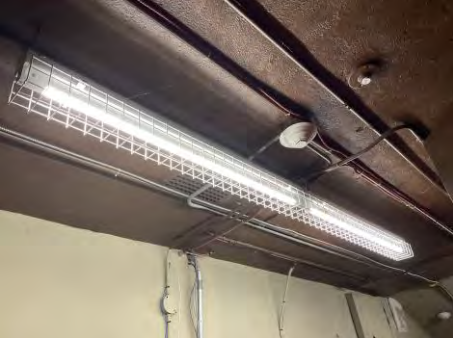
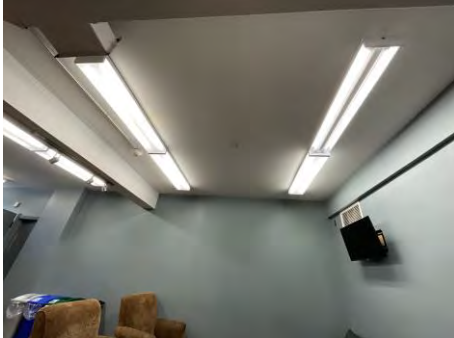
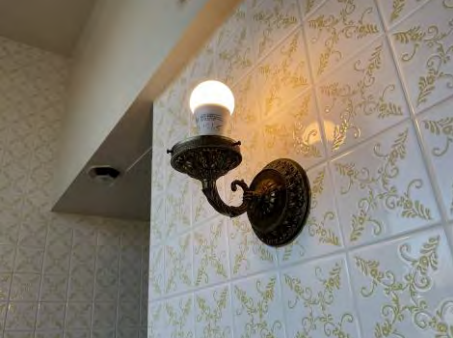
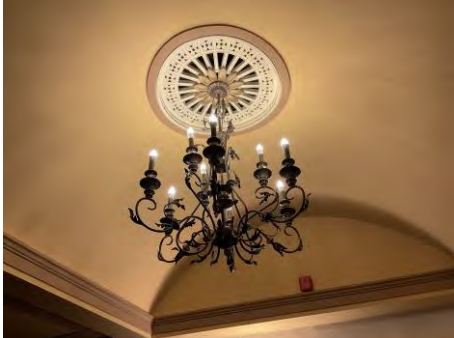
Element Name	Level 1 Major Group	Level 2 Group Element	Vintage	Service Life
Interior Fixtures - LED	D Services	D50 Electrical	2016	20
Description & Recommendation				
<p>The facility has undertaken lighting efficiency projects with LED providing the majority of illumination throughout the building. Linear fluorescent lamps were retrofitted with LED equivalent tubes. Traditional lamps (incandescent, compact fluorescent) used in screw-base sockets were replaced with A19 LED bulbs. Halogen pot lights were replaced with M16 LED bulbs. Bulbs in specialty fixtures such as chandeliers located in the Upper Lobby and Auditorium were replaced with LED Candelabra bulbs. Lighting control sensors are provided in spaces with intermittent occupancy. Overall the LED lighting systems are in good condition. Complete fixture replacement is anticipated in the long term.</p>

Good	Long Term	Replace	2036	-165,000

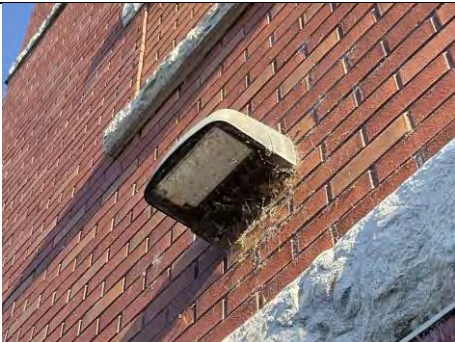
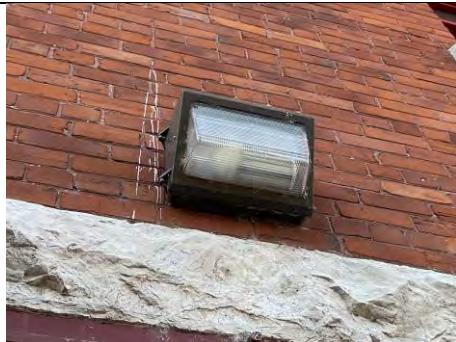
Element Name	Level 1 Major Group	Level 2 Group Element	Vintage	Service Life
Exterior Fixtures - LED	D Services	D50 Electrical	2016	20
Description & Recommendation				
<p>Exterior lighting around the building envelope is provided via five (5) wall packs. The wall packs have either been retrofitted with LED lamps, or replaced completely with LED units. There are four (4) suspended lighting fixtures at the main entrance with LED bulbs. There is one (1) wall sconce with LED bulb at the Market egress door. All exterior lighting is controlled via timer. The exterior lighting is in good condition with replacement anticipated in the long term.</p>

Condition Rating	Priority	Action	Action Year	Opinion of Probable Cost
Good	Long Term	Replace	2036	-2,900

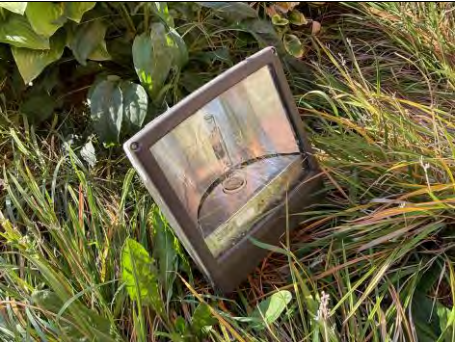
Element Name	Level 1 Major Group	Level 2 Group Element	Vintage	Service Life
Exterior Fixtures - HPS	D Services	D50 Electrical	1999	20
Description & Recommendation				
There are two (2) ground mounted flood lights on the south elevation of the building and one (1) unit on the roof directed towards the library parking lot. The fixtures are lamped with High Pressure Sodium (HPS) bulbs. Replacement are recommended on an as-fail basis. Action is anticipated in the short term.

Condition Rating	Priority	Action	Action Year	Opinion of Probable Cost
Fair	Short Term	Replace	2025	-1,000

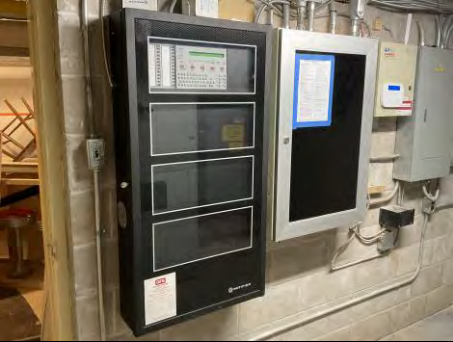
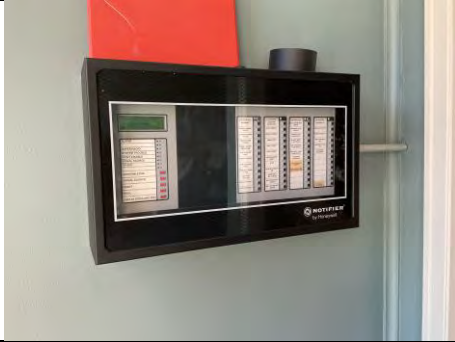
Element Name	Level 1 Major Group	Level 2 Group Element	Vintage	Service Life
Fire Alarm Control Panel	D Services	D50 Electrical	2018	20
Description & Recommendation				
Fire detection is activated by a two-stage Notifier fire alarm system. There is a NFS-3030D control panel located in the basement Electrical room with annunciator panels located in the Front Lobby and Studio Theatre Entrance. Overall coverage of detectors and alarms appeared adequate. Installation includes head end equipment, pull stations, bells, heat and smoke detectors, conduit, wire and connections. The fire alarm system is inspected annually in compliance with the requirement of

the National Fire Code. It has a 2018 vintage and is in overall good condition. Replacement is anticipated in the long term.

Condition Rating	Priority	Action	Action Year	Opinion of Probable Cost
Good	Long Term	Replace	2038	-22,300

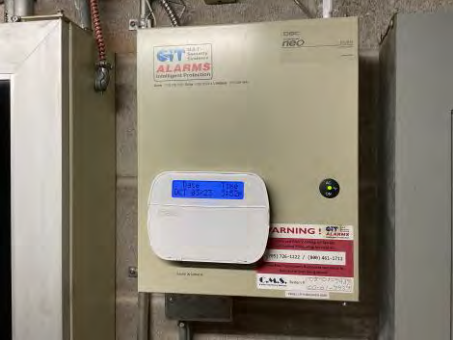
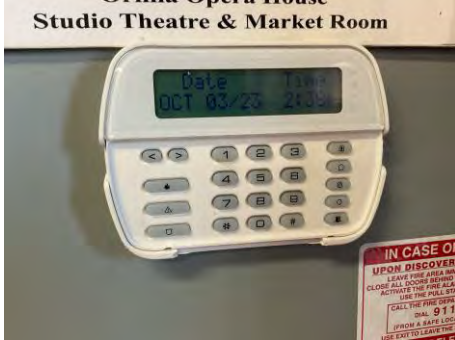
Element Name	Level 1 Major Group	Level 2 Group Element	Vintage	Service Life
Security Alarm System	D Services	D50 Electrical	2016	20
Description & Recommendation				
The facility is equipped with a DSC security system with burglary alarm. The central control panel is located in the basement Electrical room and there are three (3) keypads present including in the Main lobby, Farmers Market, and Studio Theatre Entrance. The system is understood to be monitored by a third party, in which they alert authorities should the burglary alarm activate. The keypad, associated wiring, and end-use devices have a 2016 vintage. Replacement/upgrading the security system should be done every 20 years. Replacement is anticipated in the long term.

Condition Rating	Priority	Action	Action Year	Opinion of Probable Cost
Fair	Long Term	Replace	2036	-4,300

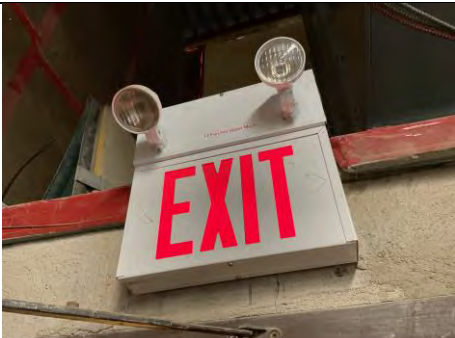
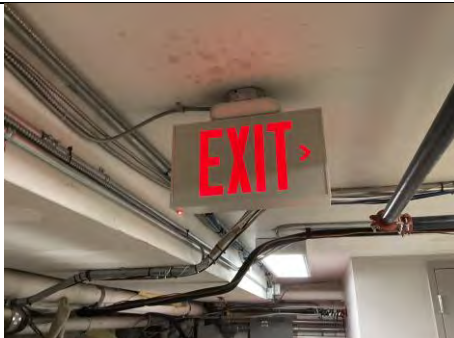
Element Name	Level 1 Major Group	Level 2 Group Element	Vintage	Service Life
Exit Lighting	D Services	D50 Electrical	2012	20
Description & Recommendation				
The building includes an average density exit lighting system of wall mounted exit signs. The quantity and coverage of the signage appeared to be adequate. All exit signs were illuminated during the site visit and which is compliant with Canadian Electrical Code (CEC) requirements. The units are in an

adequate working condition. Replacement is anticipated in the medium term and should be guided by life safety inspections.

Condition Rating	Priority	Action	Action Year	Opinion of Probable Cost
Fair	Medium Term	Replace	2032	-6,800

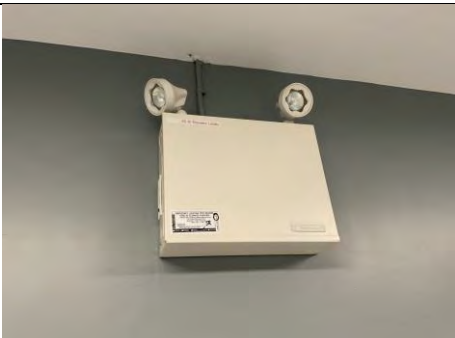
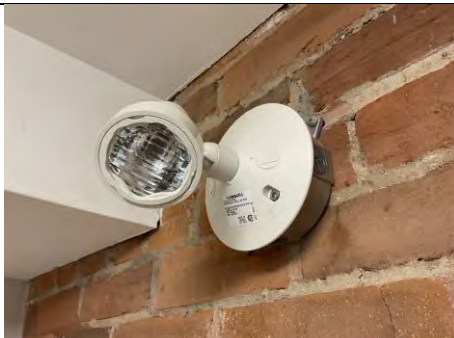
Element Name	Level 1 Major Group	Level 2 Group Element	Vintage	Service Life
Emergency Lighting, Self-Contained Lamp Pack	D Services	D50 Electrical	2012	10
Description & Recommendation				
The building includes an average density emergency lighting system consisting of self contained lamp pack and remote light heads. The units are connected to integrated batteries that will engage and illuminate when line utility power drops out. Various vintages are present indicating units are replaced on an as-fail basis as a result of routine life safety inspections. Replacement is anticipated in the medium term and should be guided by maintenance regime.

Condition Rating	Priority	Action	Action Year	Opinion of Probable Cost
Fair	Medium Term	Replace	2032	-10,200

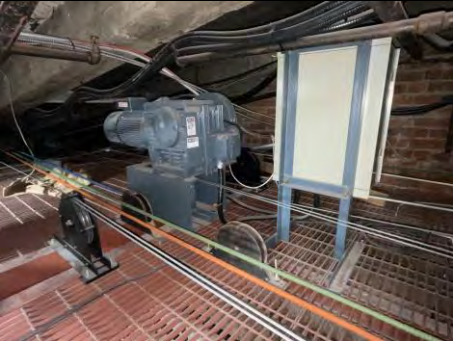
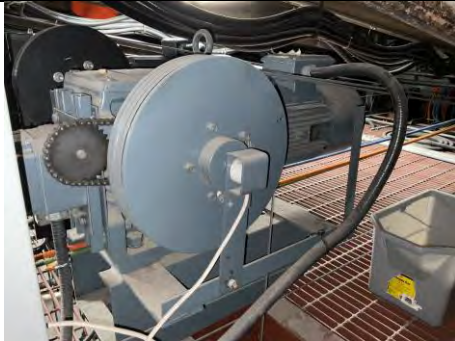
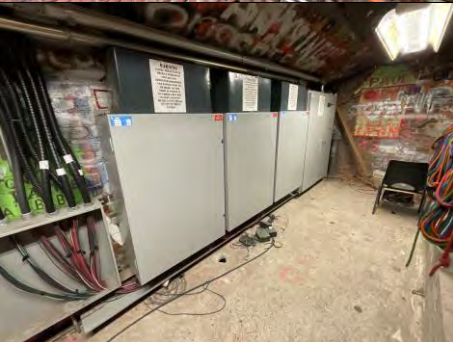
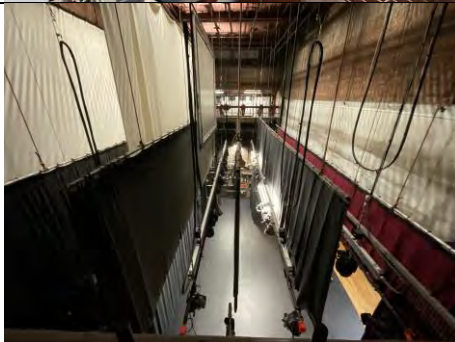
Element Name	Level 1 Major Group	Level 2 Group Element	Vintage	Service Life
Curtain System	E Equipment & Furnishings	E10 Equipment	2000	20
Description & Recommendation				
<p>The Lightfoot Theatre is equipped with a motorized curtain system. There are twelve (12) 7.5 horsepower motors located in the rafters above the stage. The SEW-Eurodrive motors operate various cable, pulley, and flybar systems to allow for controlled adjustments of stage drapes during performances. The curtain system is linked with the Fire Alarm Control Panel and will drop the fire curtain to create a fire separation between the auditorium and stage during a stage 2 event. It receives routine inspections with the last review occurring September 12 2023, by Zelus Material Handling. Replacement should be guided by maintenance program. No work is foreseen in the short or medium term other than general preventative maintenance assuming normal use is continued. The curtain system is anticipated to function adequately for another 10 years. Opinion of probable cost for curtains, drapes, backdrop, etc. was not considered.</p>

Condition Rating	Priority	Action	Action Year	Opinion of Probable Cost
Fair	Medium Term	Replace	2034	-63,800

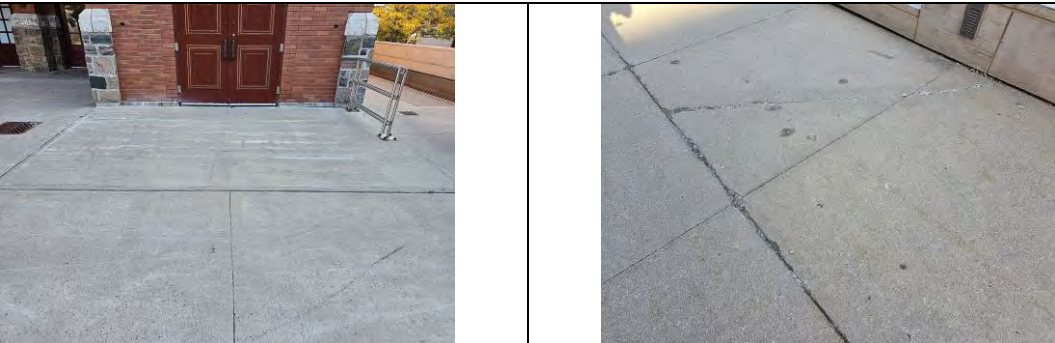
Element Name	Level 1 Major Group	Level 2 Group Element	Vintage	Service Life
Concrete Walkways	G Building Sitework	G20 Site Improvements	1980	40
Description & Recommendation				
A concrete walkway is installed around the building and includes ways for visitors with mobility issues to access the building via integrated ramps that lead to raised doorways. The concrete is intact and showing no areas of concern, though there is scraping visible. No action is required at this time. A major replacement is expected in the long term.

Condition Rating	Priority	Action	Action Year	Opinion of Probable Cost
Fair	Long Term	Replace	2037	-160,000

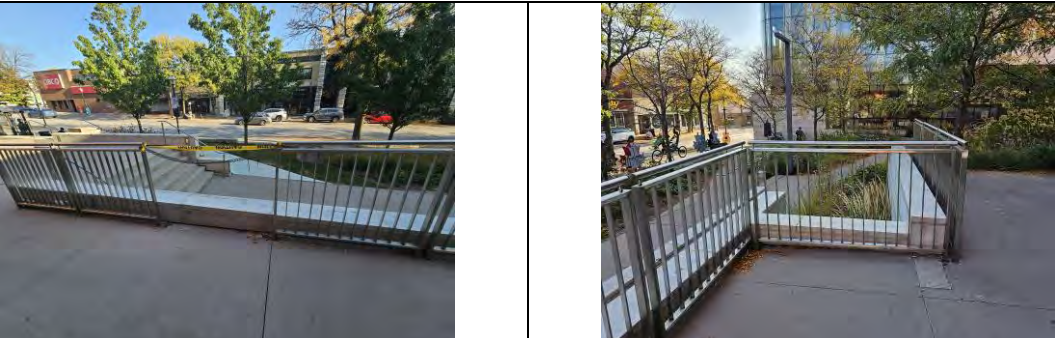
Element Name	Level 1 Major Group	Level 2 Group Element	Vintage	Service Life
Railings - Metal	G Building Sitework	G20 Site Improvements	2013	30
Description & Recommendation				
The units are intact and set into the concrete approximately two inches. There is a known issue of persons attempting, and succeeding, in removing sections of railing. No action is required at this time, though methods to deter malice is advisable. A major replacement of the fencing is expected to be required in the long term.

Condition Rating	Priority	Action	Action Year	Opinion of Probable Cost
Fair	Long Term	Replace	2043	-11,000
