ORILLIA OPERA HOUSE | CONSERVATION PLAN UPDATE 2025

July 2nd, 2025 DRAFT

Orillia Opera House

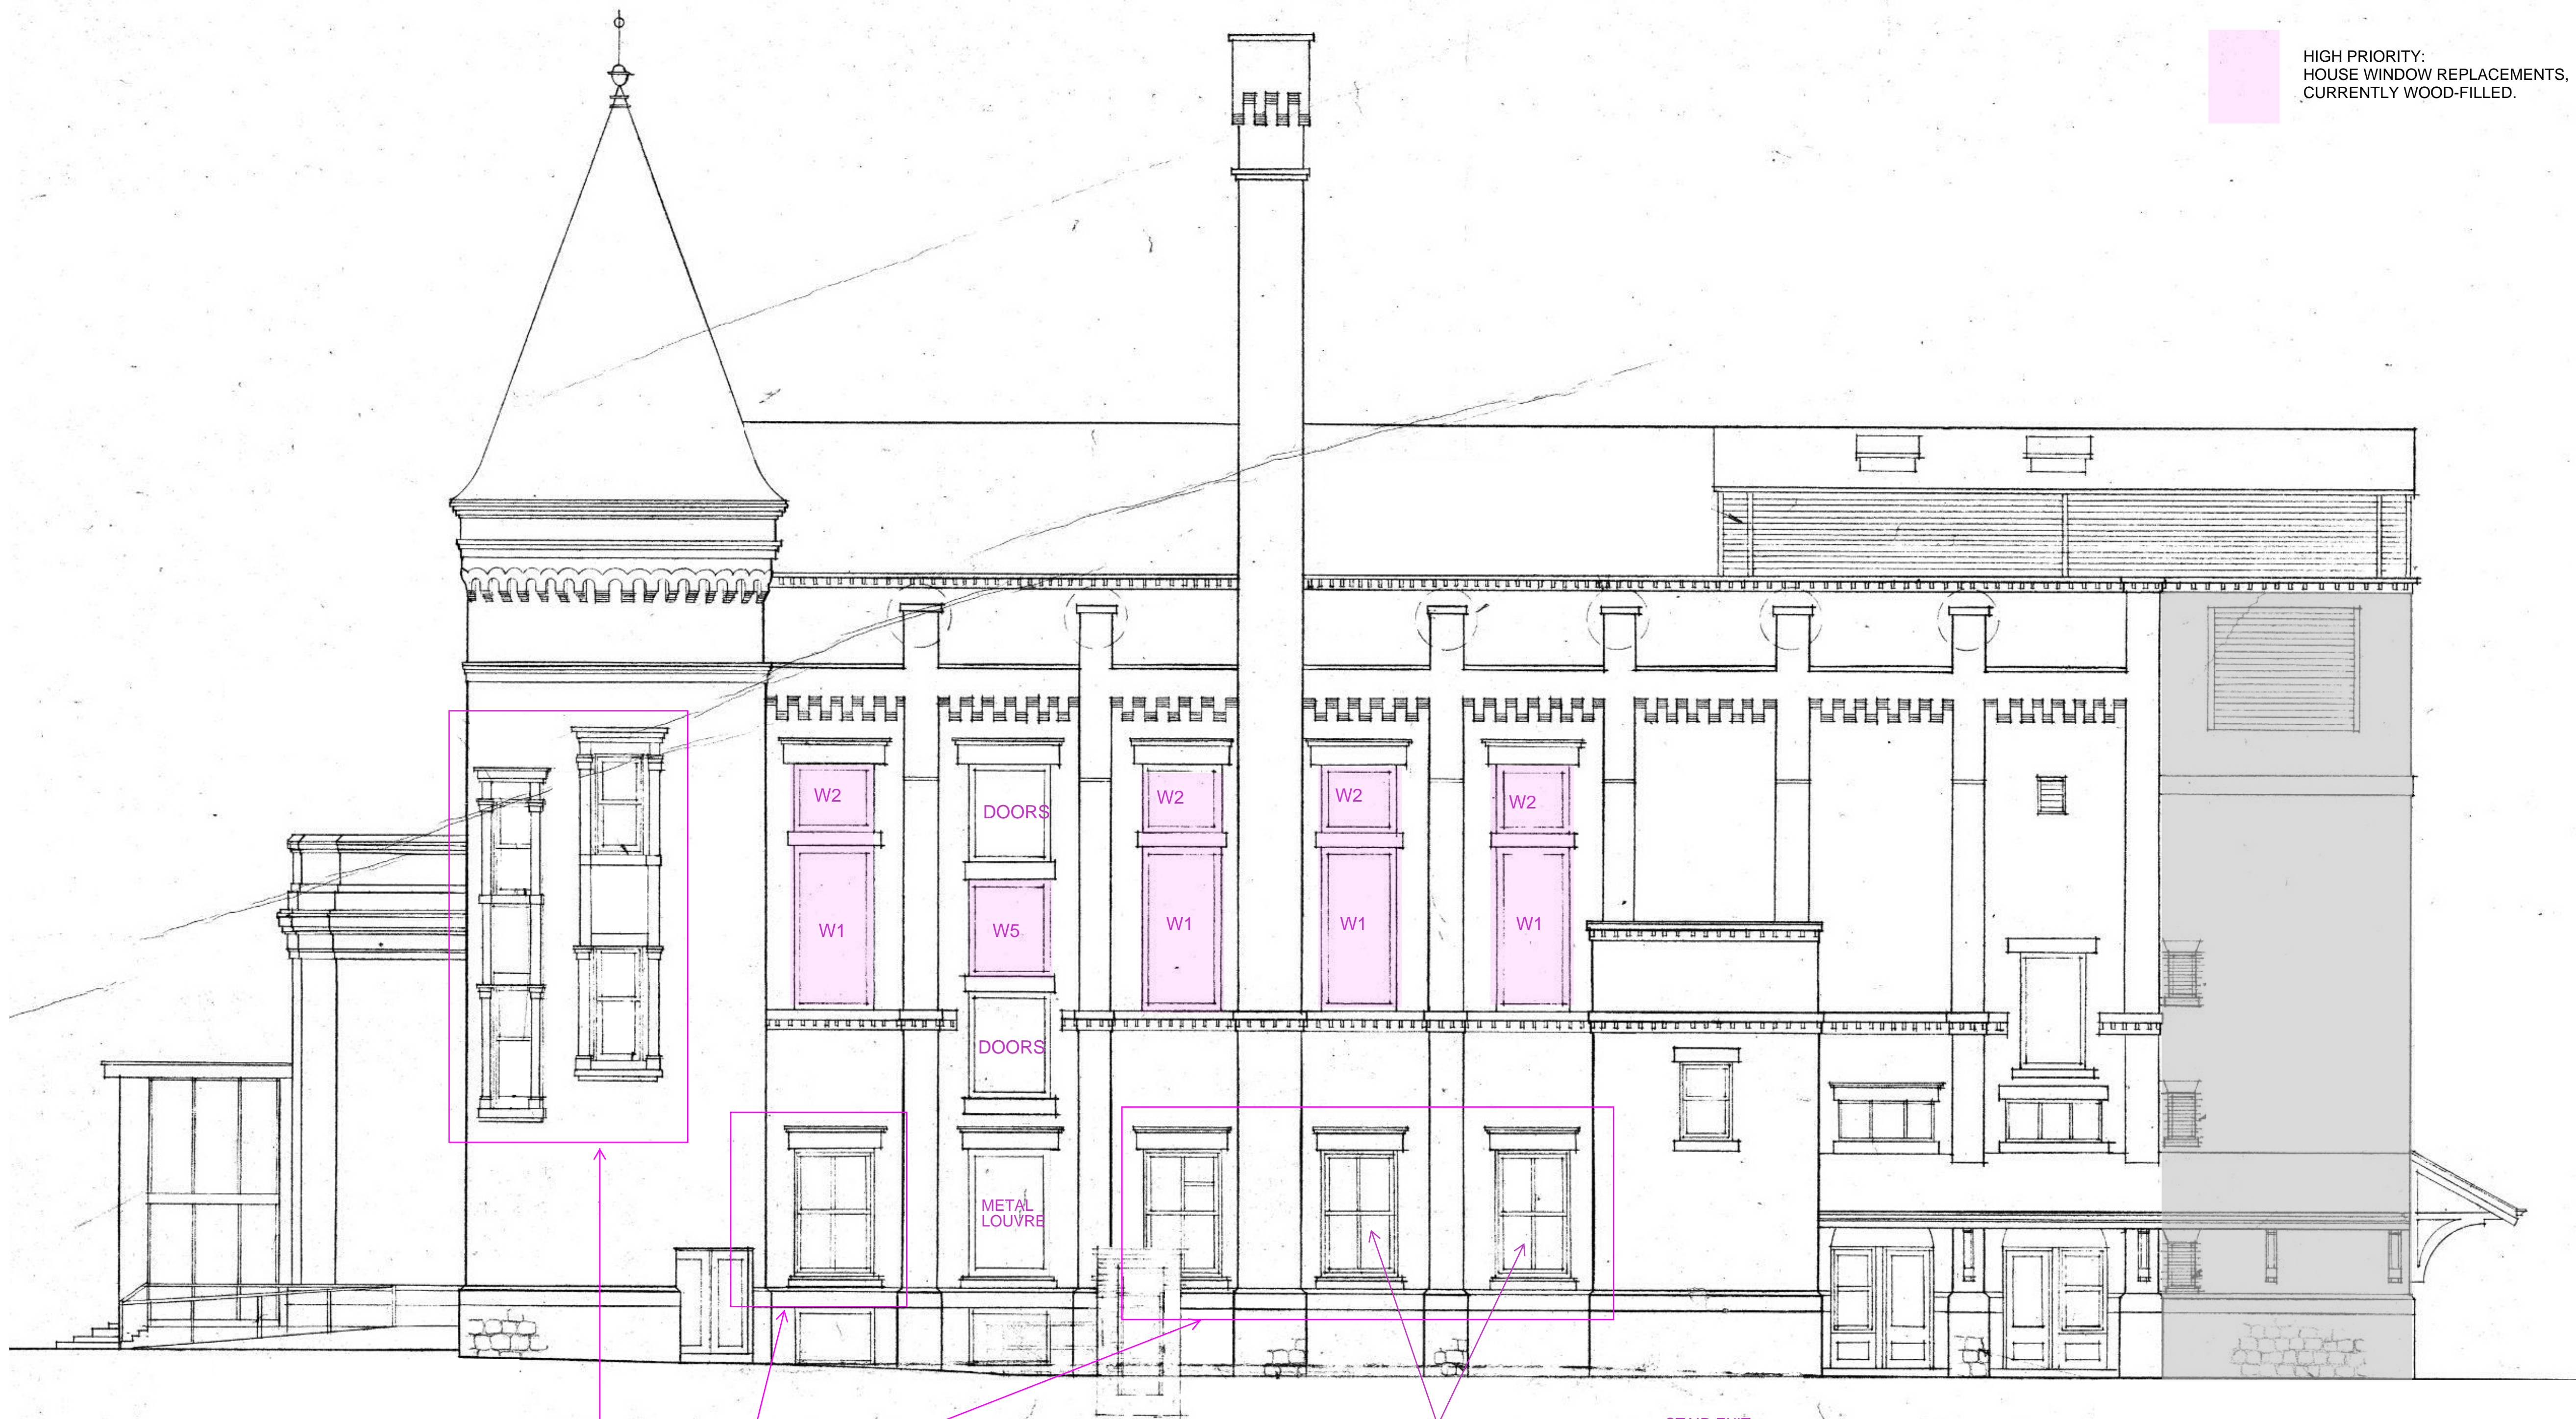
HIGH PRIORITY:
HOUSE WINDOW REPLACEMENTS,
CURRENTLY WOOD-FILLED.
